Lemon Creek Watershed Recovery and Management Plan

July 2007

Statement of Purpose and Need

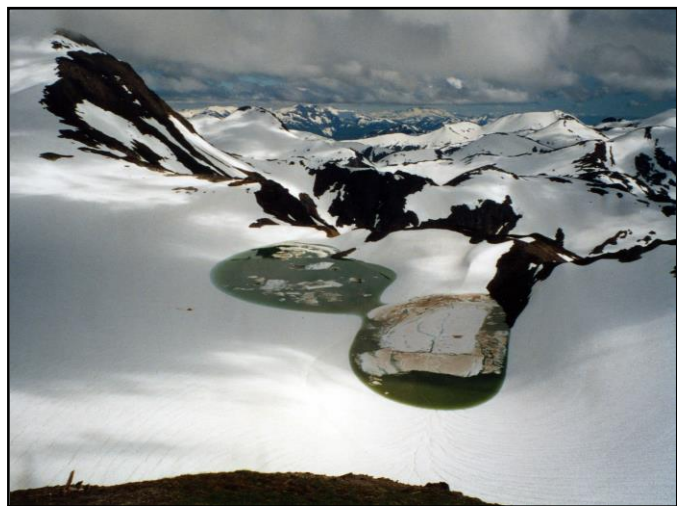
Figure 5. Supra-glacial lakes on Lemon Glacier fill and drain intermittently throughout the summer and into fall. *Photo: S. Seifert.*

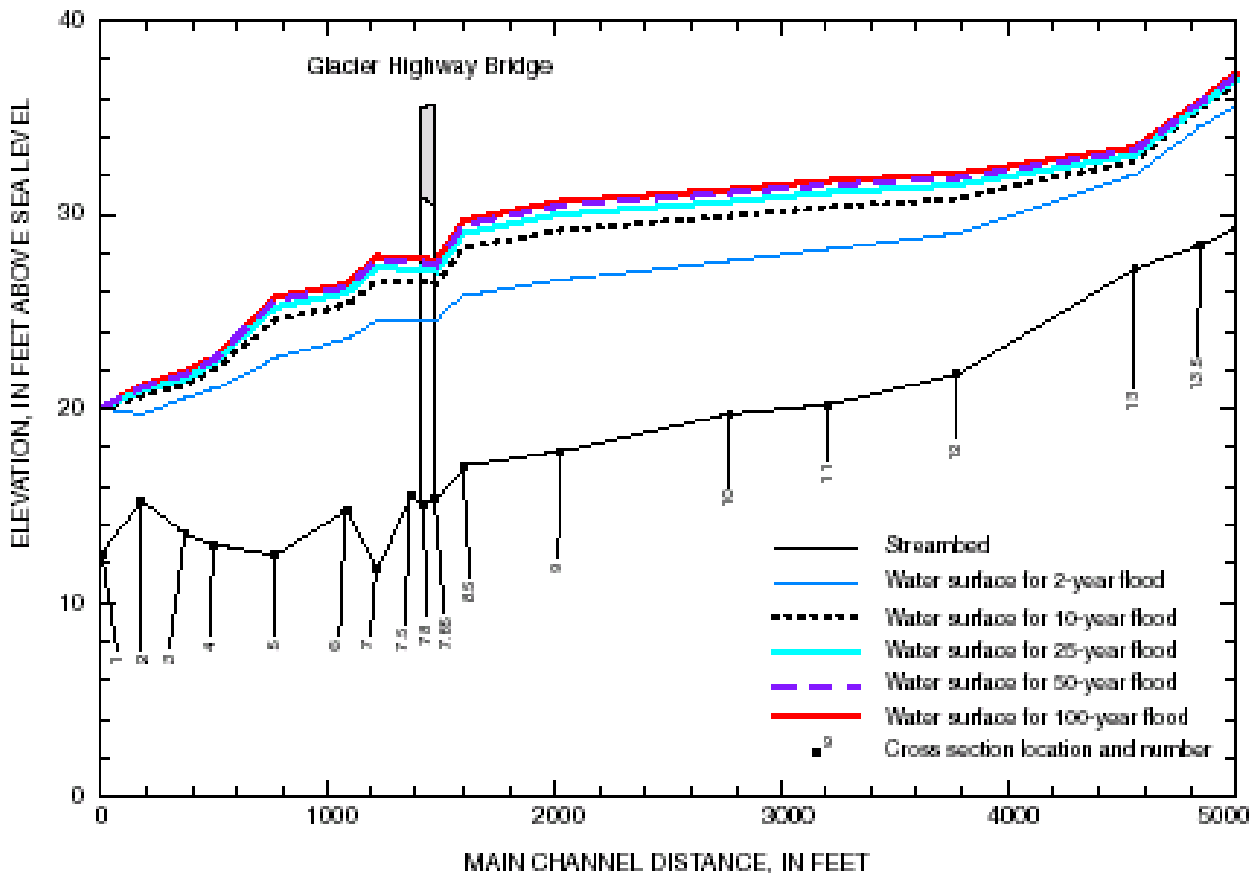
Figure 6: Profile of computer water-surface elevations, streambed elevations, and locations of cross sections on lower Lemon Creek for 2-, 10-, 25-, 50-, and 100-year floods, with the lower ReadMix Bridge removed. Reproduced from U.S. Geological Survey results of HEC-RAS streamflow simulation on Lemon Creek (Host, 2005).

The USGS surveyed Lemon Creek channel cross sections to determine rates of channel aggradation or degradation between 2002 and 2004. No clear trend of aggradation or degradation was defined for this two-year period of study. Subsequent U.S. Army Corps of Engineers HEC-RAS streamflow modeling resulted in estimates generated profiles of water elevations for 2-, 10-, 25-, 50-, and 100-year floods (assuming the Juneau ReadMix bridge was removed). Figure 6, reproduced from the USGS report, shows these flood profiles. Channel cross-section 8.5, just upstream of the Glacier Highway Bridge, is the only cross-section showing over-bank flow (flooding). Since the removal of the ReadMix Bridge in 2006, this model is potentially representative of existing conditions (Host, 2005), however the impact of Ready-Mix Bridge removal has not yet been assessed.

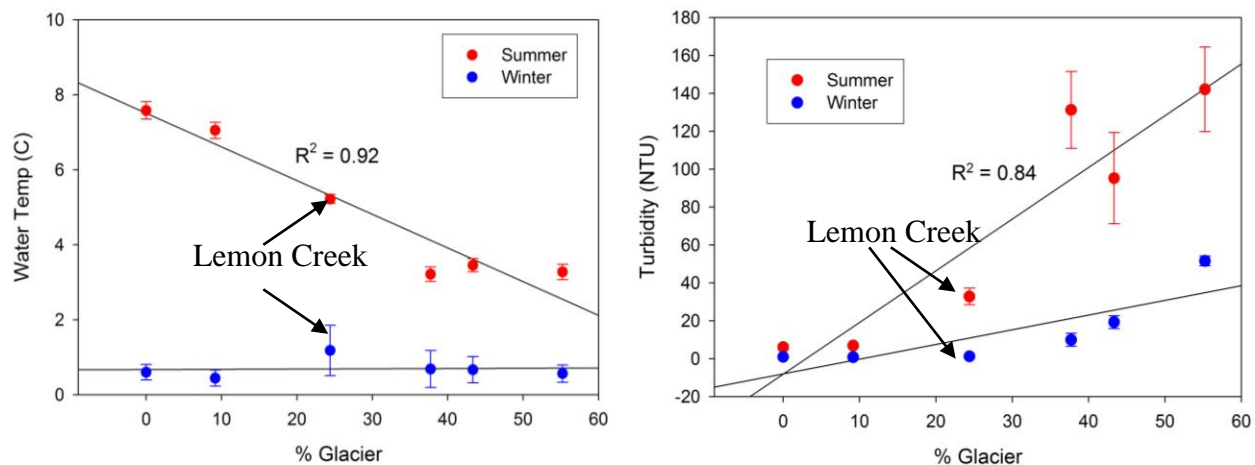
Figures 8 and 9: Water temperature and turbidity as a function of percent glaciated area for five southeastern Alaska watersheds. Lemon Creek is highlighted in the middle of the data set. Figures provided by Dr. Eran Hood, UAS.

As Lemon Creek Watershed transitions from a glaciated to a non-glaciated catchment, the hydrology regime will change, exhibiting lower sustained summer flows during dry periods and more “flashy” peak flows associated with rainfall and a lack of precipitation storage as snow. In addition to this change in discharge regime, widespread sediment and turbidity changes will also occur. For example, in comparison to other watersheds in the Borough of Juneau, Lemon Creek’s summer turbidity levels more closely resemble those of Cowee and Montana Creeks (highly productive salmon streams, little to no glaciated area in the watershed) than Mendenhall, Herbert, and Eagle Rivers (less productive, glaciated watersheds). Winter turbidity levels are the same across the board since glacier activity is minimal in winter (Eran Hood, UAS, personal communication). Figures 8 & 9 demonstrate water temperature and turbidity as a function of watershed area for six watersheds on the Juneau road system: from left to right, Montana Creek, Cowee Creek, Lemon Creek, Herbert River, Eagle River, and Mendenhall River. Notice that Lemon Creek falls in the middle of this group and exhibits lower turbidity and higher water temperatures relative to other local glaciated watersheds.

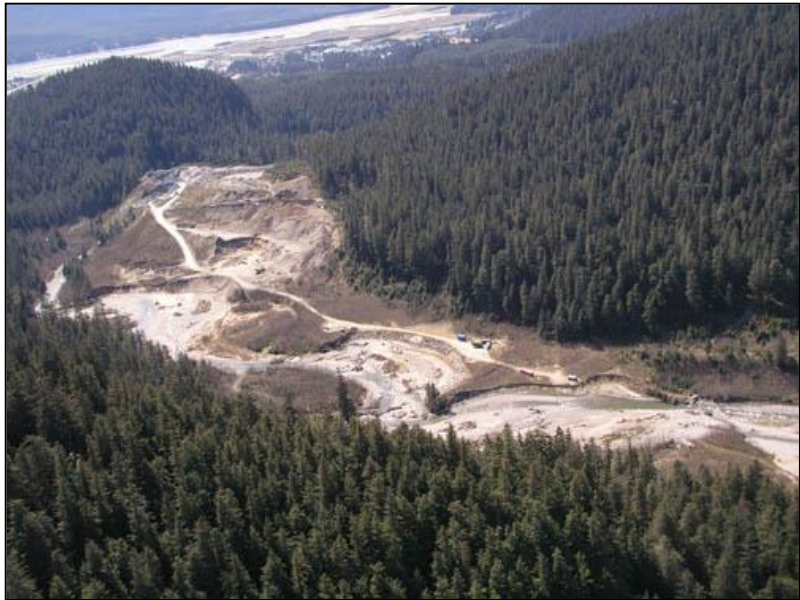
Figure 10: Hidden Valley. Land use, highly erodable banks, and Lemon Creek collide, sending sediment downstream. *Photo: CBJ*

Highly erodable stream banks in the Hidden Valley area supply excessive sediment to lower-gradient, confined urban reaches downstream (Figure 10: Hidden Valley Area of Lemon Creek). In November 2005, high streamflow undermined two large cut banks, transporting tons of sediment, vegetation, and debris into Lemon Creek. This event carried away two large containers and some other equipment stored at the end of the access road and lodged them downstream.

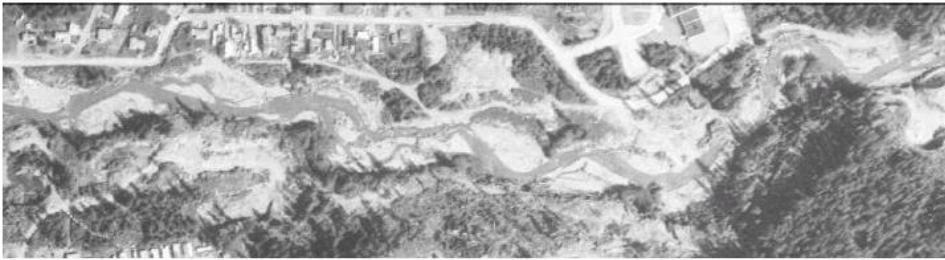
1974 AIR PHOTO

PARTIALLY INTACT RIPARIAN MARGIN AND CHANNEL COMPLEXITY PROVIDES HABITAT. CHANNEL IS DISTURBED BUT SIMILAR TO WHAT MAY HAVE EXISTED BEFORE DEVELOPMENT. AVULSION CHANNELS AND SIDE CHANNELS MAY HAVE OCCURRED ALONG HISTORIC FLOOD TERRACES WHERE ROADS AND BUILDINGS EXIST IN THIS PHOTO. THIS CANNOT BE CONFIRMED DUE TO THE LACK OF HISTORICAL RECORDS.

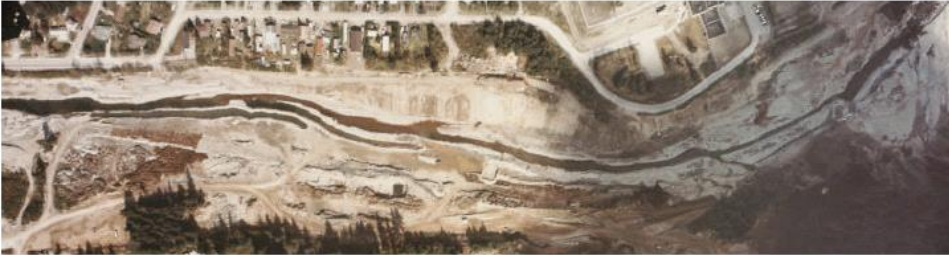
1984 AIR PHOTO

PHOTO SHOWS MINING OPERATIONS HAVE STRAIGHTENED AND DEEPEINED THE STREAM CAUSING MULTIPLE STREAM MEANDER CUTOFFS. THE LOSS IN GRADE DUE TO CUTOFFS AND EXCAVATION RESULTED IN HEADWARD EROSION UPSTREAM OF THE WORK AREA AND A FLATTER DEPOSITIONAL REACH WITHIN THE EXCAVATED AREA.

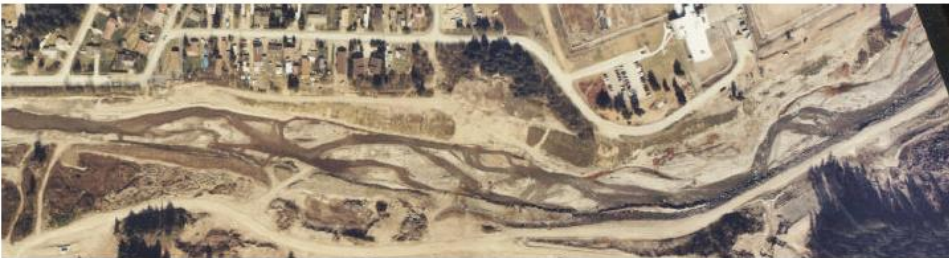
1988 AIR PHOTO

PHOTO SHOWS PREVIOUSLY EXCAVATED CHANNEL TRANSFORMING BACK TO THE BED FORM THAT EXISTED BEFORE EXCAVATION OBSERVED IN 1984 PHOTO. FORMATION OF GRAVEL BARS AND MEANDERING PLANFORM ARE CHANNEL RESPONSE TO RESTORE GEOMORPHIC FORM AND COMPLEXITY.

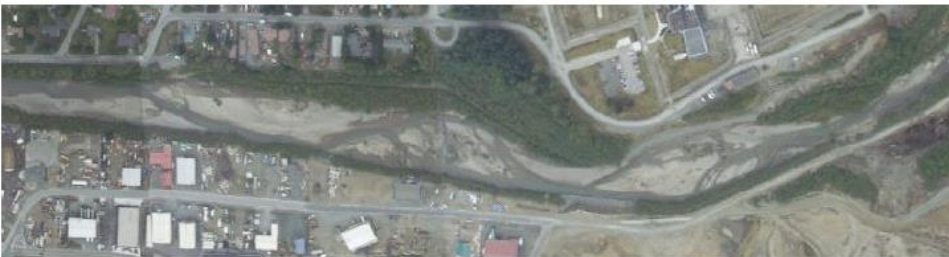
2002 AIR PHOTO

PHOTO SHOWS A CONTINUATION OF DEPOSITION AND REBUILDING OF GRADIENT AND CHANNEL GEOMETRY THAT EXISTED BEFORE EXCAVATION. THE PHOTO SEQUENCE IN THIS DRAWING IS A GOOD EXAMPLE OF CHANNEL PROCESSES REBUILDING STREAM GRADE AND GEOMETRY THAT ARE CONSISTENT WITH PHYSIOGRAPHIC LOCATION WITHIN THE WATERSHED. MATURATION OF GRAVEL BARS AND MEANDERING PLANFORM LEADS TO BANK EROSION AS THE CHANNEL ATTEMPTS TO REESTABLISH MEANDER WIDTH.

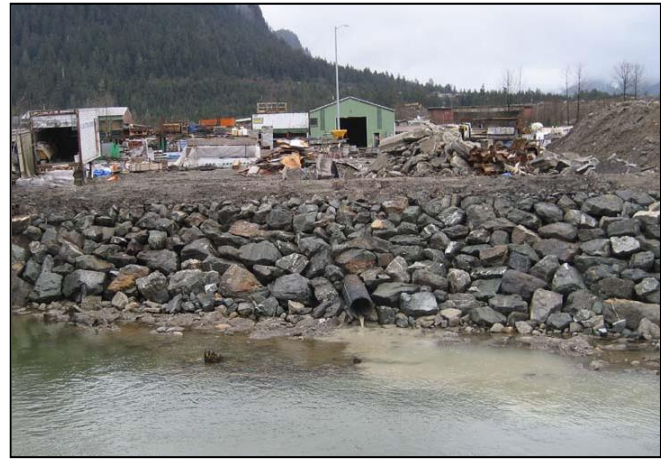
Figure 14: Turbid stormwater discharge into Lemon Creek from a failing oil-water separator at the (removed) Juneau ReadMix Bridge site, May 2007. *Photo: S. Seifert.*

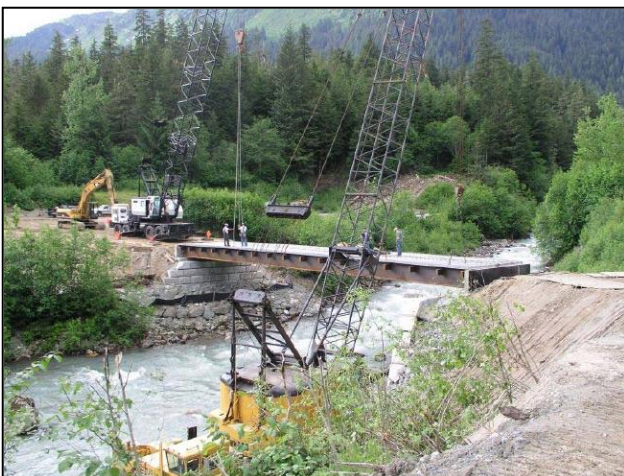
Figure 15: Construction of the CBJ Upper Lemon Creek Bridge (completed July 2007). *Photo: Bob Millard, CBJ project manager, June 14, 2007.*

The CBJ Area-Wide Transportation Plan (1991) recommended construction of a third Lemon Creek crossing near the Correctional Facility to provide additional transportation between the residential and commercial zones of the valley. A fourth bridge crossing upstream from the correctional facility was constructed in June 2007 for CBJ resource development access as per the CBJ comprehensive plan update recommendation. This bridge joins the existing haul road along the south bank to the north
