ALASKA DEPARTMENT OF ENVIRONMENTAL CONSERVATION
Division of Spill Prevention and Response
Prevention Preparedness and Response Program
SITUATION REPORT (SITREP)

Big State Dayville Road Fuel Truck Rollover

SITREP #: 3 and Final

SPILL #: 18229905301

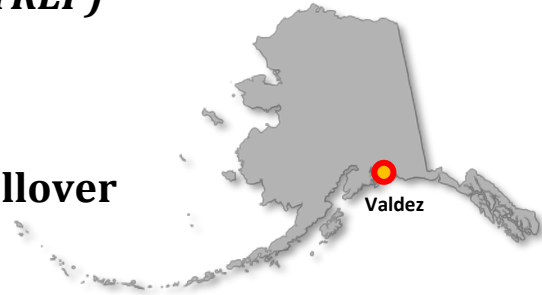
CAUSE OF SPILL: The trailer of the BSL truck flipped over after leaving the roadway. Icy road conditions and low visibility contributed to the accident.

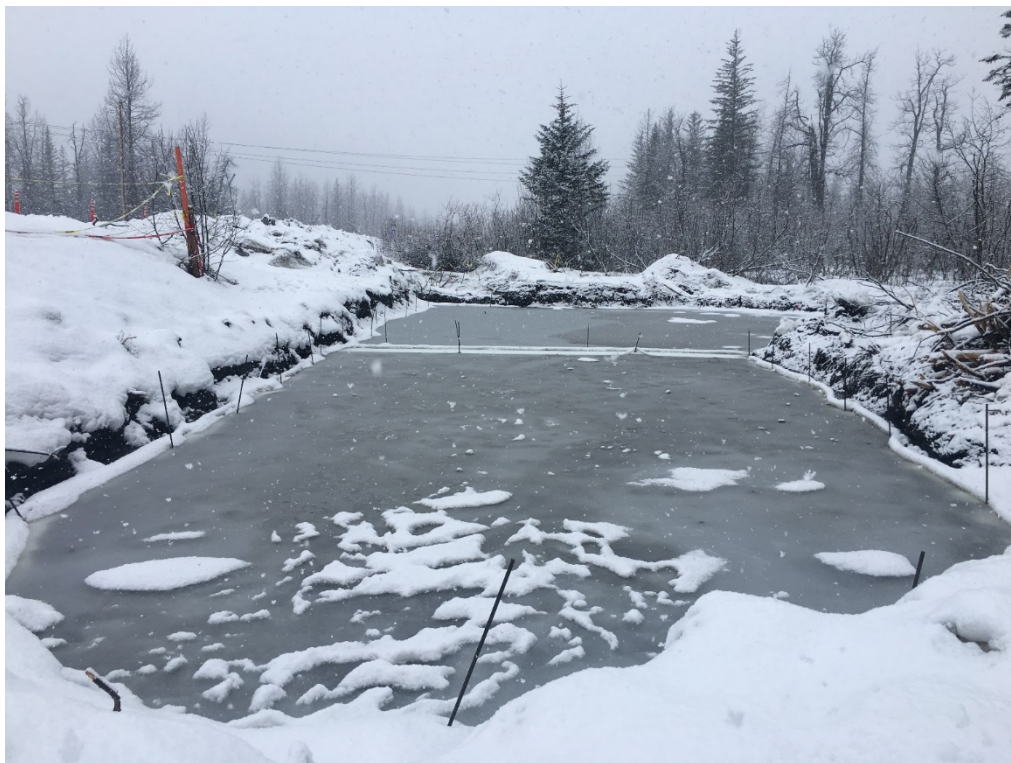
The bulk of the contaminated snow, soil, and groundwater has been removed. The excavated area of the spill site has been monitored daily for any further seepage of product. BSL has reported 9,013 gallons of recovered product, which includes the lightered fuel and the fuel from oily water mixtures and sorbents. The majority of the contaminated snow, soil and collected groundwater has been transported to approved disposal facilities. BSL is in the process of obtaining a backfill permit through the US Army Corps of Engineers and plans to backfill the affected area will soon follow.

Excavated area of the spill site, 3/19/2018 (Photo by ADEC)

FUTURE PLANS AND RECOMMENDATIONS: ADEC will continue to monitor the response actions and review plans being developed to further delineate the affected area, as well as additional containment and cleanup actions that may be required.
