RIVER TERRACE RV PARK
Soldotna, Alaska

RIVER TERRACE RV PARK
2013 APRIL GROUNDWATER MONITORING REPORT
Soldotna, Alaska

PCE EXTENT AND CONCENTRATION MAP
RIVER TERRACE RV PARK
Soldotna, Alaska

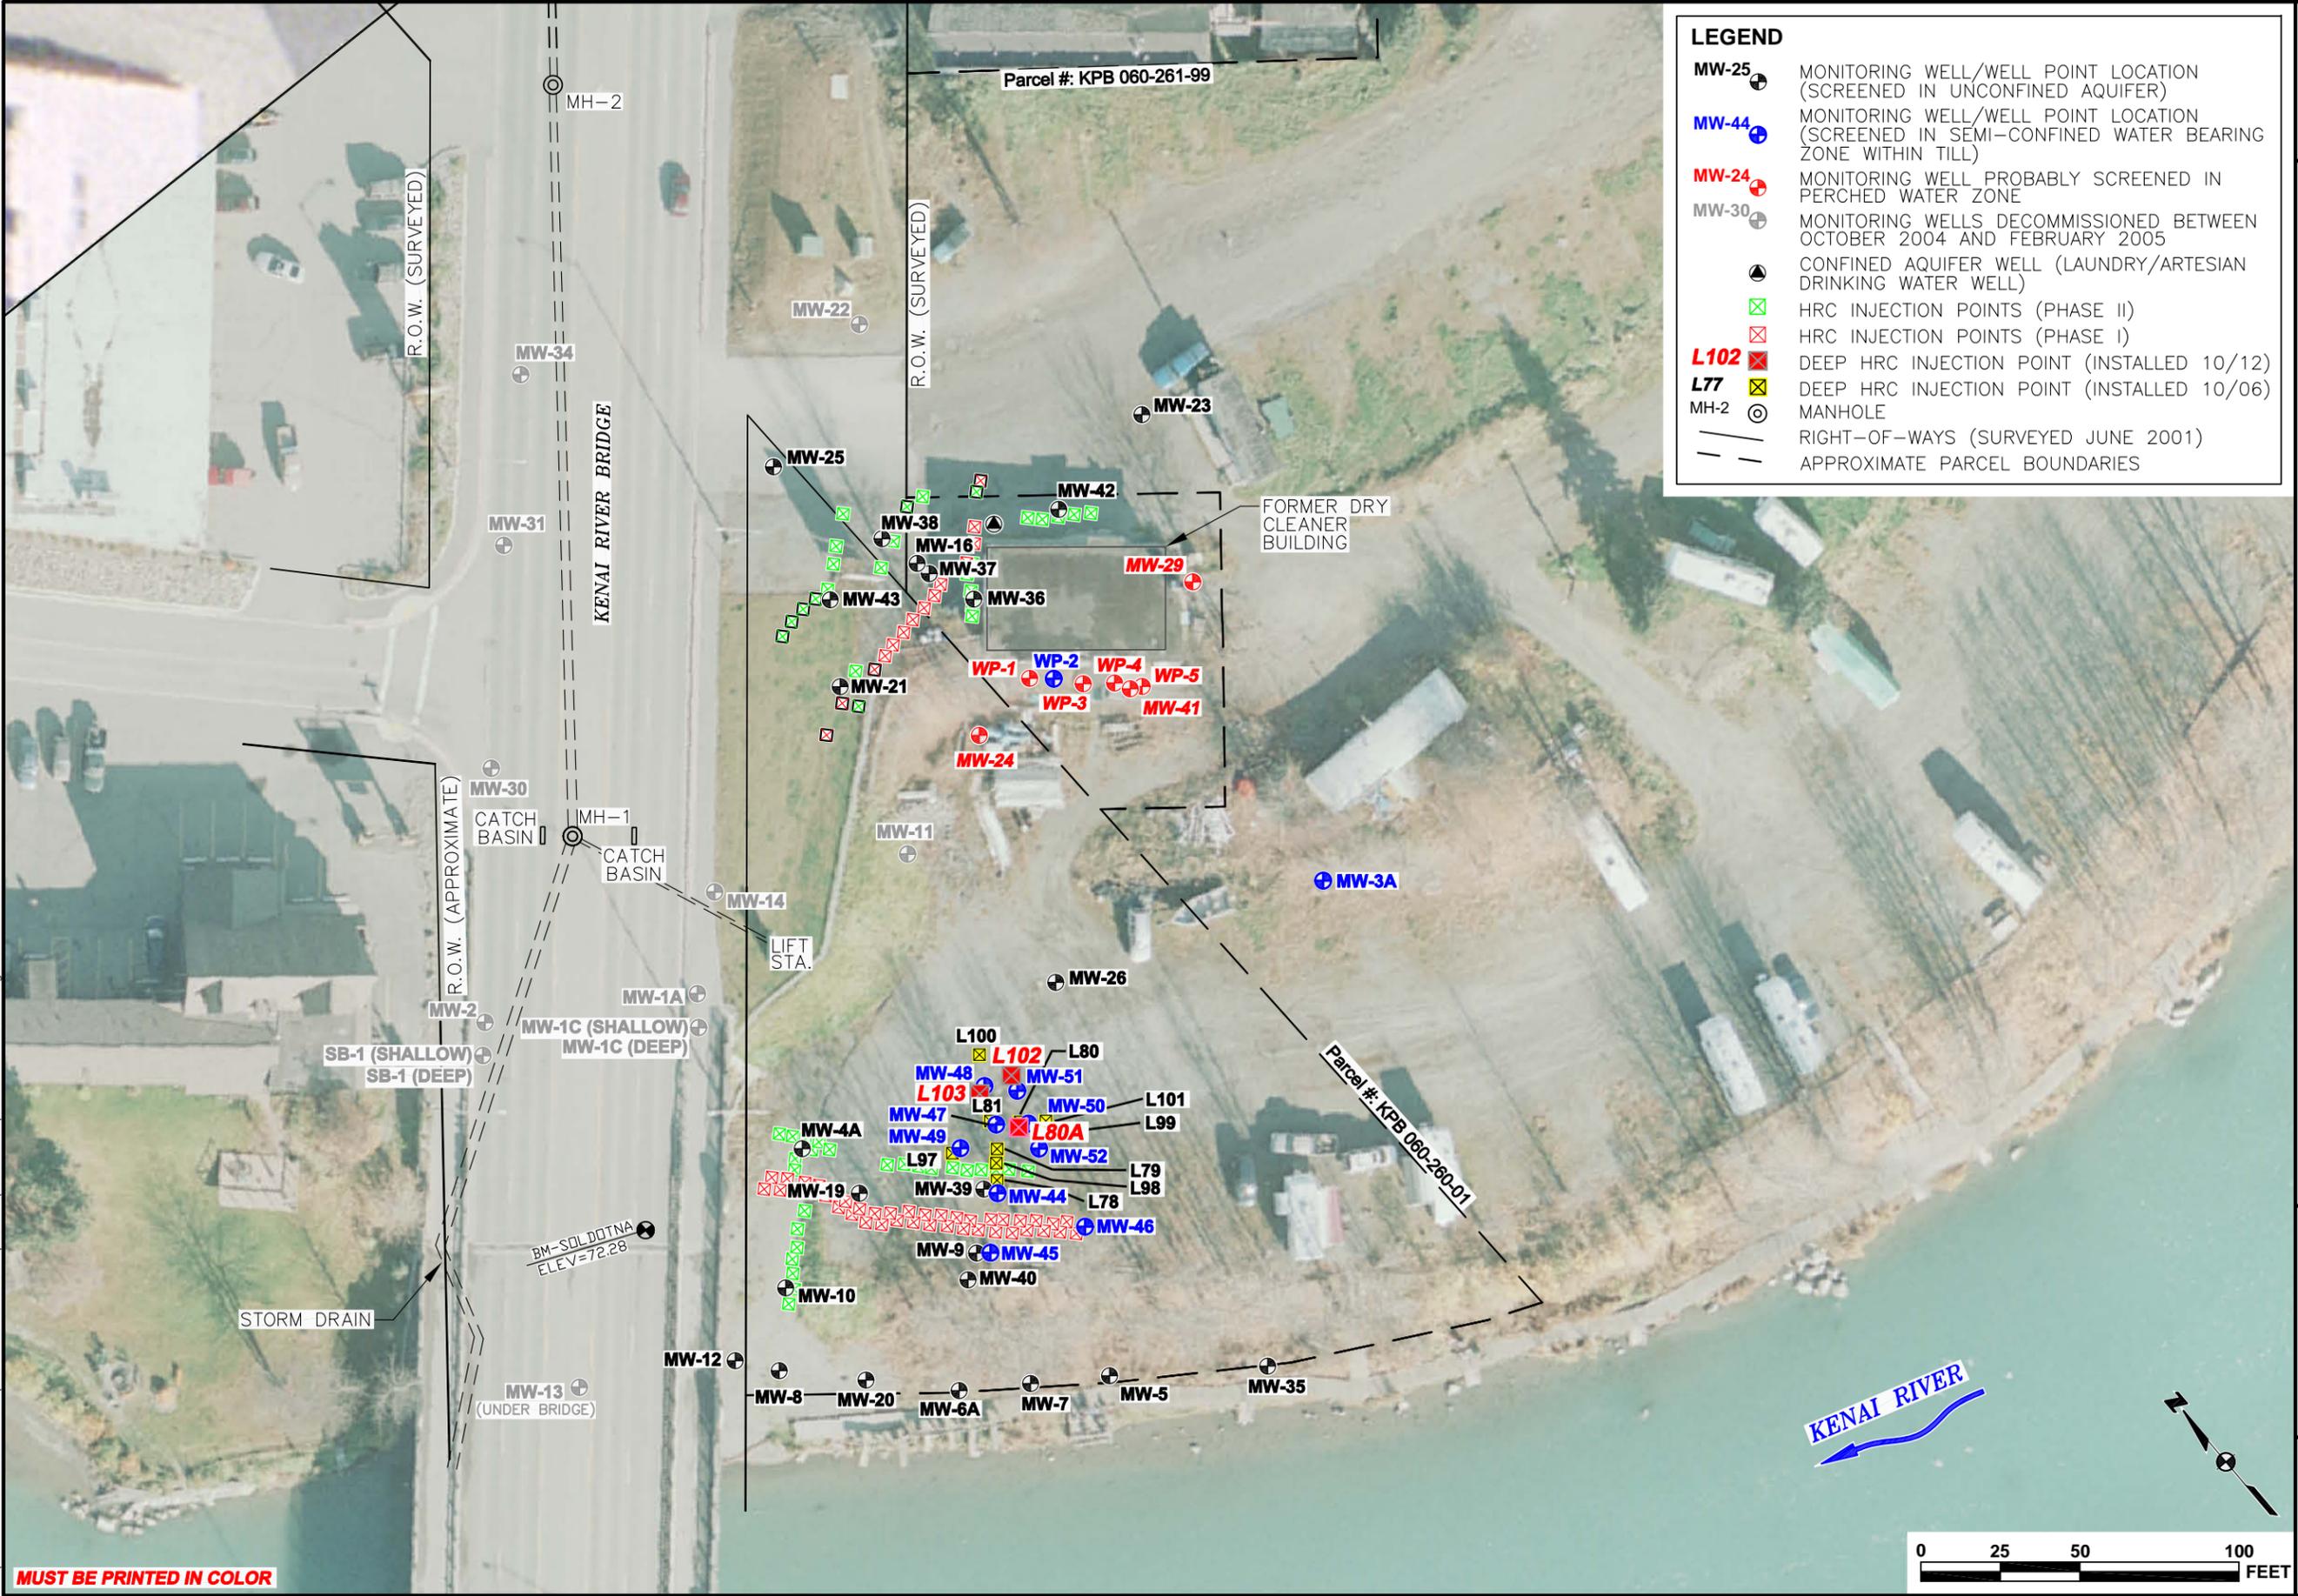
FIGURE 1

SITE MAP

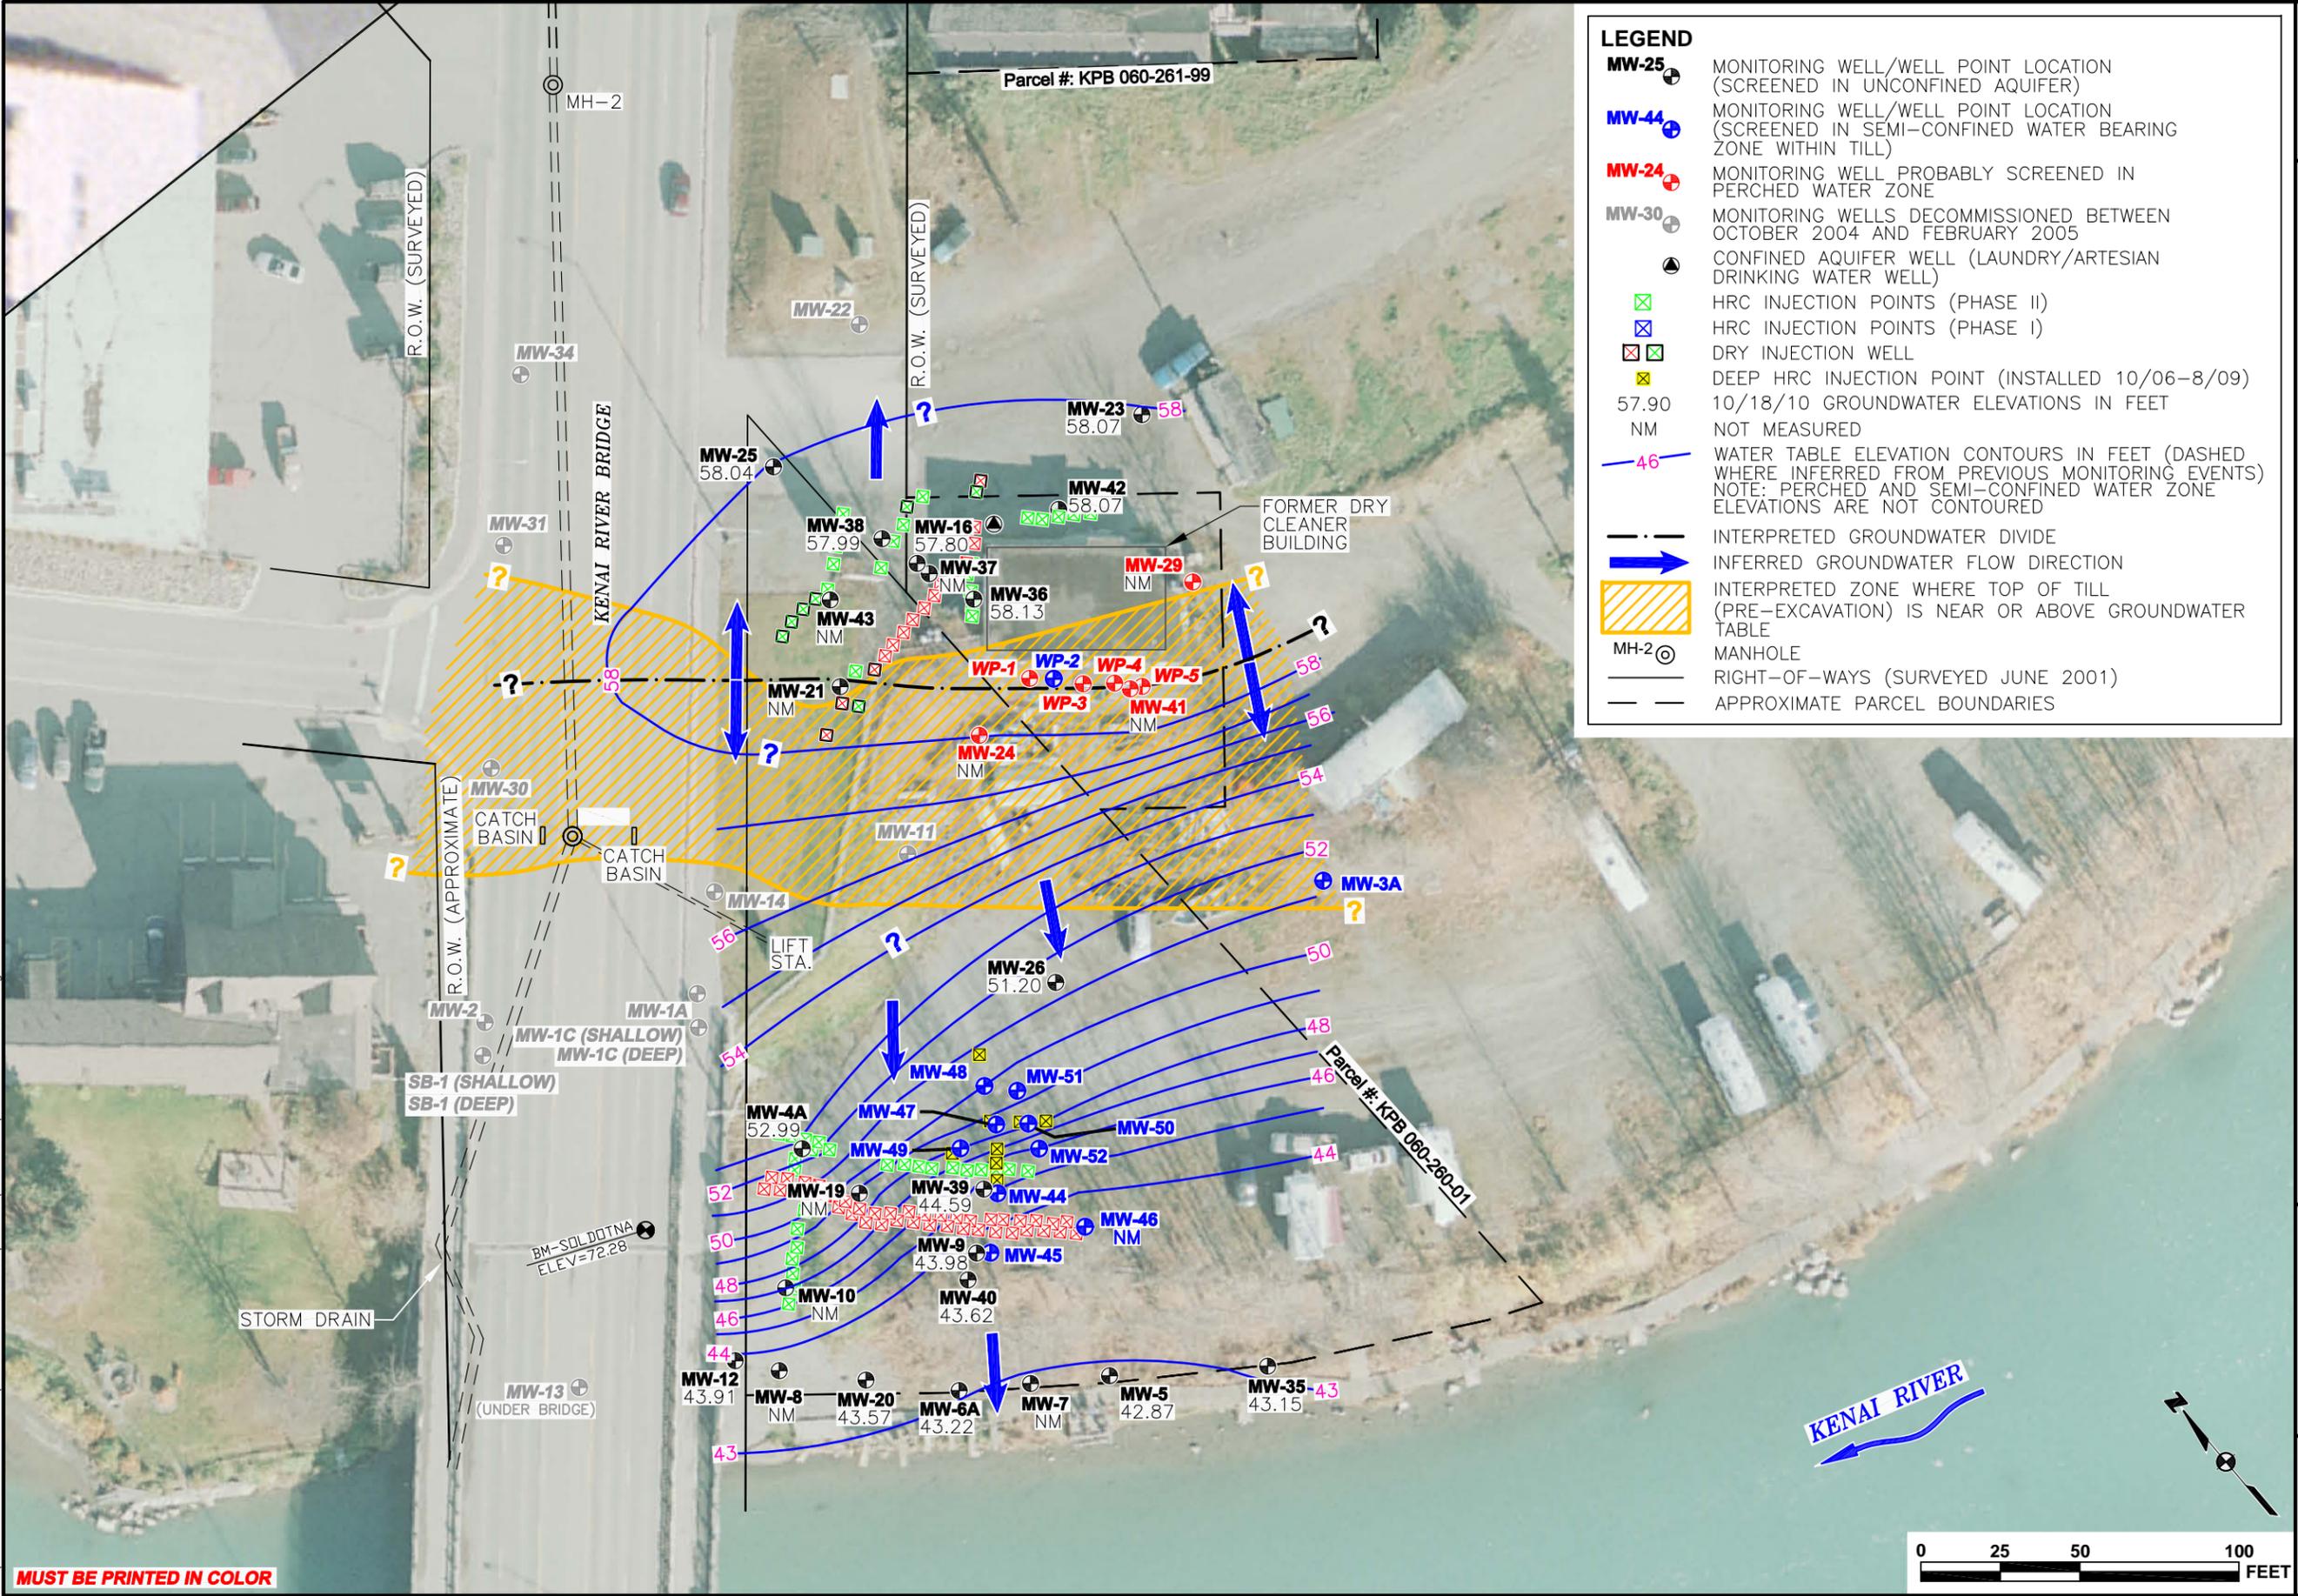
2

APRIL, 2013 WATER TABLE CONTOURS

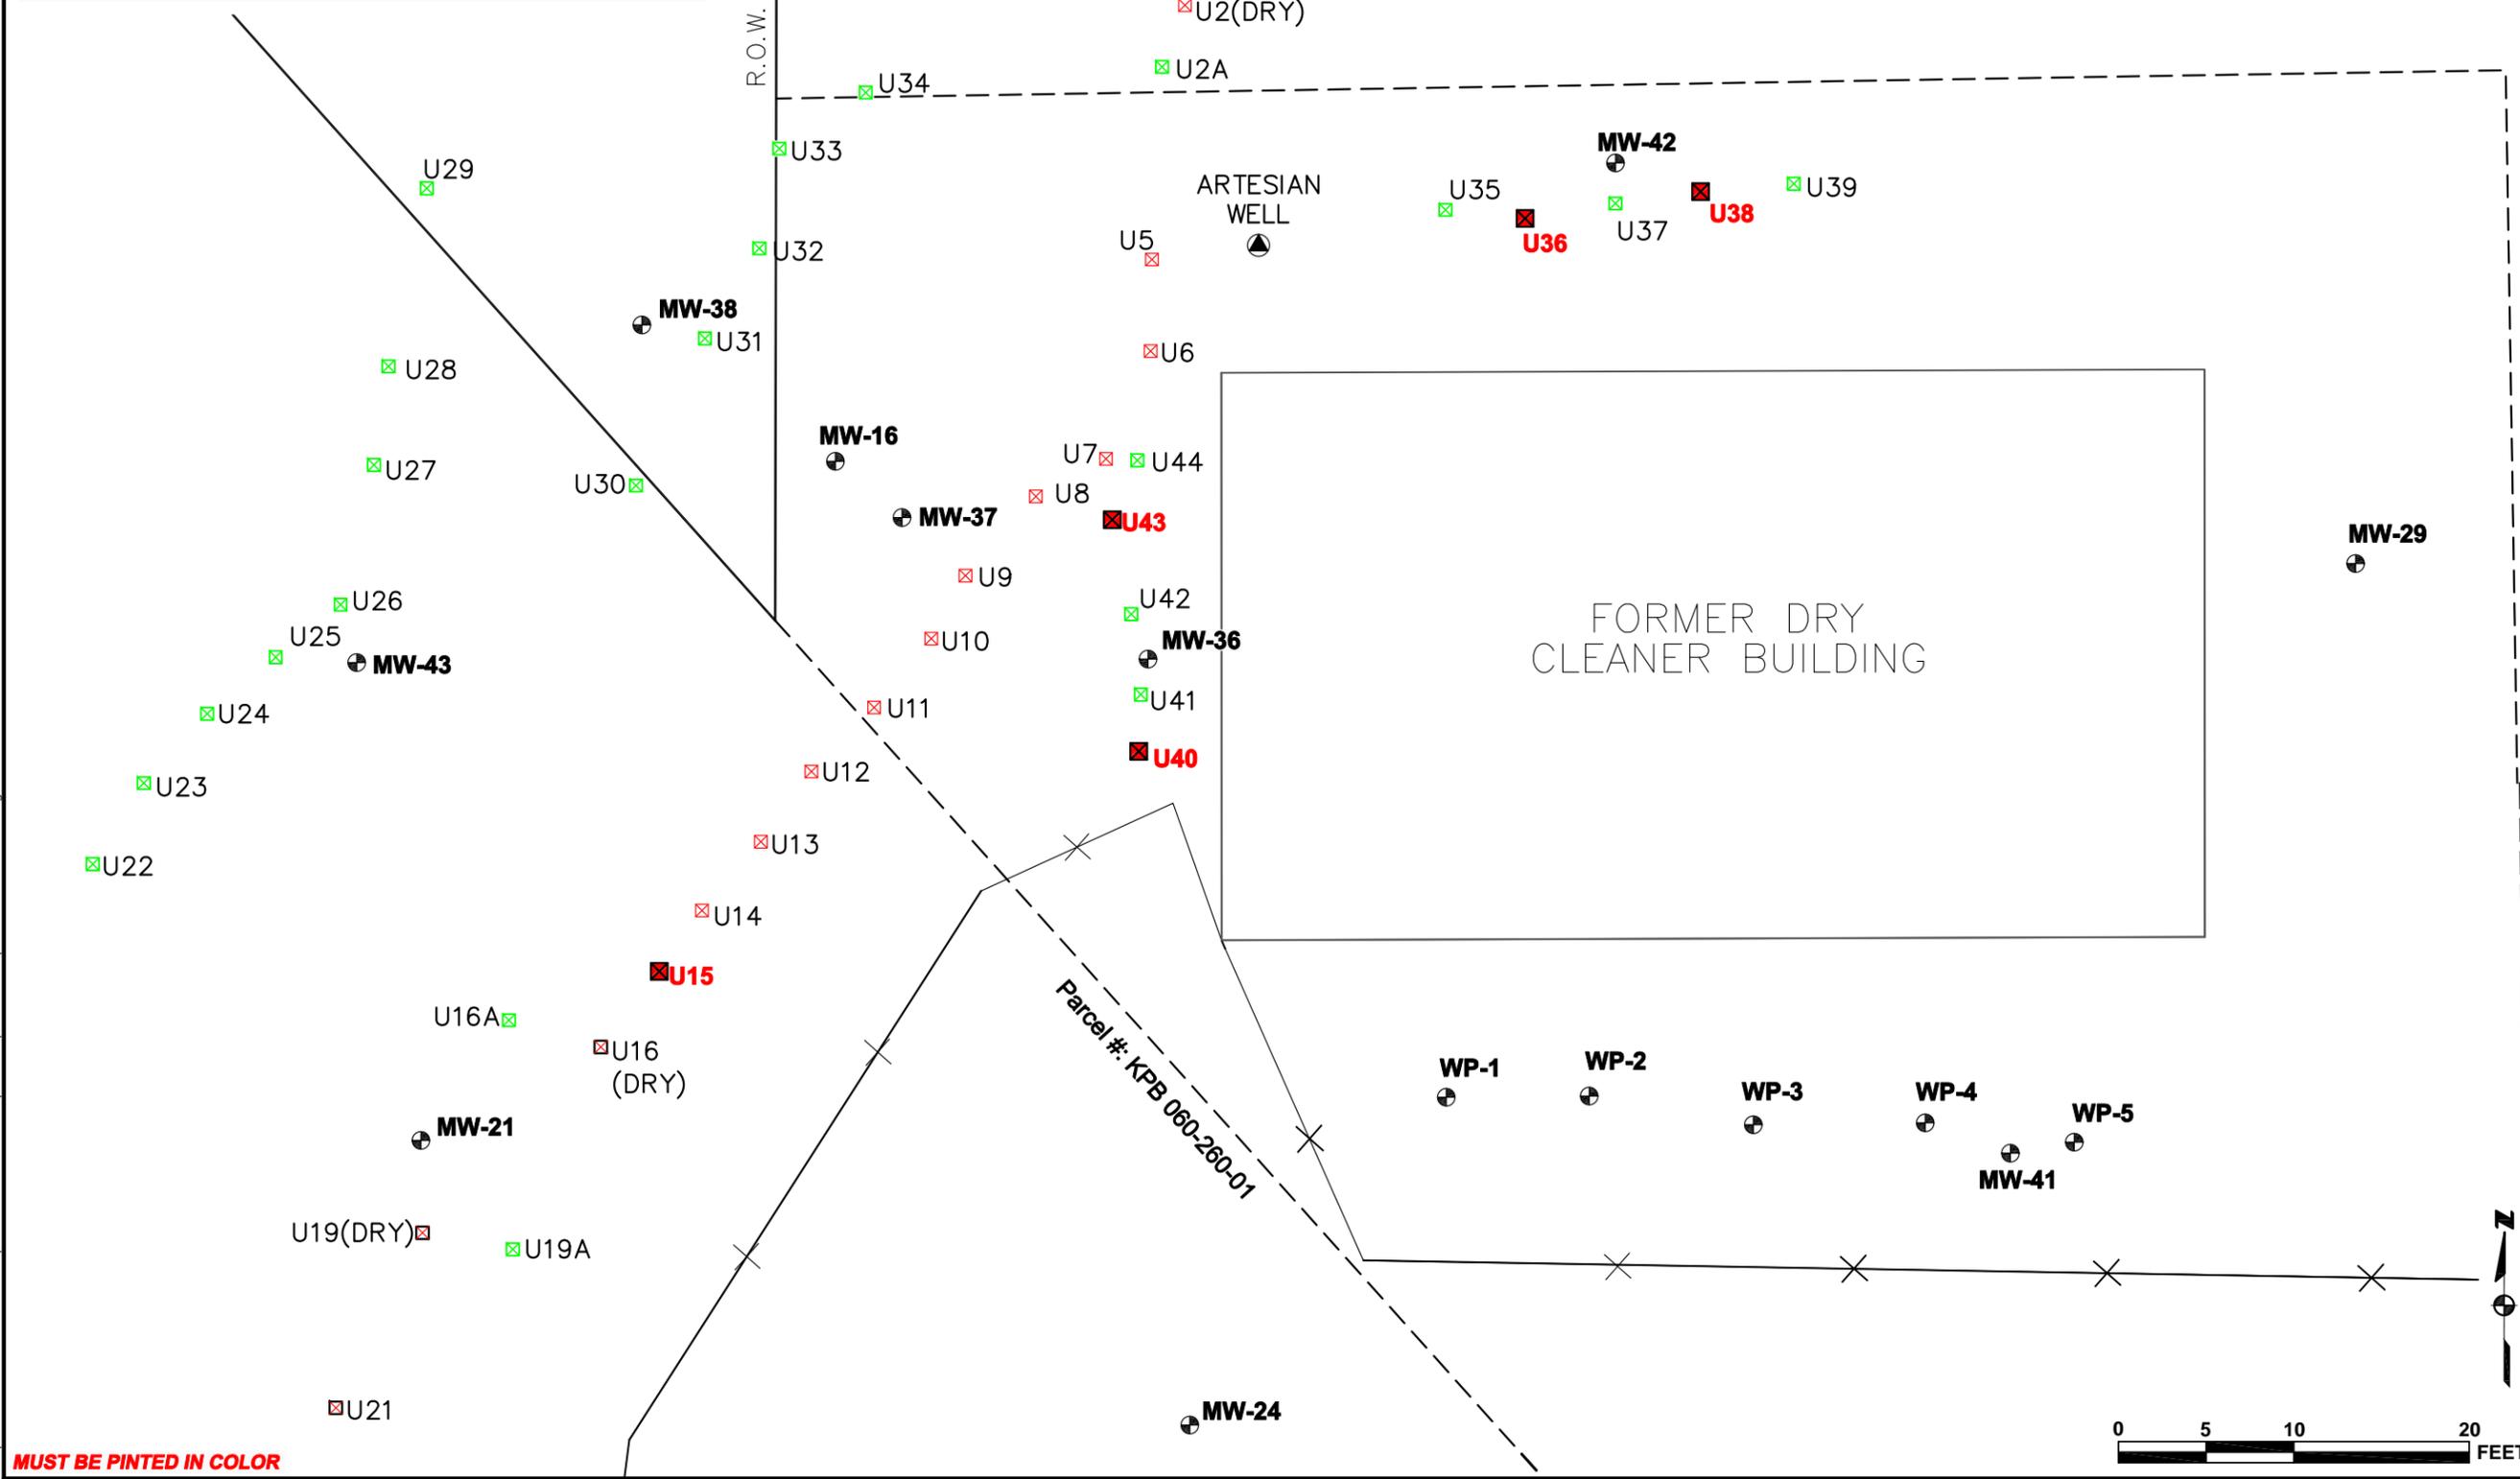
3

**UPPER PLUME ENLARGED
HRC INJECTION LOCATIONS**

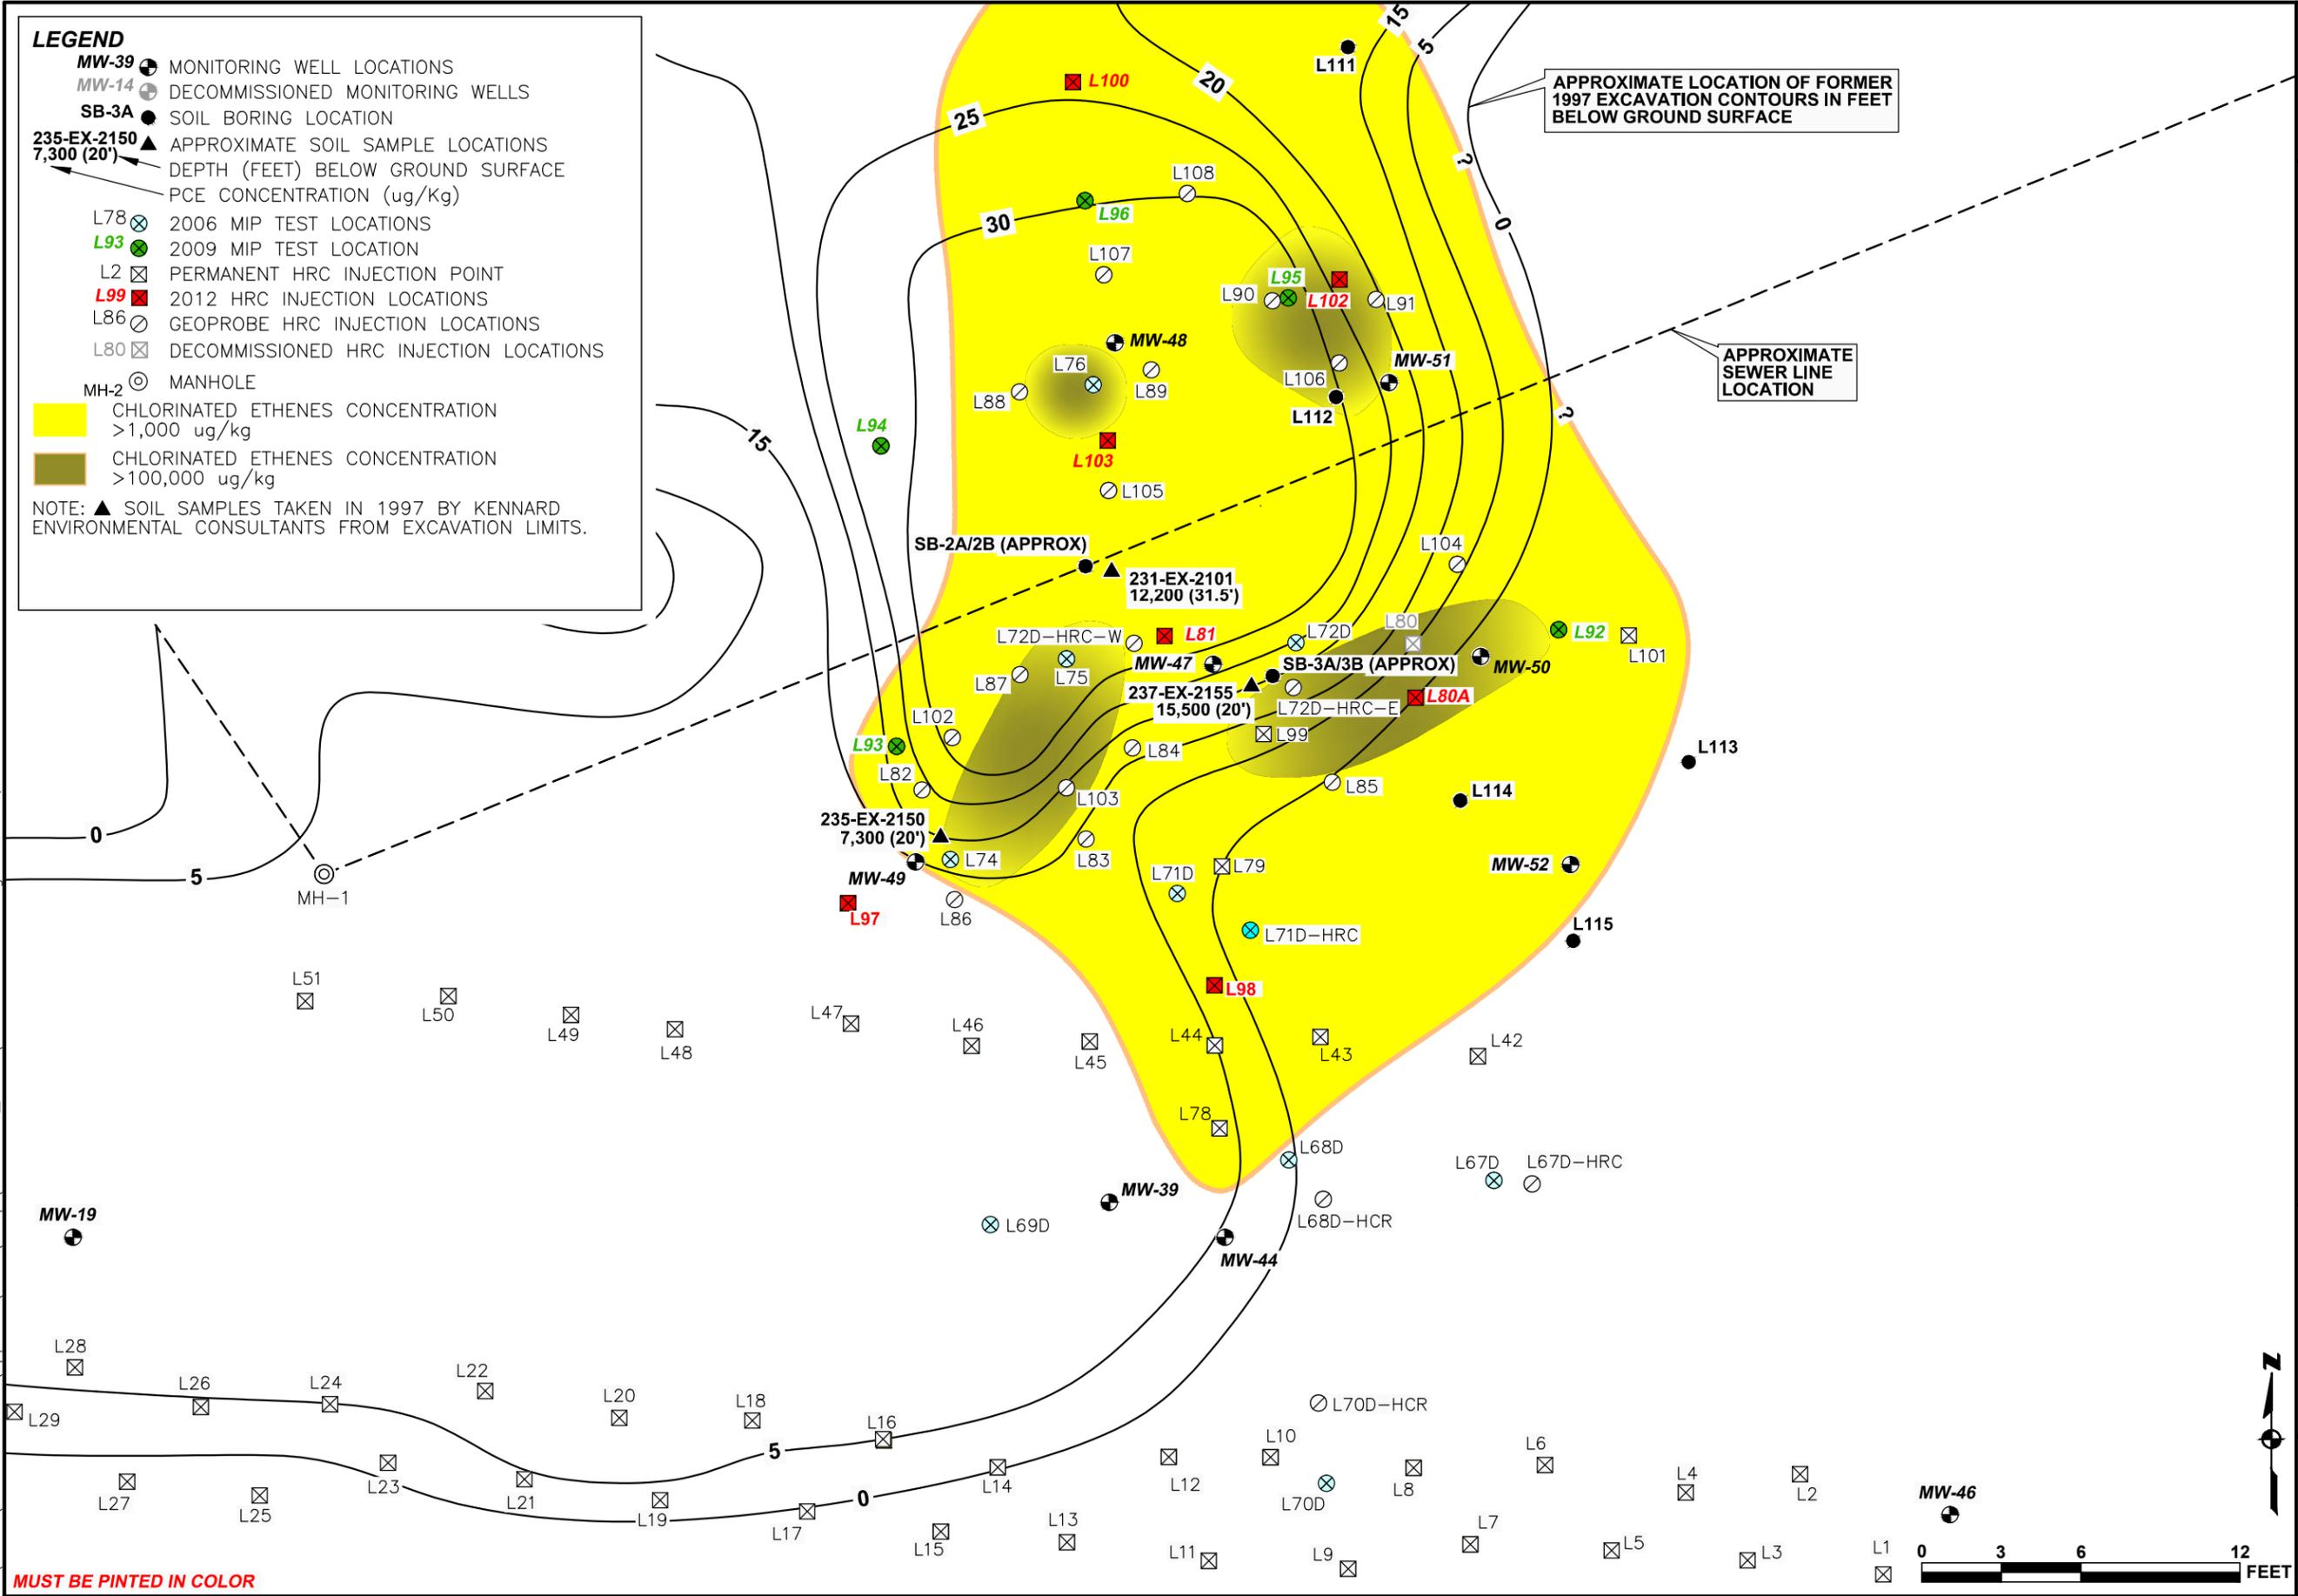
FIGURE 4

LOWER PLUME ENLARGED HRC INJECTION LOCATIONS

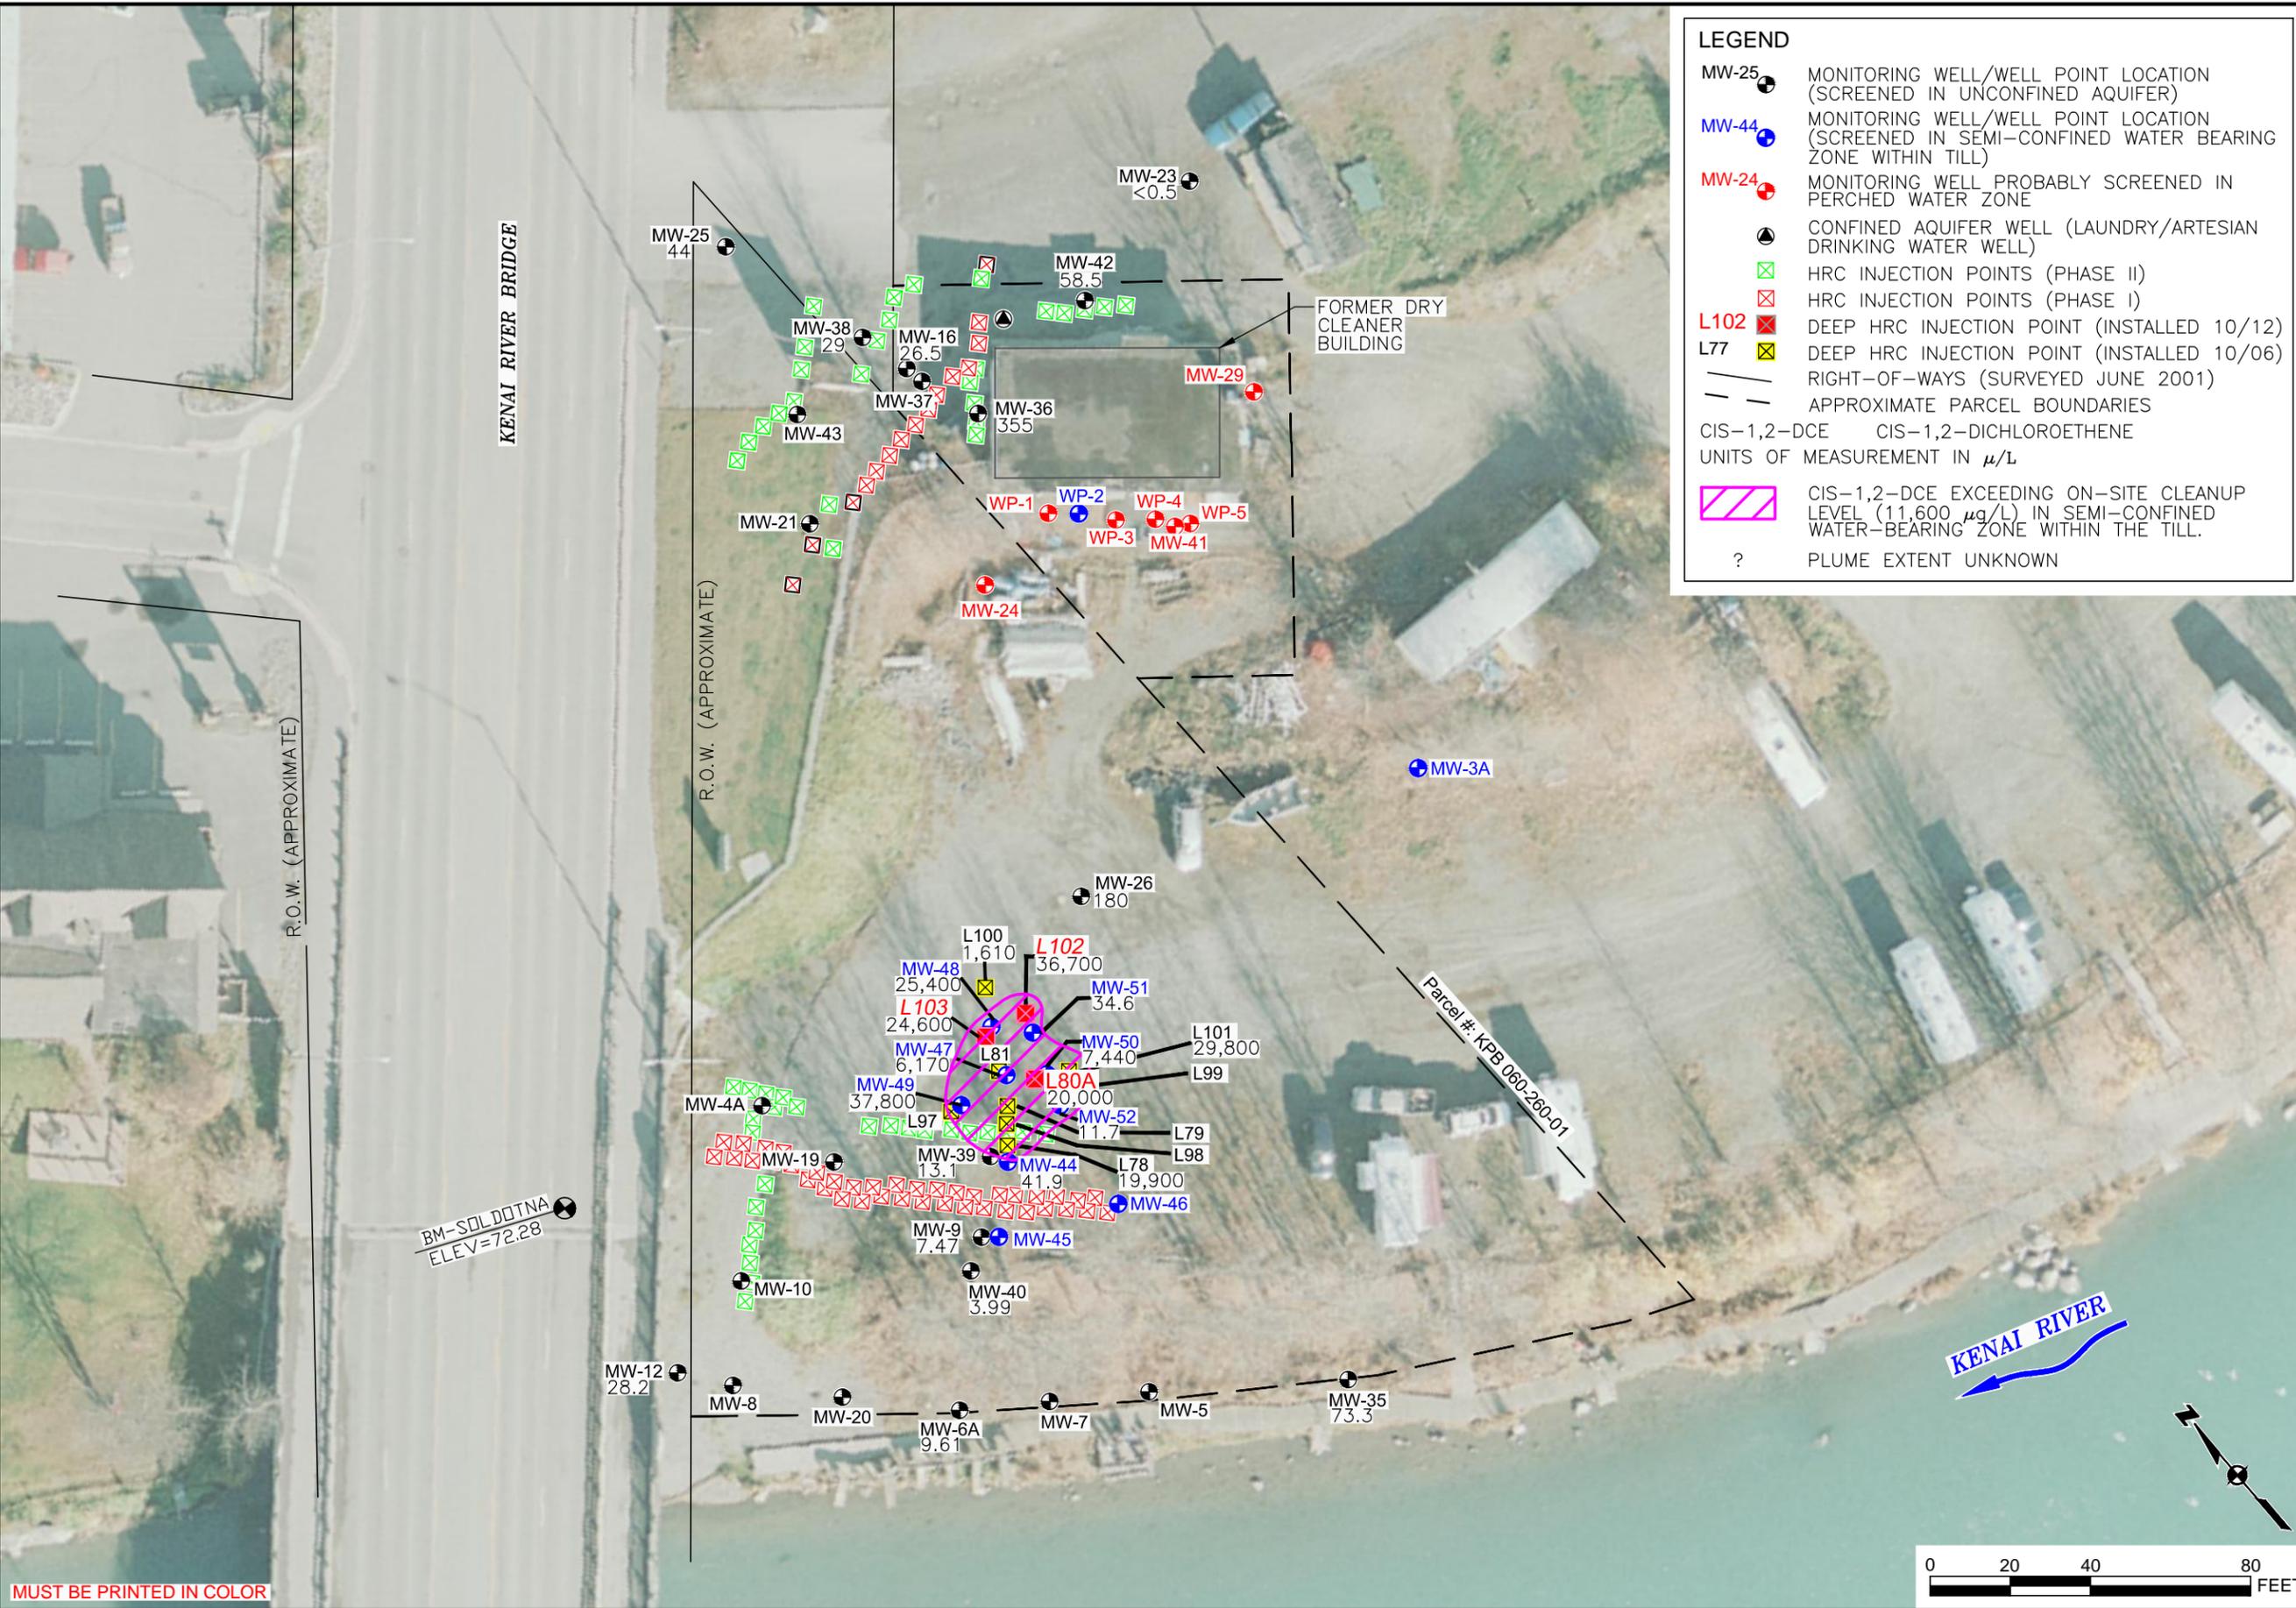
6

CIS-1,2-DCE EXTENT AND CONCENTRATION MAP

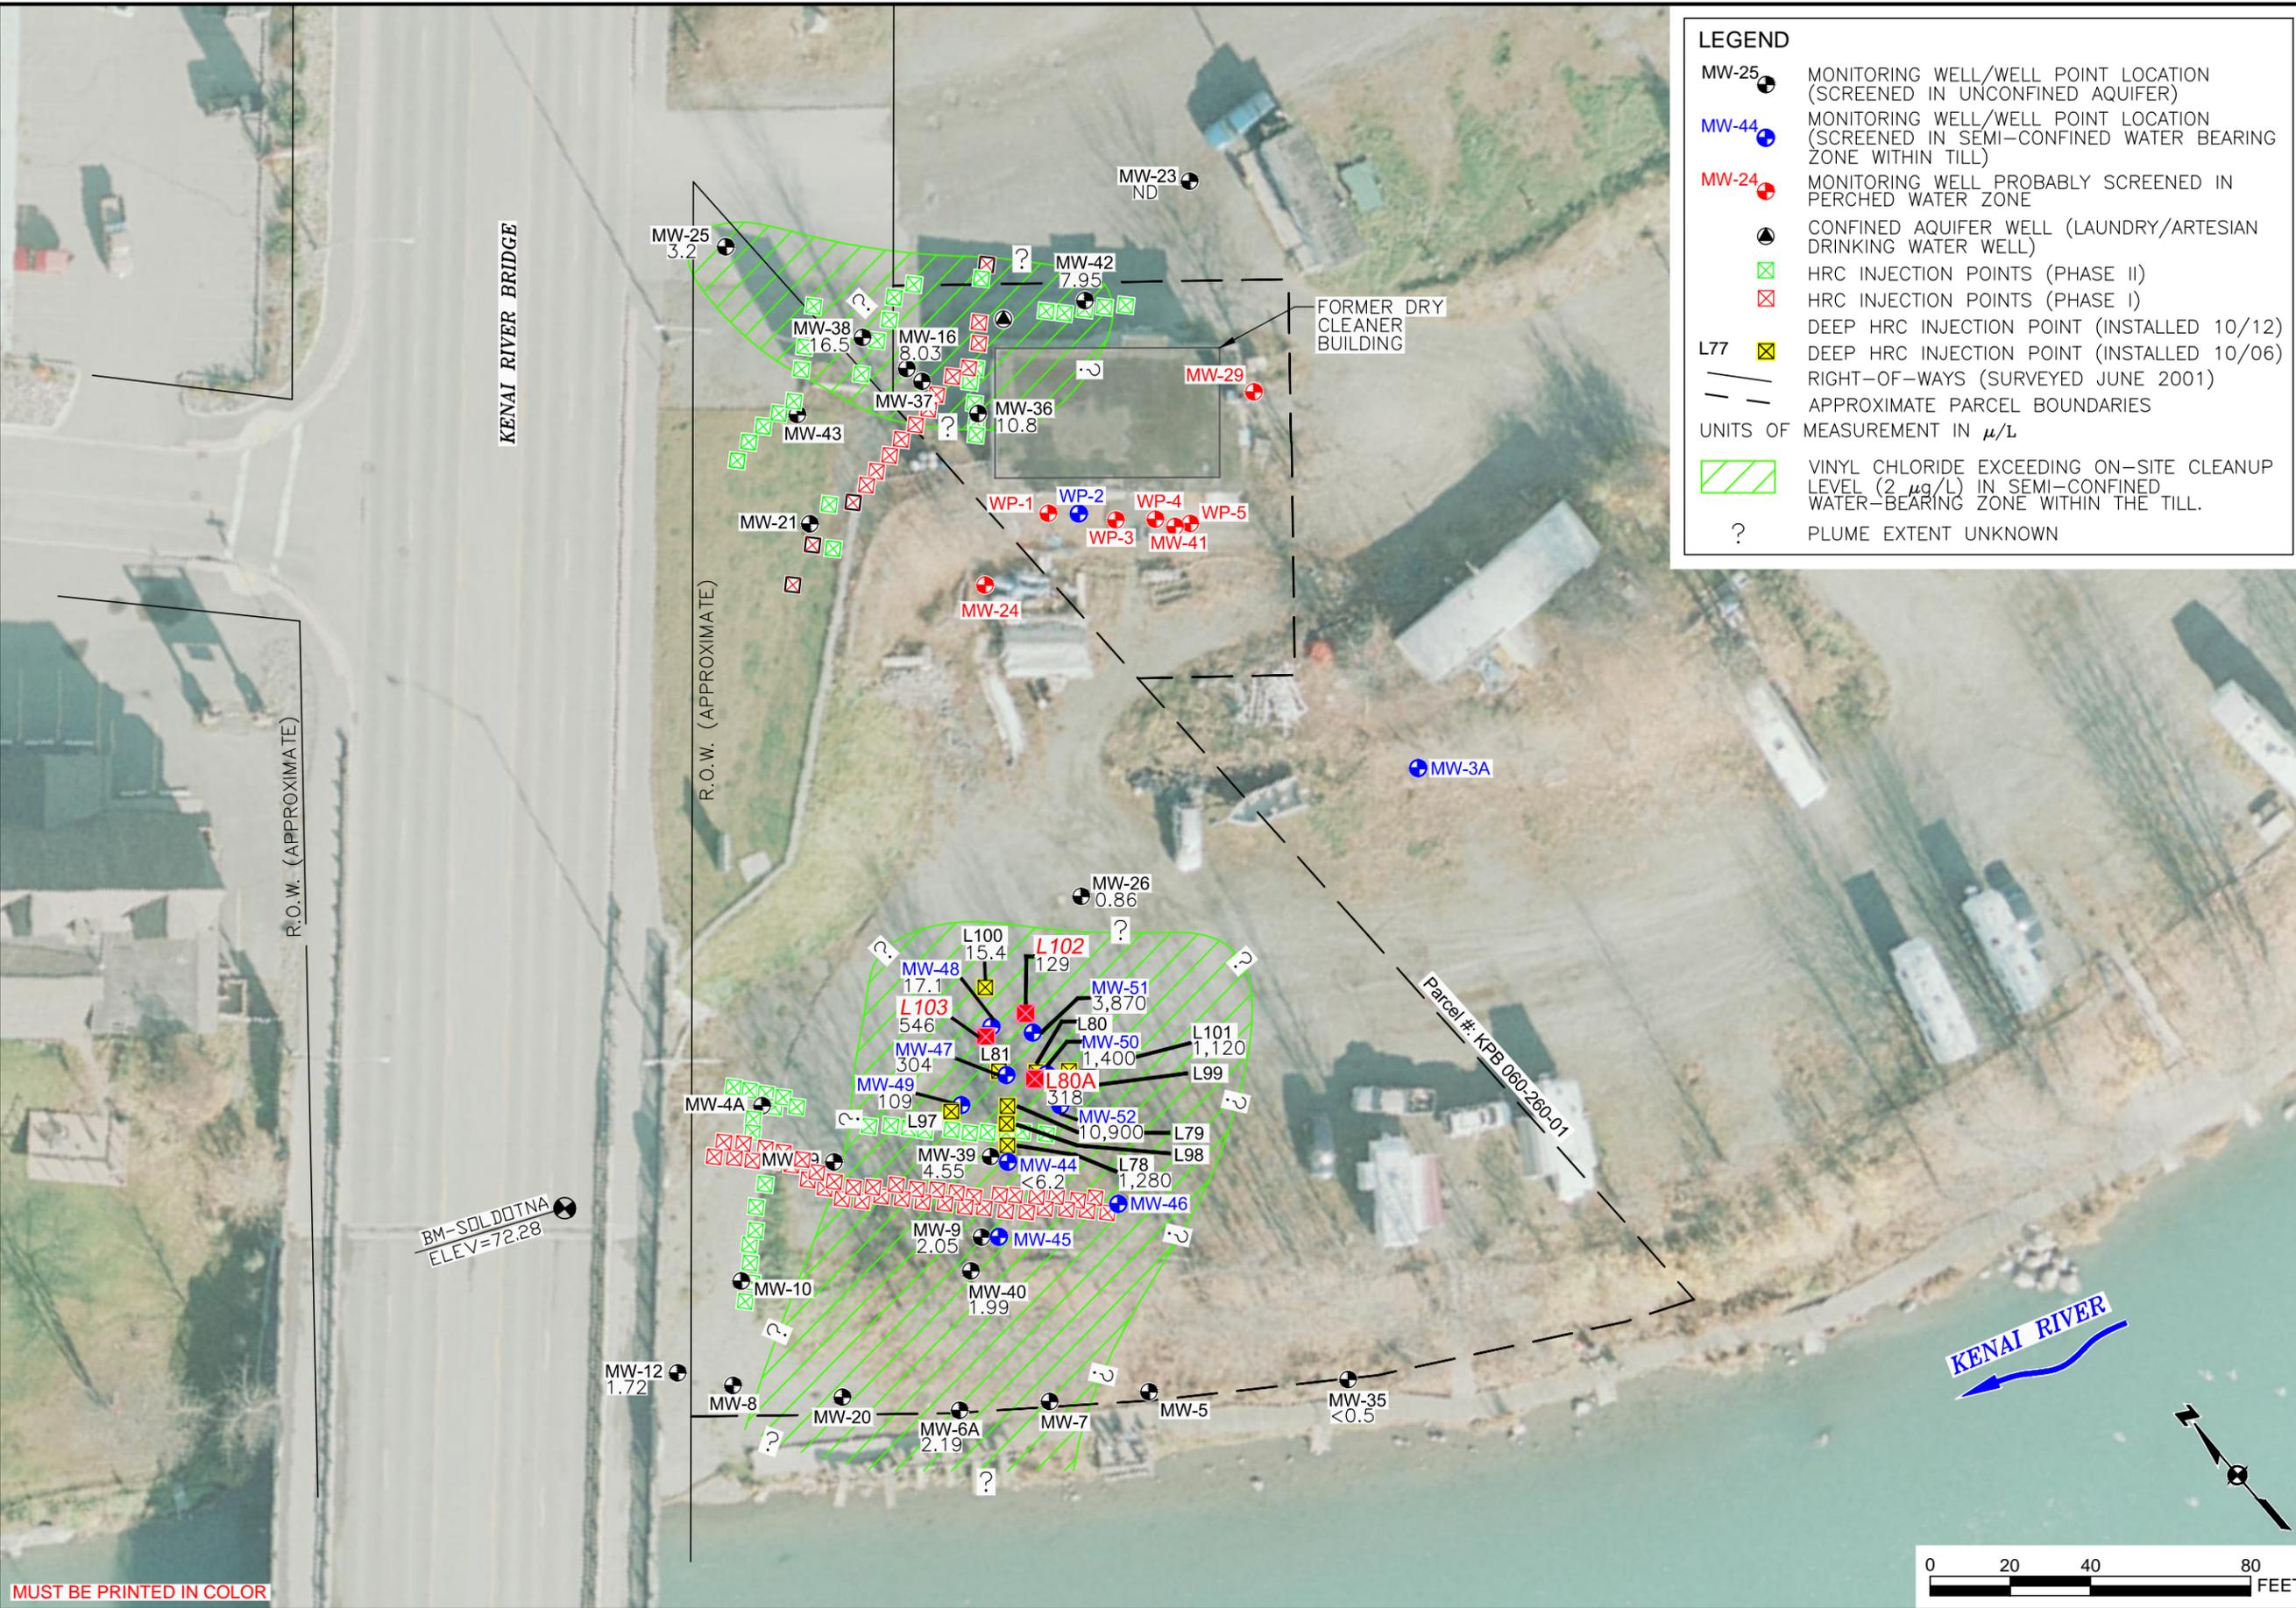
7

VINYL CHLORIDE EXTENT AND CONCENTRATION MAP
