SITUATION REPORT

Kaktovik Tank KAK-70 ULSD Release

SITREP # 4

SPILL #: 17399900901

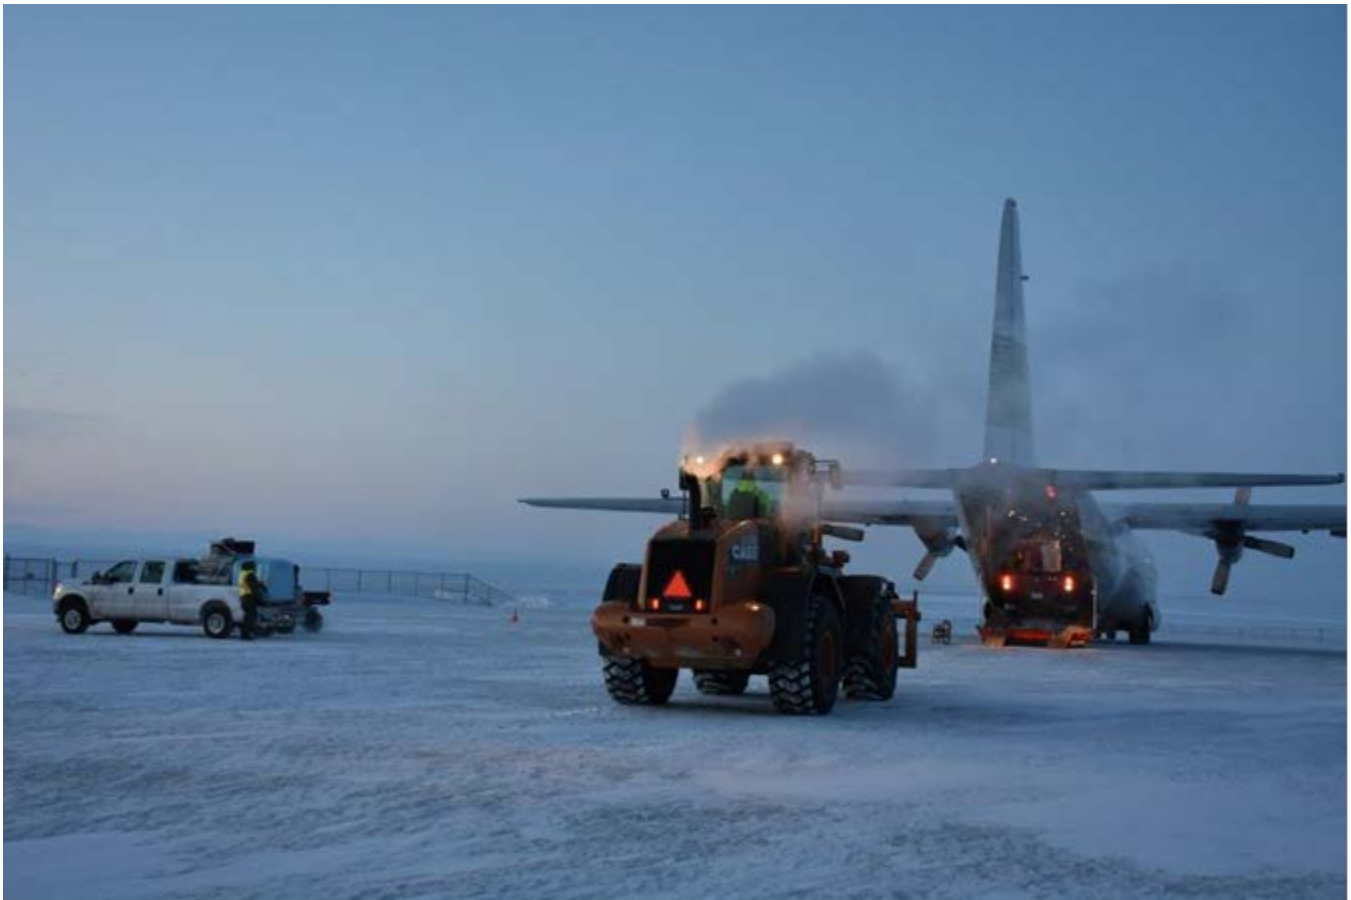
Photo showing response contractors offloading additional response equipment in Kaktovik on January 22, 2017.
(Photo/ADEC)
