FACT SHEET
BENTLEY FAMILY CHARITABLE TRUST
TAX LOT 201
FAIRBANKS, ALASKA

JANUARY 2002

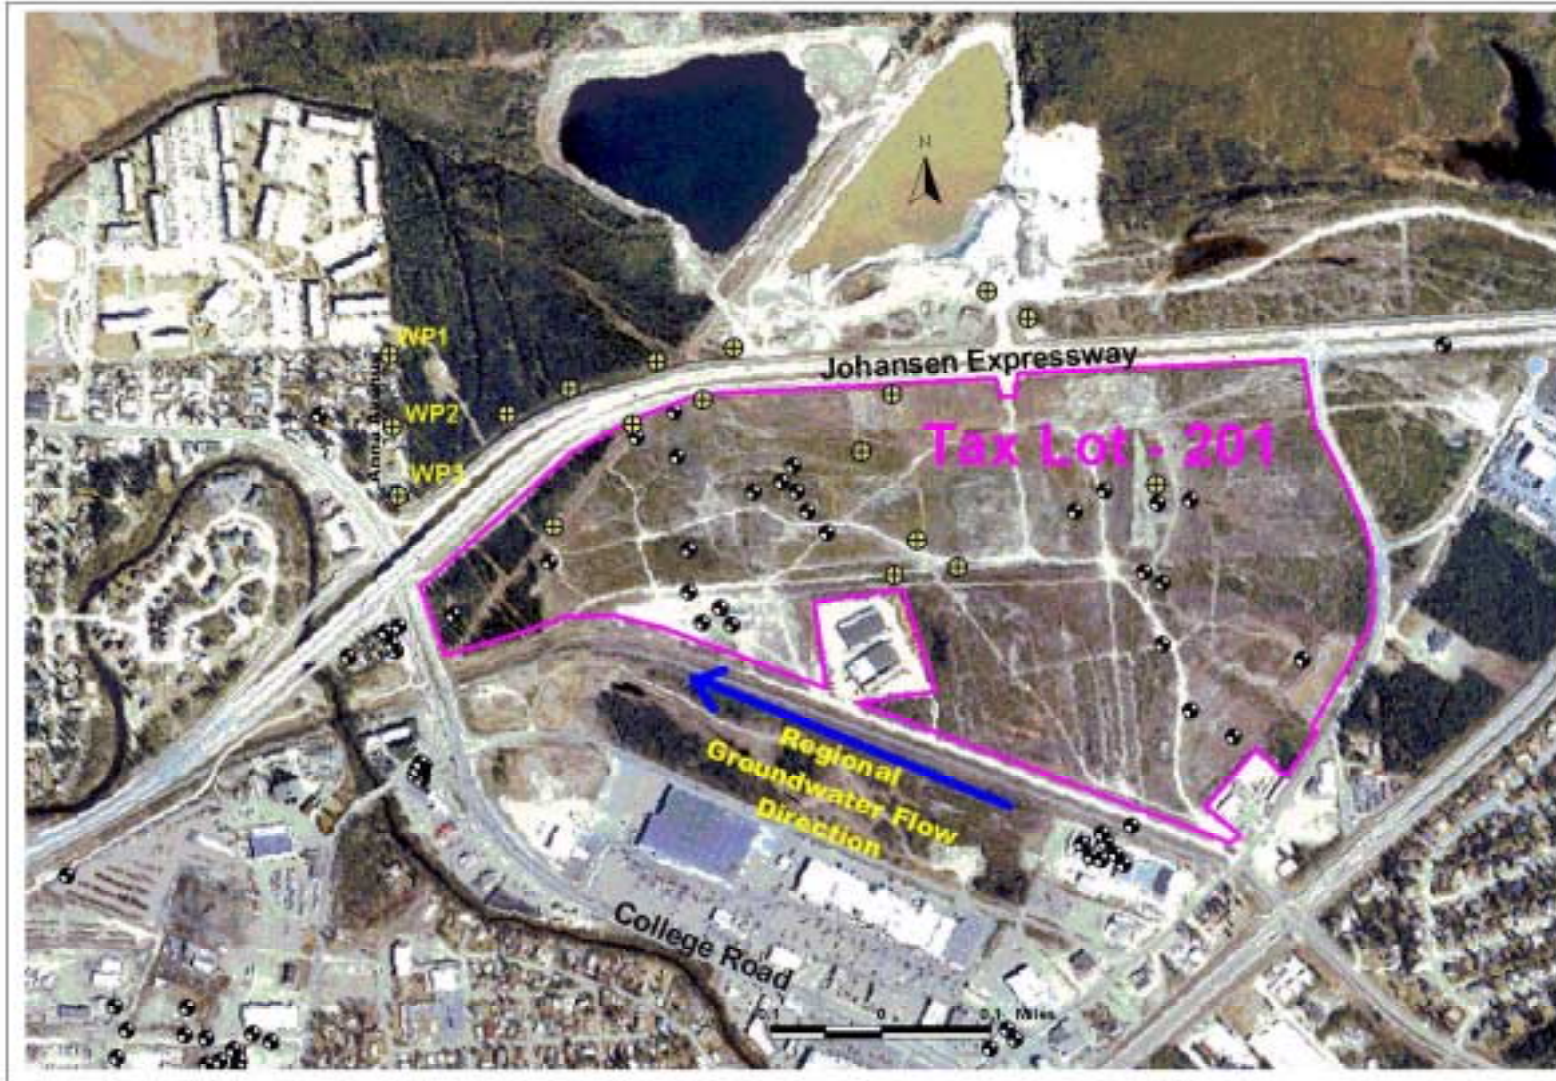
LEGEND	
⊕	Temporary Well Points
⊙	Monitoring wells
Bentley Trust Property Tax Lot 201 Fairbanks, Alaska	
Figure 1 Well Point Locations

The fall 2001 sampling results suggest that the TCE groundwater contamination may extend beyond Anna Avenue to the west-northwest. The TCE concentration at well point three (WP-3) averaged roughly 130 µg/l. For reference, the safe drinking standard for TCE in public drinking water wells is 5 µg/l. Additional monitoring wells or well points will have to be installed to determine if the groundwater contamination extends beyond Anna Avenue (see Figure 1) and how far. The installation of these wells is tentatively scheduled for spring 2002.

The primary groundwater contaminant is TCE. There appear to be several source areas that have groundwater plumes associated with them. One of the TCE groundwater plumes extends off of Tax Lot 201 to the west-northwest and has gone as far as WP-3 (see Figure 1).

The installation of additional monitoring wells or well points are required to answer the question.

It is anticipated that installation of the wells will progress in stages. A set of wells will be installed and water samples collected from them will be analyzed. These results will be used to determine if additional monitoring wells are necessary. This iterative process will continue until the extent of the plume is delineated. This may take at least several months to complete.
