# Alaska Department of Environmental Conservation Spill Prevention and Response

## ARNESS SEPTAGE

### THE CURRENT STATUS

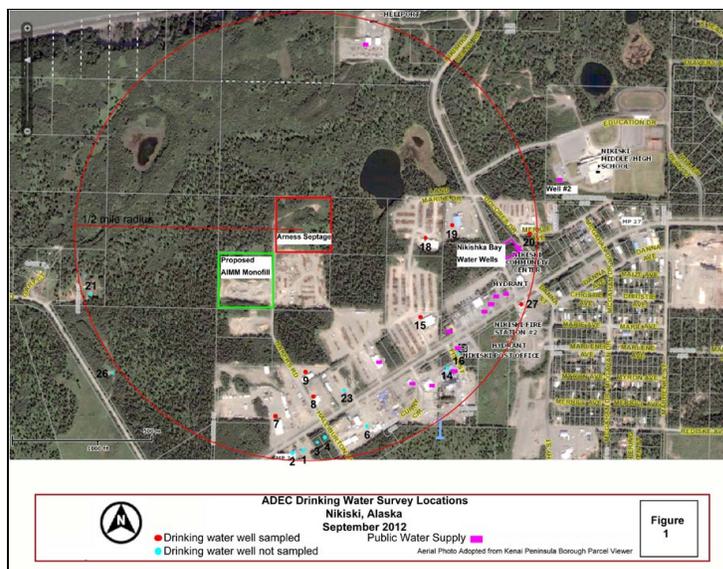
The area within the red circle on the photo is within a half mile of the Arness Septage property.

The eight red dots show the eight drinking water wells within the half-mile radius that were sampled. All eight wells are for small businesses.

The eight light blue dots show other wells within the half-mile radius that weren't sampled. Half of those are private wells and half are wells for small businesses; they all declined sampling.

The rectangles represent businesses and residences that are all served by Nikishka Bay Utilities' water system, a community water system, with the exception of the Nikiski Middle/Senior High School and the heliport. Those two have their own public water systems. Nikishka Bay also serves the neighborhood east of the red circle in the photo diagram.

(Aerial photo adopted from the Kenai Peninsula Borough's Parcel Viewer program; diagram courtesy of DEC)

The eight drinking water wells that were sampled in August and September 2012 are shown by red dots in the diagram (see photo diagram, top).

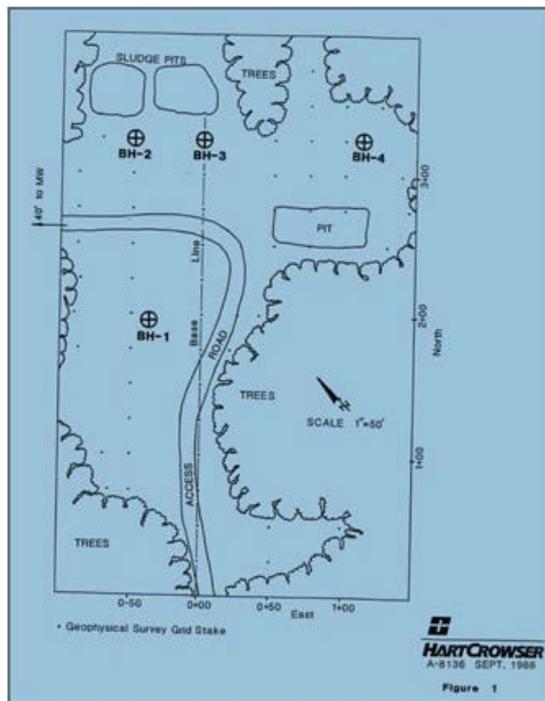
The layout of what the Arness Septage site looked like in 1988, along with the boring hole locations, is shown in this September 1988 drawing by a DEC contractor. (DEC file)

In September 1988, the site assessment work included (1) installing a single groundwater monitoring well to a depth of 135 feet; (2) geophysical surveys (magnetometer and ground penetration radar) to detect buried metal objects; and (3) drilling and sampling four soil borings to a depth of 30 feet. In one soil boring (BH-4 in the blue diagram below), workers encountered visual hydrocarbon staining that prompted additional excavation. In the area near another soil boring, BH-3, the geophysical survey data also prompted additional cleanup excavation.
