# Division of Spill Prevention and Response Contaminated Sites Program

## ALASKA PULP CORPORATION – SITKA MILL SITE

**Database Name:** Alaska Pulp Corporation – Sitka Mill Site

**Status:** Cleanup Complete – Institutional Controls

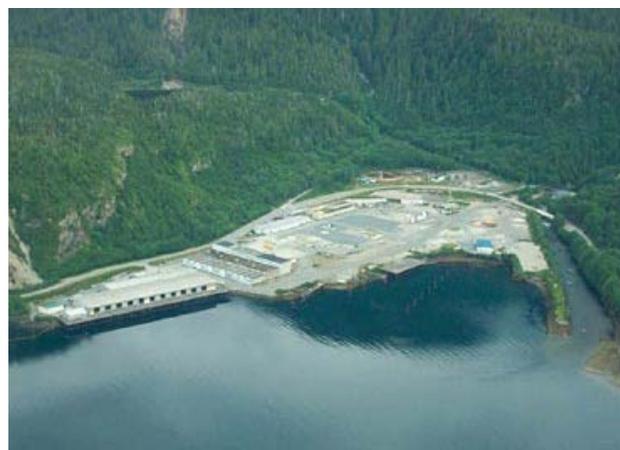
The former site of the Alaska Pulp Mill, Sitka, Alaska, as of 2004. Photo courtesy of the City and Borough of Sitka

DEC recently completed its evaluation of the deed restriction. In late 2004 the City and Borough of Sitka requested a change in land use to increase its development options for the site, now known as the Sawmill Cove Industrial Park. Specifically, a new tenant wished to construct housing for seasonal seafood industry workers. DEC has determined that the site can be safely occupied and used in an unrestricted manner.
