FLINT HILLS RESOURCES ALASKA, LLC  
 NORTH POLE REFINERY, NORTH POLE, ALASKA  
**FOURTH QUARTER 2012  
 GROUNDWATER MONITORING REPORT**

**ANALYTICAL RESULTS FOR BTEX  
 AT WATER TABLE**

FIGURE <b>4-9</b>
---	----------------------

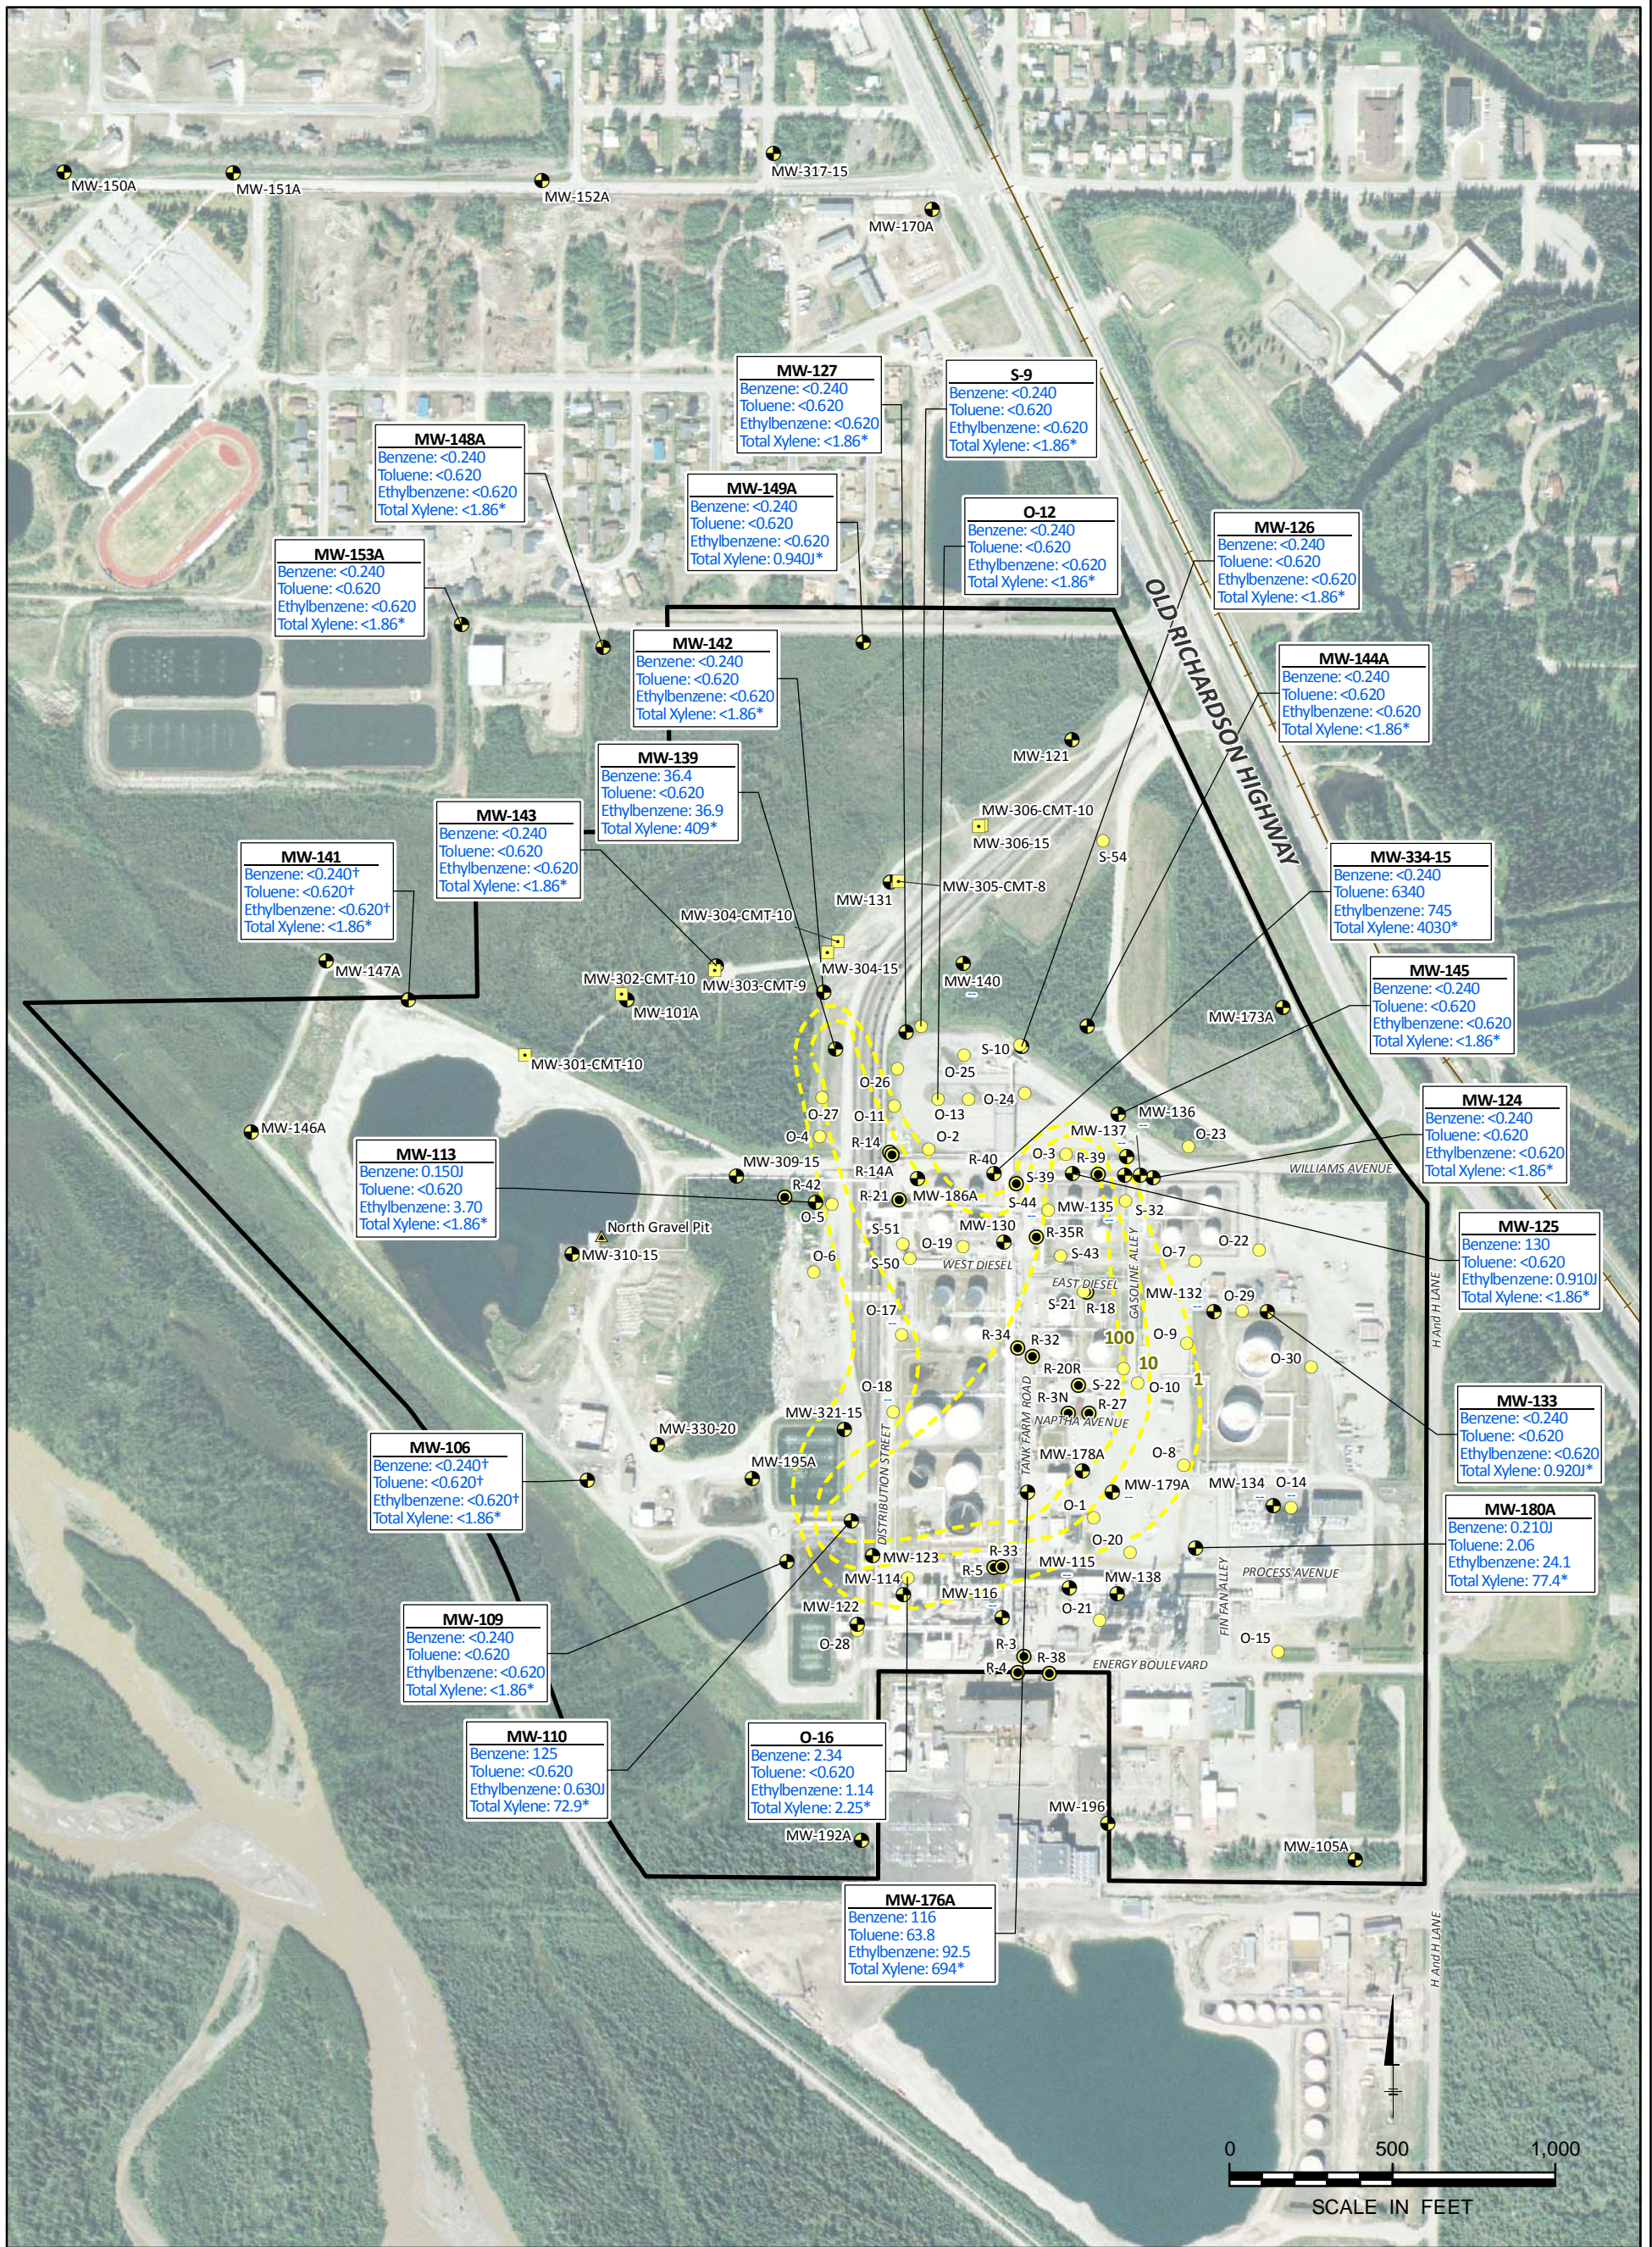
Results are displayed in µg/L  
 BTEX Benzene, toluene, ethylbenzene and total xylenes  
 < Not detected; detection limit listed  
 - - Not sampled due to cold weather constraints  
 † Total Xylenes calculated by SWI  
 ‡ BTEX analyzed by USEPA Method 624 (equivalent to SW8260B)  
 \* Result is considered estimated (no direction of bias) due to QC failures (flagged by SWI)
