Jones Point, NWA-S09

June 28, 2011

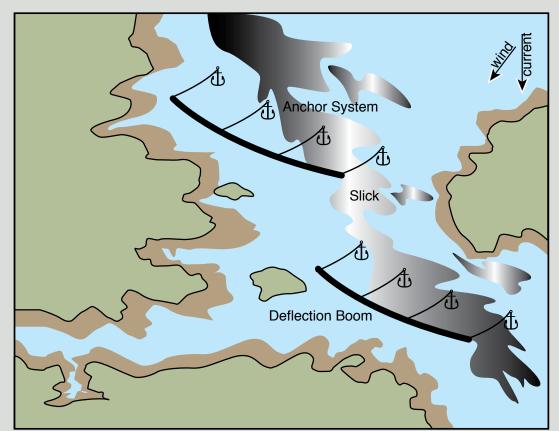
An example of the *Deflection Booming Tactic*. Actual deployment should be adjusted for local conditions.
