ALASKA DEPARTMENT OF ENVIRONMENTAL CONSERVATION
Division of Spill Prevention and Response
Prevention and Emergency Response Program

SITUATION REPORT

INCIDENT NAME: Lisburne Common Line Release

SITREP #: 11

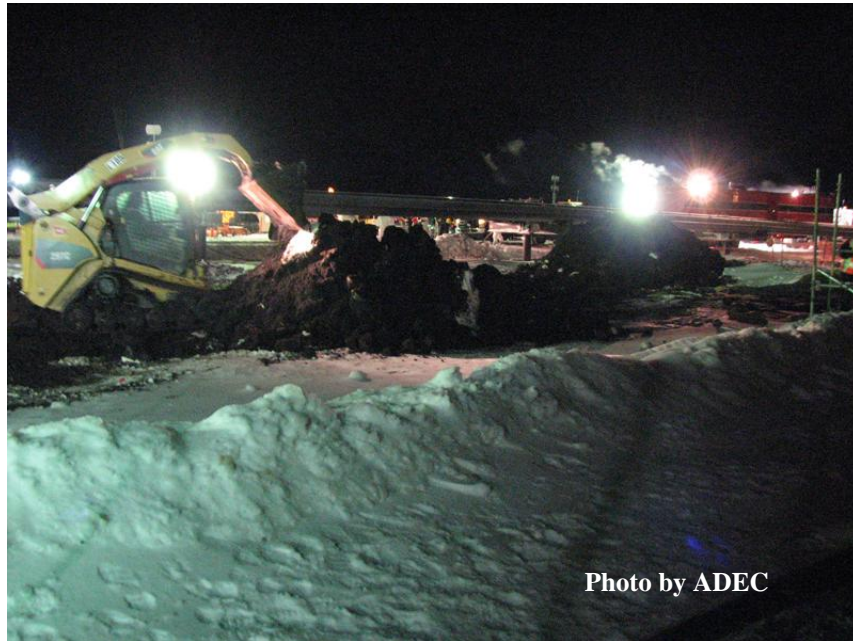
Photo by ADEC

A bobcat collects contaminated snow for removal during cleanup operations.

RESPONSE ACTION: A bobcat rubber-track loader is mechanically collecting contaminated material from within the heavily contaminated area. The material is being collected in totes, passed to clean equipment outside the contamination zone, and ultimately transferred to the East Dock for storage. Mechanical recovery continues to be the primary clean-up method. Work crews mechanically removed approximately 226 cubic yards of contaminated material from the site during the 24-hour operational period ending at 6:00 AM today.

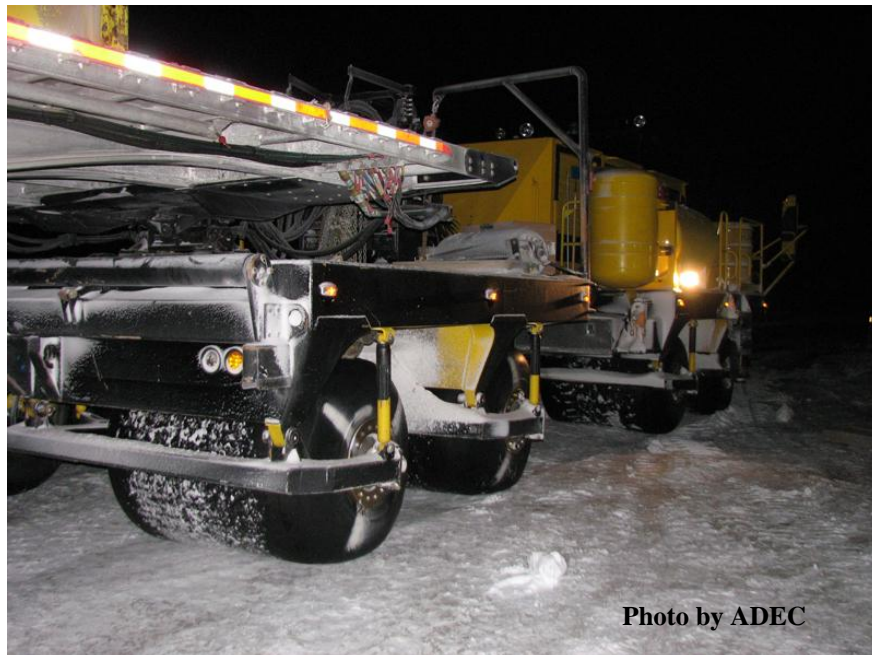
Photo by ADEC

A rolligon moves contaminated soil from the spill site to the Lisburne Production Center (LPC). Rollagons have large oversized tires which allow them to drive on tundra without causing damage.

Work on the ice-road continues; approximately 1.1 miles of the ice-road is complete. BPXA continues the moving of contaminated snow across the tundra using rolligon equipment. A rolligon is a specialized, low-impact, off-road vehicle. The rolligon will be replaced with flatbed trucks once the ice-road is complete.
