ALASKA DEPARTMENT OF ENVIRONMENTAL CONSERVATION
Division of Spill Prevention and Response
Prevention and Emergency Response Program

SITUATION REPORT

Rampart Tanker Fuel Release

SITREP # 6

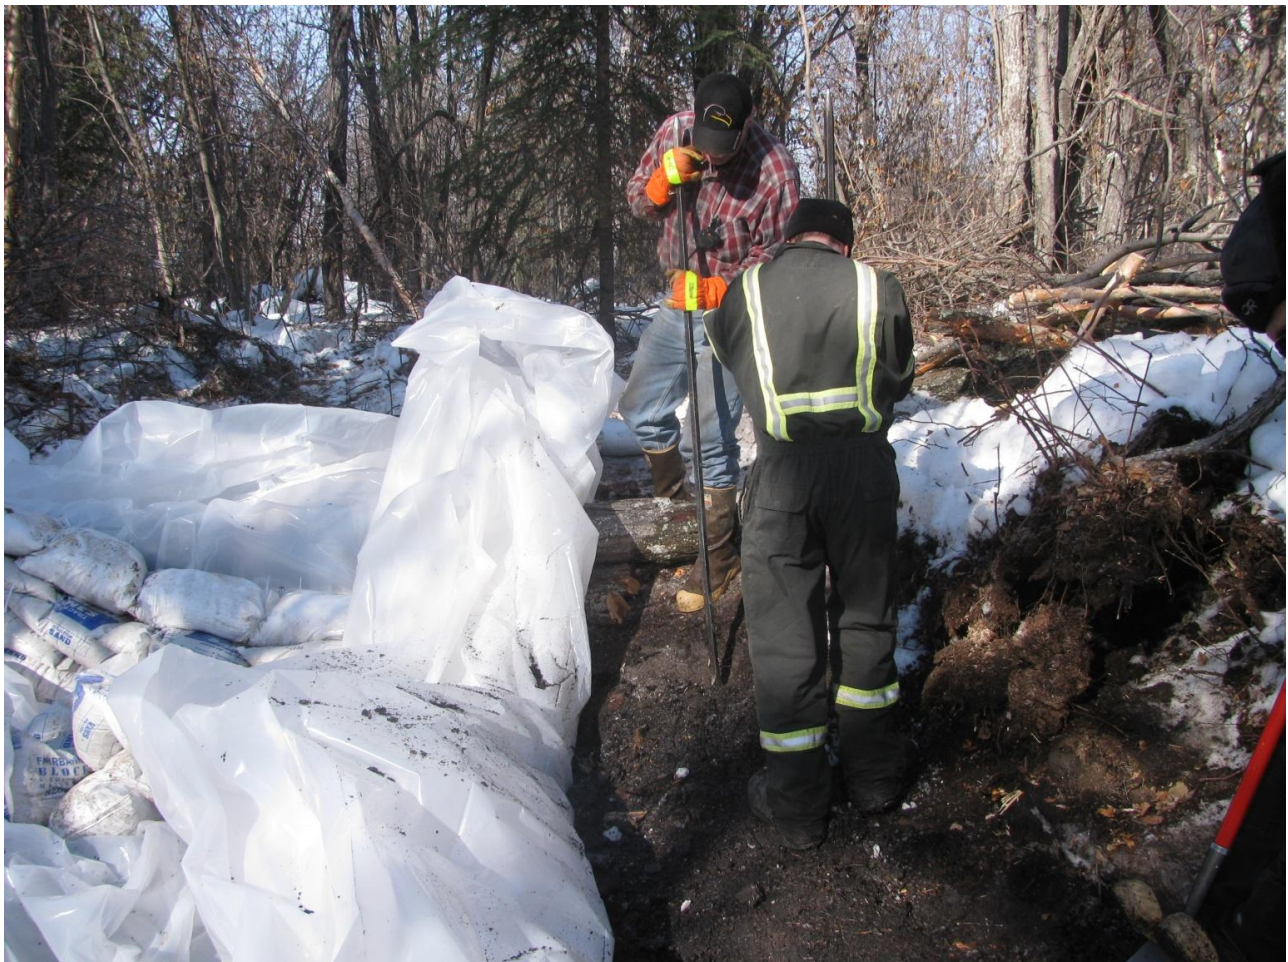
ADEC Photo of spill site showing an Emerald and a local responder constructing the underflow dam used to manage runoff and melt water from the site.

RESPONSE ACTION: Two ADEC Responders worked with two Rampart Village Council responders to remove clean snow from the spill site to expose the underlying contaminated snow and vegetation. Heavy equipment operated by a local responder was used to stock pile the material. **Four response contractors from Emerald Alaska arrived on site last Friday and placed the contaminated snow into portable tanks. Contaminated snow is currently contained within those tanks and fuel will be recovered once the snow has melted. Filtering and underflow dams were constructed in the forest to manage runoff and melt water from the site. Melt water started accumulating in the dam as of late yesterday.**

FUTURE PLANS AND RECOMMENDATIONS: **ADEC and Emerald responders have completed the initial response and are scheduled to return to Fairbanks today. Local responders will monitor the site and add sorbent pads to**

the dam when needed. ADEC and Emerald responders will return to Rampart once the snow in the tanks has melted and will filter the melted snow to remove contaminants. ADEC, the village of Rampart and Emerald are researching various options that will allow responders to access the area with heavy equipment in order to excavate the contaminated soil once spring breakup has occurred.
