**ALASKA DEPARTMENT OF ENVIRONMENTAL CONSERVATION**  
Division of Spill Prevention and Response  
Prevention and Emergency Response Program

***SITUATION REPORT***

## **Galena Flooding Event 2013**

**SITREP # 5**

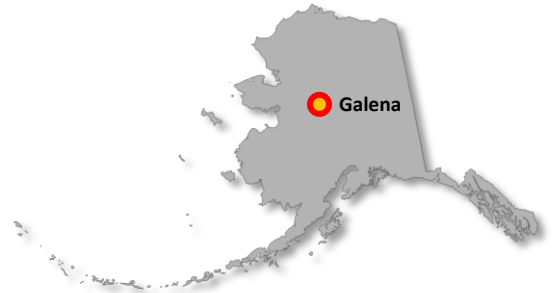
More than 800 drums containing hazardous liquids have been collected to date and brought to the accumulation area. Equipment to separate oil from water arrived in Galena on July 18. The system for separating oil and water will include six interconnected components: a 300 gallon intermediate bulk container for simple phase separation, two oil-water separators, and three granular activated carbon (GAC) systems. A temporary containment will also be constructed to collect the discharge water from the GAC system so it can be visually inspected for sheen. Oil absorbent boom will be placed in the containment area to capture any residual hydrocarbons.

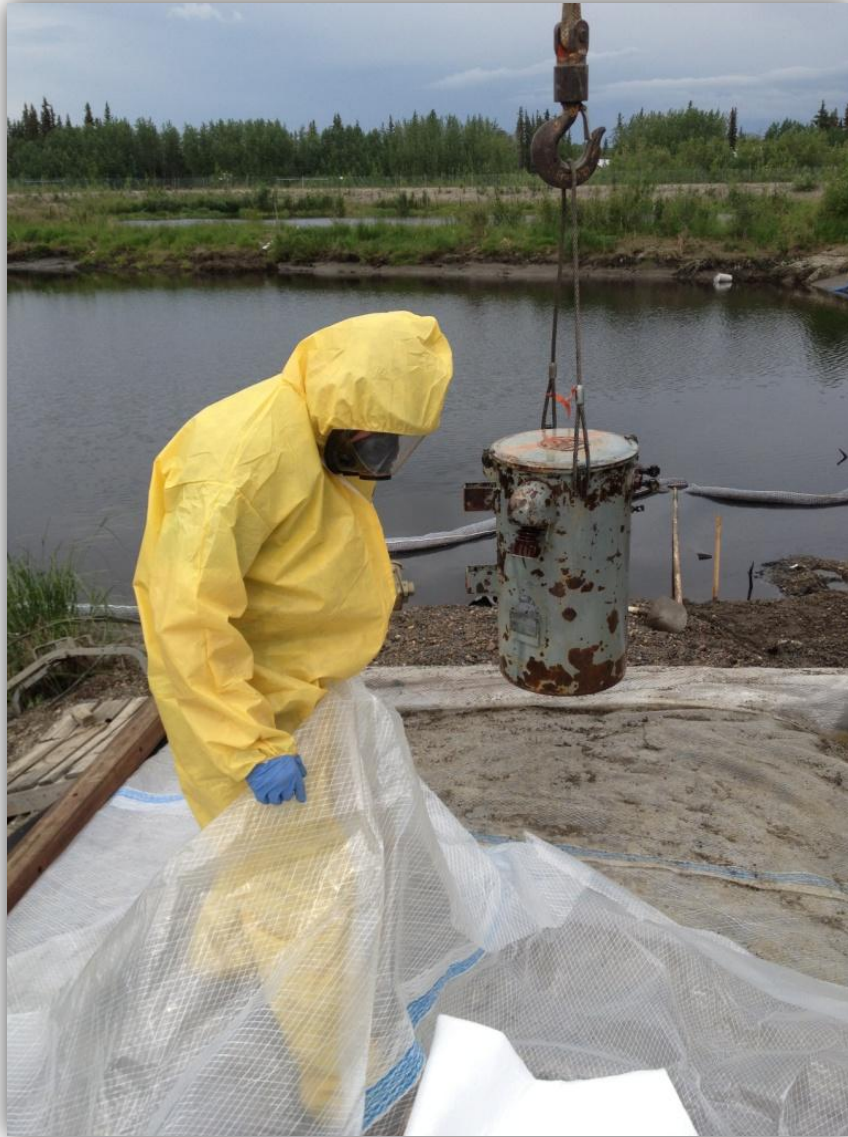
*Emerald personnel removing transformer from the city's sewage lagoon, July 7, 2013. (Photo/ADEC)*

Approximately 65 electrical transformers, both pole and pad mounted, potentially contaminated with PCBs were identified during field surveys. To date, 60 pole mounted transformers have been collected, wrapped and transported to the hazmat staging area. Five pad mounted transformers will be collected at a later time. Shannon & Wilson finished collecting analytical samples from 65 transformers for PCB contamination. Samples have been sent to a laboratory of analysis. The flood deposited 18 pole mounted transformers into the city sewage lagoon. The city's sewage lagoon will not return to service until the level of PCB contamination has been determined and a cleanup completed, if necessary.
