ALASKA DEPARTMENT OF ENVIRONMENTAL CONSERVATION
Division of Spill Prevention and Response
Prevention and Emergency Response Program
SITUATION REPORT

Dalton Highway Truck Rollover MP 309.5 Diesel Release

SITREP # 5

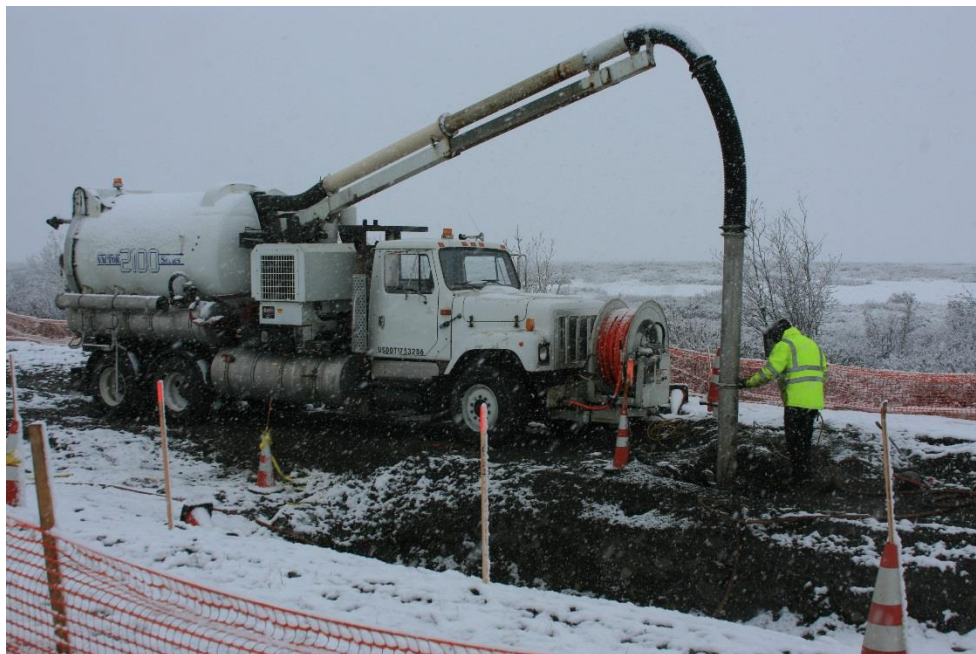
Today, Hamilton crews began removing contaminated soil from an area above the pipeline and utilities associated with it, which include a power line and cathodic protection cables. They are digging small holes with a vacuum truck at several locations within the spill area to expose the utilities, which are buried at a depth of roughly three feet. They will then proceed with larger-scale soil removal using an excavator that arrived on-site this afternoon. APSC representatives are providing assistance and guidance throughout the cleanup operation to help ensure the safety of responders and the integrity of the TAPS.

Cleanup crew using a vacuum truck to uncover TAPS utility lines, May 13, 2014. (Photo/ADEC)

FUTURE PLANS AND RECOMMENDATIONS: **Hamilton crews will continue to remove contaminated soil from the TAPS right of way and stockpile it in the containment cell for eventual transport to a disposal site.**
