ALASKA DEPARTMENT OF ENVIRONMENTAL CONSERVATION
Division of Spill Prevention and Response
Prevention and Emergency Response Program
SITUATION REPORT

NOSI Diesel Truck Rollover Dalton Highway Milepost 299.4

SITREP #: 5 and Final

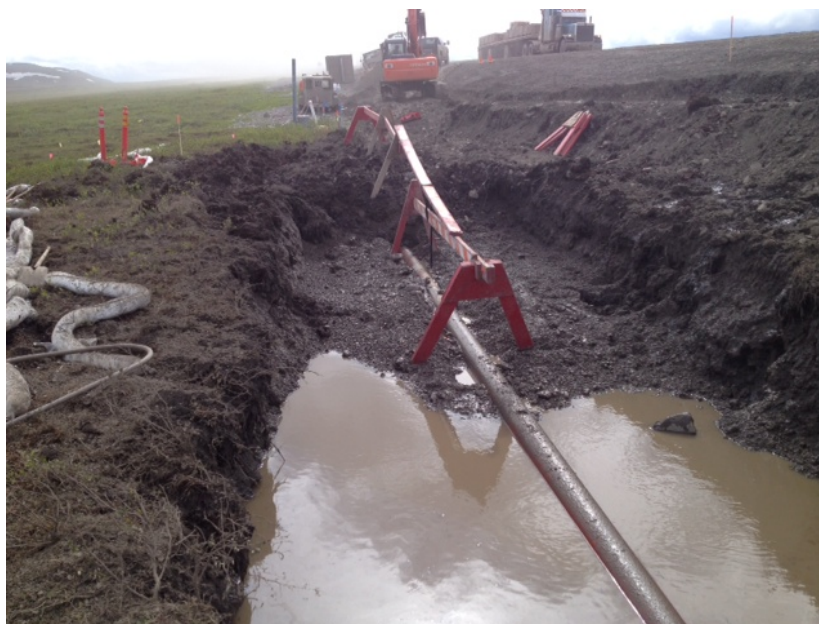
Excavation of contaminated soil along the APSC right of way. (Photo/ADEC)

The spill area included a portion of a utility right of way managed by Alyeska Pipeline Service Company (APSC). In accordance with a corrective action plan approved by the unified command, NOSI has hired an APSC contractor to excavate contaminated soil in the right of way and transport it to an ADEC-approved thermal treatment facility. Excavation began on June 23 and should be completed by June 27.

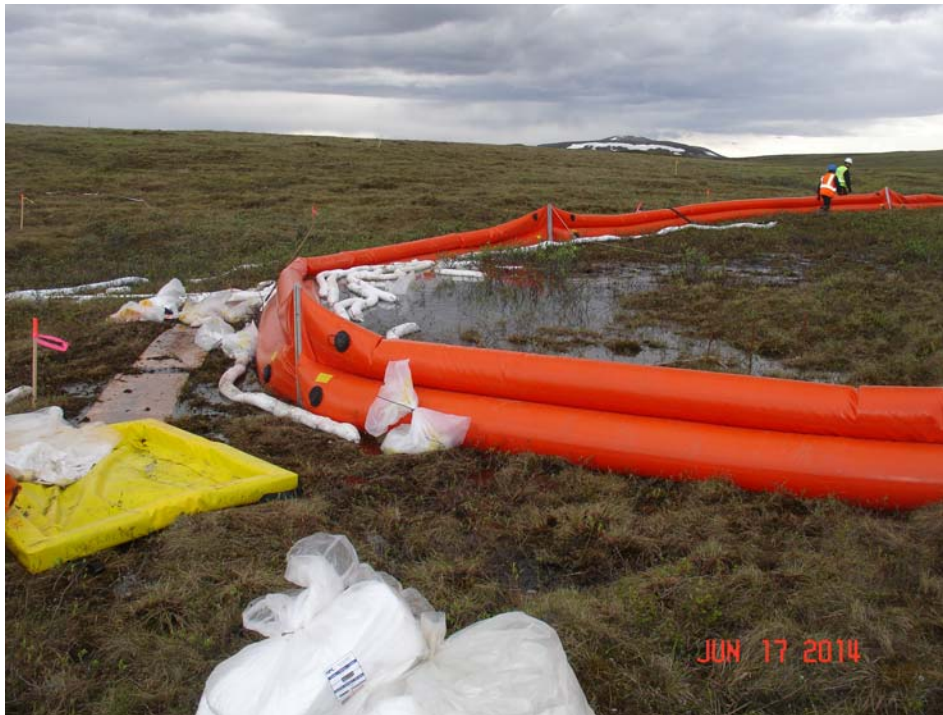
Treatment cell #2 during the flooding operations. (Photo/ADEC)

RESPONSE ACTION: Responders completed the cold-water tundra deluge on June 19. More than 750,000 gallons of water were used to flush fuel from the tundra. Over the course of the response, responders recovered 565 bags of oiled absorbents, which will be shipped to an approved facility in Anchorage for recovery of the fuel and disposal of wastes. Most of the resources used for the deluge tactic were demobilized from the spill site on June 20. Several containment cells will remain along the stream channel to collect sheen within the spill site.
