ALASKA DEPARTMENT OF ENVIRONMENTAL CONSERVATION
Division of Spill Prevention and Response
Prevention and Emergency Response Program
SITUATION REPORT

Alaska Petroleum Mile 48 Richardson Hwy

SITREP #: 4 (and Final)

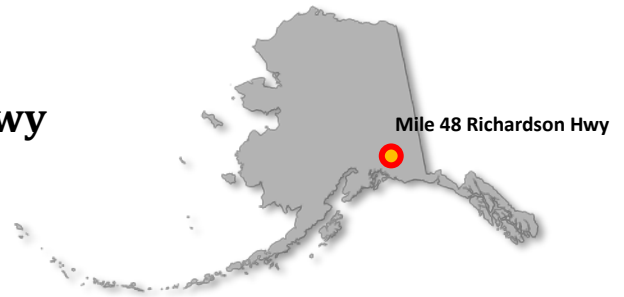
Management (EQM) and Ecology and Environment (ENE) mobilizing to the site. Over the next 11 days, EQM excavated another 1100 cubic yards of contaminated gravels effectively removing all of the rest of the contaminated gravels previously delineated. The stream channel was reconstructed and the site was graded back to similar contours as before the spill. EQM also replaced 80 cubic yards of Class 2 rip rap along the base of the roadbed.

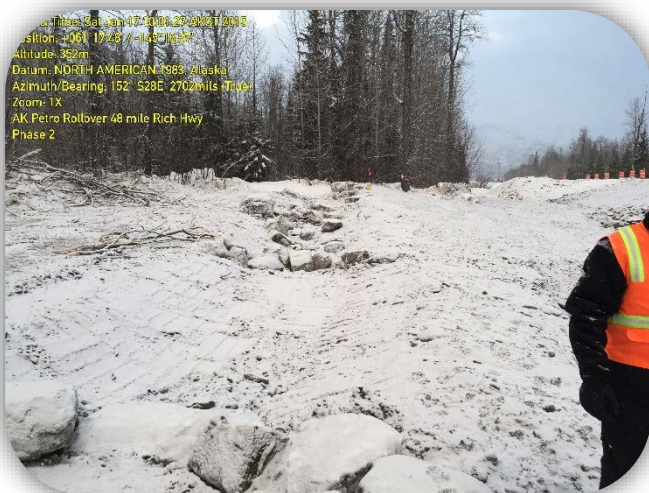
*Completed site work and stream reconstruction.
Photo take 01/17/2015 by ADEC*
