## ALASKA DEPARTMENT OF ENVIRONMENTAL CONSERVATION

SITUATION REPORT

**SPILL #:** 14399934901

**INCIDENT LOCATION**: Kuparuk River Unit, Drill Site 1B

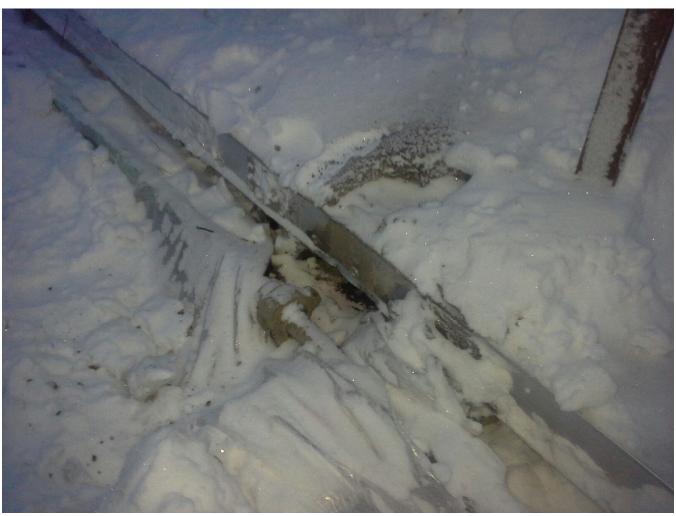
CAUSE OF SPILL: During normal operations a gasket along a 2 inch hard line on Pad 1B failed and released a mixture of drilling mud, brine, and diesel to gravel pad and a closed reserve pit. An area of approximately 3,000-4,000 square feet was impacted by the release.

Release point from hard line, December 15, 2014. (Photo by Paul Lhotka/ADEC)

**SOURCE CONTROL:** The ball mill injection facility was shut down and the hard line isolated stopping the release. The failed gasket was identified and repaired. The line was inspected to insure there were no additional leaks.
