ALASKA DEPARTMENT OF ENVIRONMENTAL CONSERVATION  
Division of Spill Prevention and Response  
Prevention, Preparedness and Response Program  
**SITUATION REPORT**

## Lynden Truck Hazmat Rollover Richardson Highway

**SITREP #:** 3 and Final

**SPILL #:** 16309900801

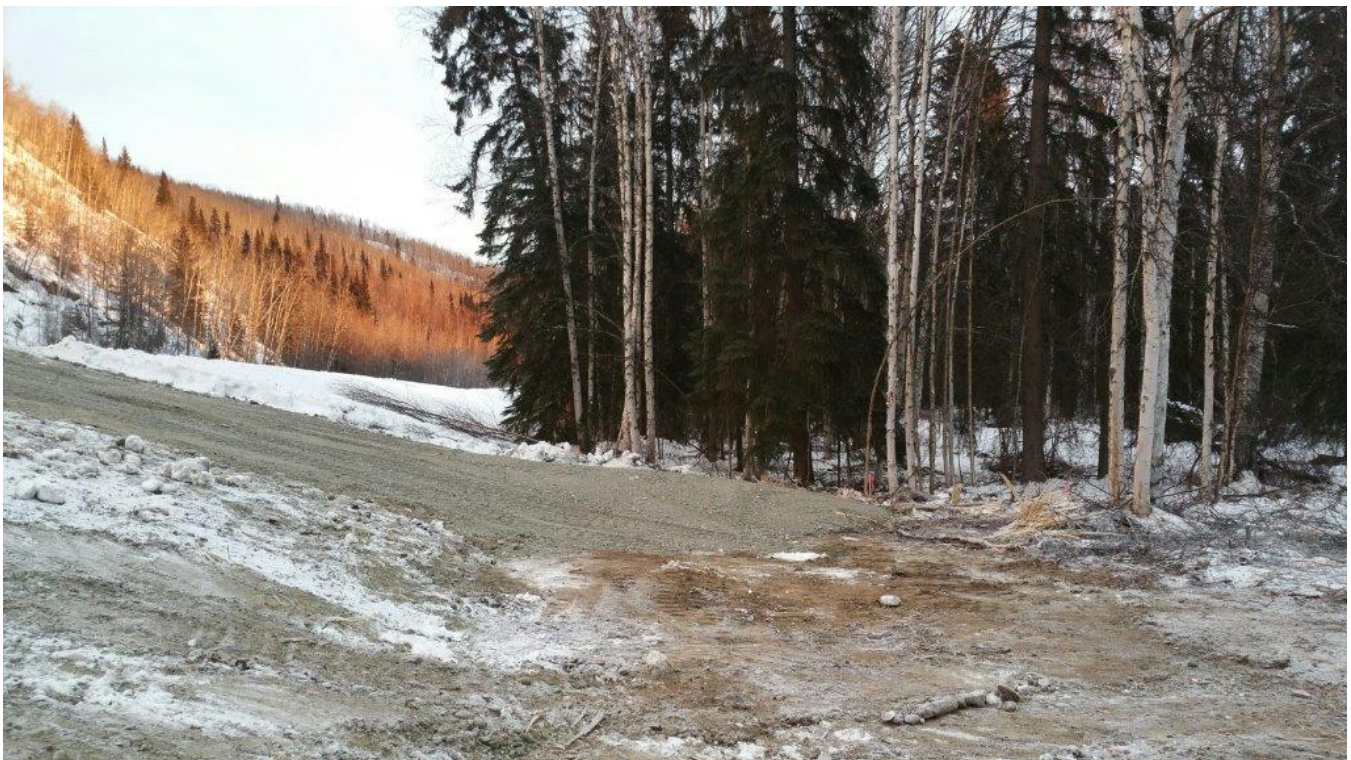
clean fill was placed over the affected area. ADEC and Lynden will remain in close contact with the appropriate agencies during any further remediation efforts. At this time emergency operations have ended, personnel and equipment have demobilized from the site, and travel along the Richardson Highway is no longer affected.

**RESOURCES AFFECTED:** Soil adjacent to the Richardson Highway roadbed was impacted from this spill. Soil samples extended to groundwater were neutral in pH and showed no signs of impacts to groundwater.

Figure 1. Spill area with a "cap" of clean fill two feet deep. [Photo: RSE]

**FUTURE PLANS AND RECOMMENDATIONS:** RSE will be providing interim data from the neutralization and a corrective actions summary report for agency review. The data provided in this report will assist in additional discussions regarding final cleanup options, which are expected to take place to coordinate remedial site activities in the spring. This cleanup has now moved from the response phase to the project management phase.
