ALASKA DEPARTMENT OF ENVIRONMENTAL CONSERVATION
Division of Spill Prevention and Response
Prevention and Emergency Response Program

SITUATION REPORT

Big State Birch Lake Rollover Diesel Spill

SITREP # 2

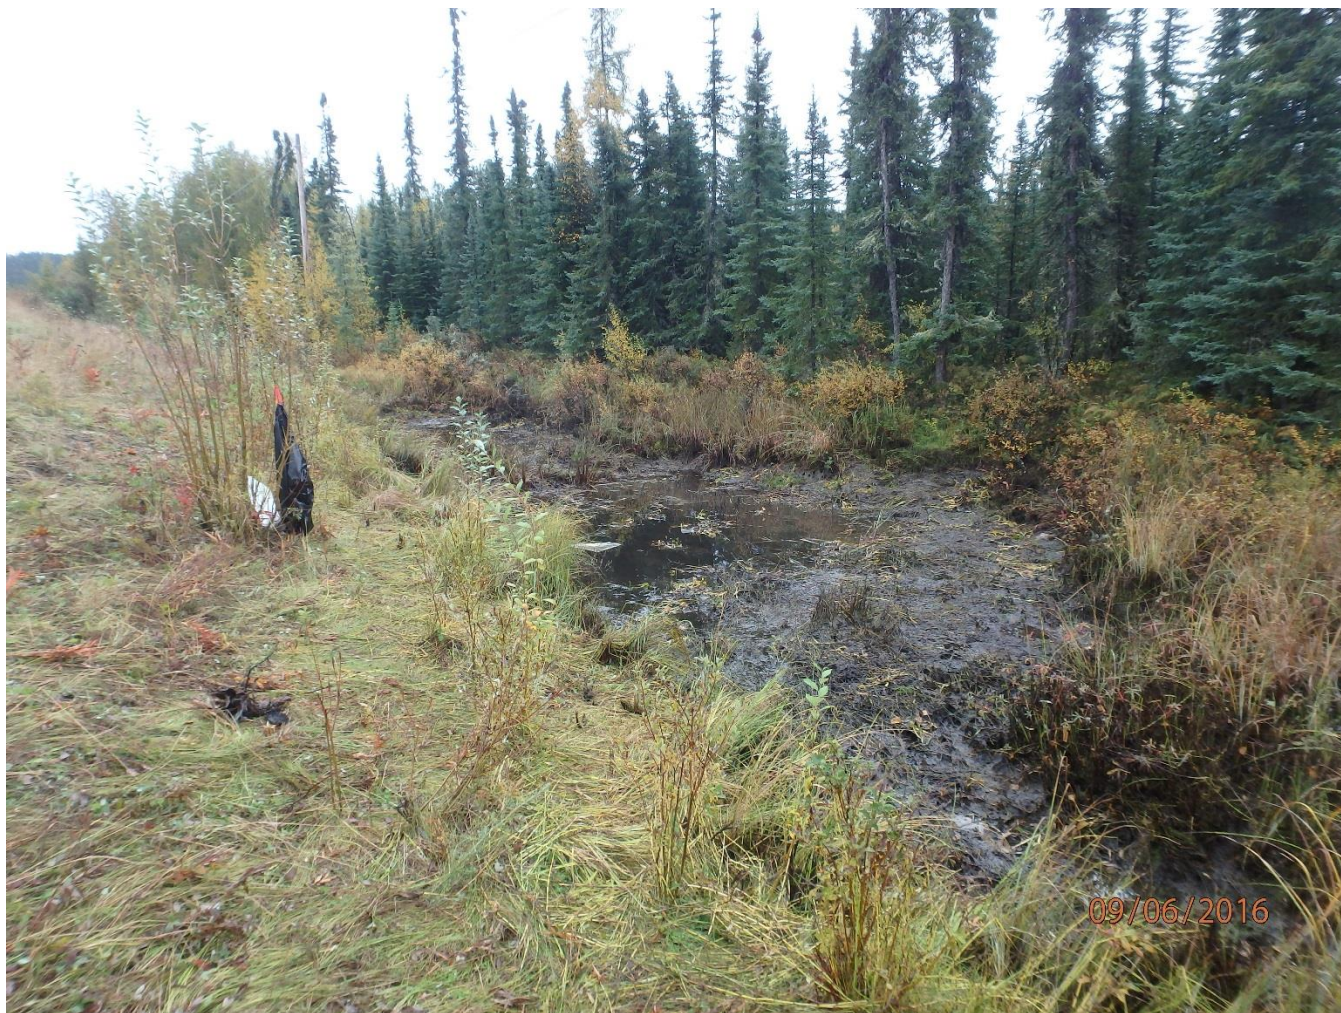
RESOURCES AFFECTED: Marsh land and a small roadside pond were impacted from the diesel release. There have been no reports of impacts to wildlife.

Photo of the pond that was impacted by the release after recovery of free standing liquids, including fuel was completed. The pond recharged with water, allowing for additional recovery, September 6, 2016. (John Ebel, ADEC)

A Hydro-excavator was used to dig two recovery pits in the saturated area on the afternoon of September 6, 2016. Due to high groundwater conditions and an area of moist vegetation present on site the fuel is floating on the surface of the pooled water in the collection areas. These conditions are also aiding the sumps in collecting oil-water mixture. An additional two smaller sumps were put on site to aid in recovery.

FUTURE PLANS AND RECOMMENDATIONS: Recovery of diesel will continue through today. Big State Logistics, Inc. is working with ADEC to develop plans to recover impacted soil. While cleanup actions are being performed a traffic control plan will be implemented and flaggers will be on site to guide traffic.
