The objective of this report is to summarize water quality monitoring data of Clearwater Creek and its adjacent wetlands near Delta, Alaska, and to determine any impacts from agricultural activity. This summary can be used to evaluate past monitoring activities and make recommendations for any future monitoring in the Clearwater Creek watershed.

## **HISTORY OF CLEARWATER CREEK WATER QUALITY MONITORING**

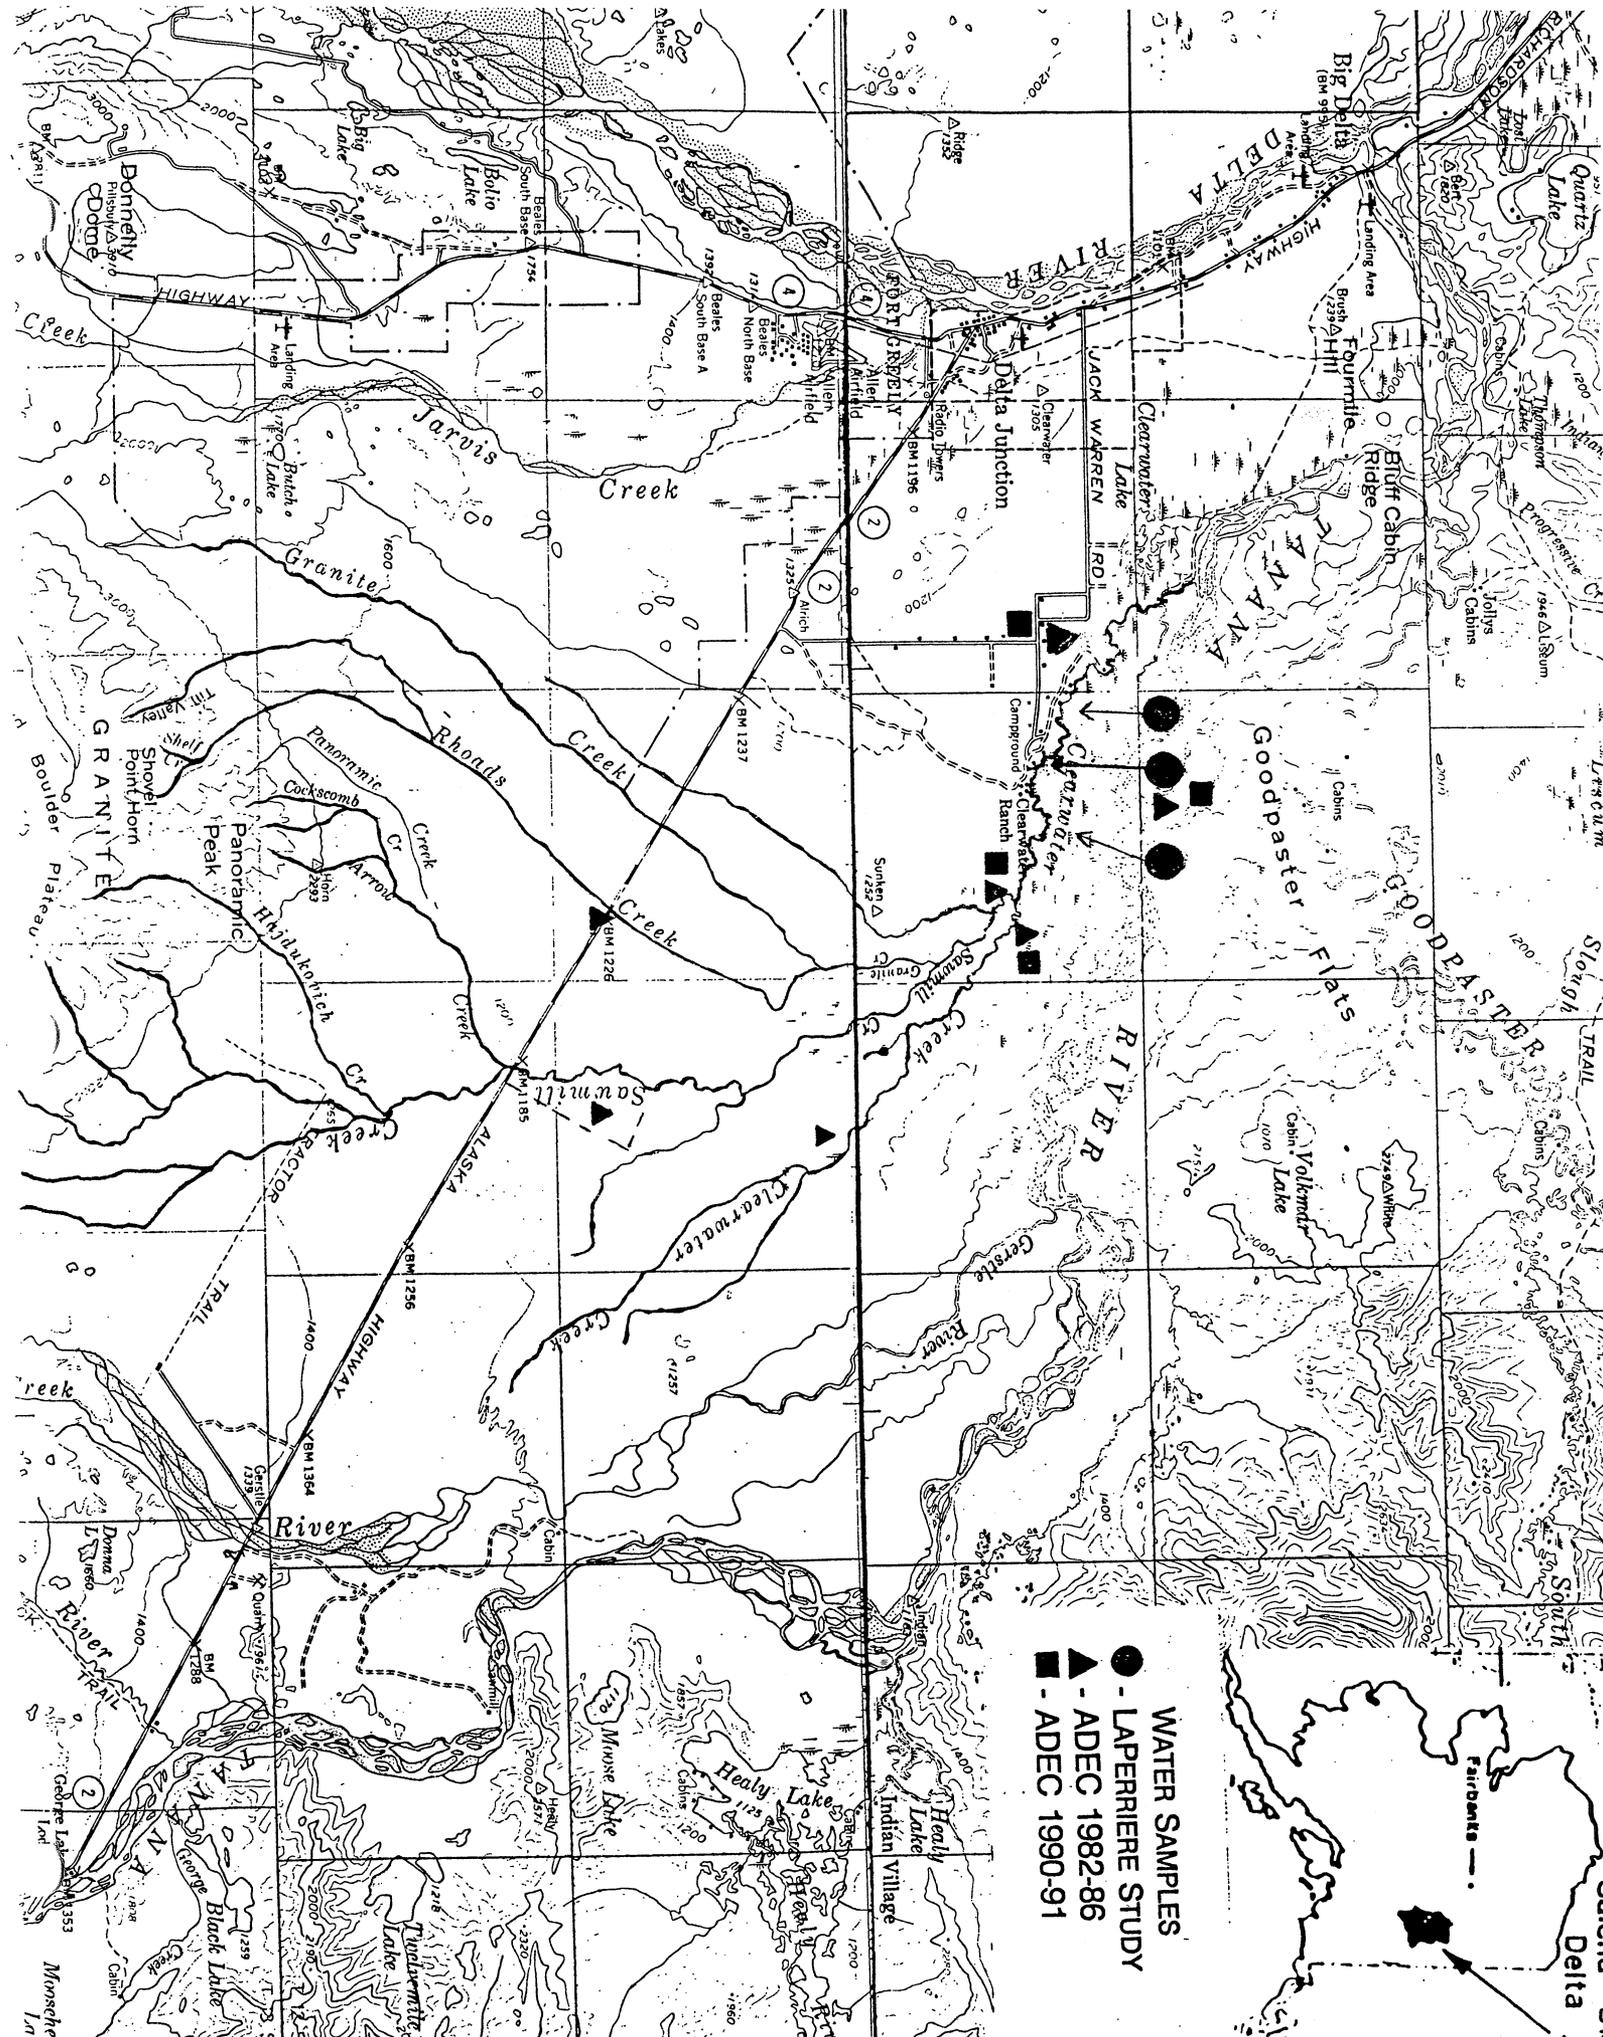
**WATER SAMPLES**  
 ● - LAPERRIERE STUDY  
 ▲ - ADEC 1982-86  
 ■ - ADEC 1990-91
