103-60-57  
8-23-76  
Jackinsky

LOCATION: No. shore of Pt. St. Nicholas,  
4 1/4 miles E. of Cape Suspiro  
LATITUDE: 55 27 ~~18~~ 20"  
LONGITUDE: 133 01 ~~53~~ 56"  
WATERSHED: Length 3 miles, area 5 sq. miles, small lake, runoff  
WEATHER: Overcast, rain, 57 F., High tide.  
STREAM: pH 7.5, 51 F, 10 cfs, light brown/clear.  
SPAWNING: 2453 m<sup>2</sup> (5280'x10'x50% ASA)  
REARING: Pool and eddies, much trash in stream,  
good overhead cover - good rearing  
throughout.

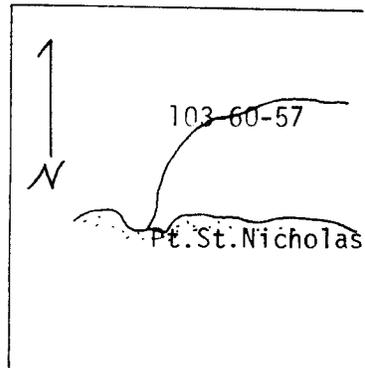
Jam & falls  
overflow area

10% ASA  
Mostly bedrock.  
Log and stick jam,  
barrier to most  
upstream movement  
by adult salmon.

2 water ouzels at work.  
Old evidence of rehab.  
effort rejammed with  
sticks.

Rubble overflow  
area, log jam.

Fry (coho) in pools.

Stream divides into  
many small channels  
and pools among logs,  
stumps and bushes.

Silt cut-  
bank. 60% ASA

Island divides  
stream into 2  
channels.

Falls, log jam  
on right channel

Stream  
channel  
has  
changed Pools 25% or less

Falls over log  
Old channel

Over-  
hanging  
bushes Clean coarse gravel  
to 8". 20% fines.

ITZ gravel  
with *Fucus*, some  
green algae.

Not logged here on up.  
Steeper gradient, steep hillsides.

2'  
Falls

Huge logs in big jams indicate  
past floods of tremendous size  
(maybe from landslides).
