DIVISION OF SPILL PREVENTION AND RESPONSE  
Contaminated Sites Program

Re: Decision Document; ARRC M-I Swaco Lease Property  
Cleanup Complete – Institutional Controls Determination

ARRC M-I Swaco Lease Property  
721 West 1<sup>st</sup> Avenue  
Anchorage, Alaska 99501

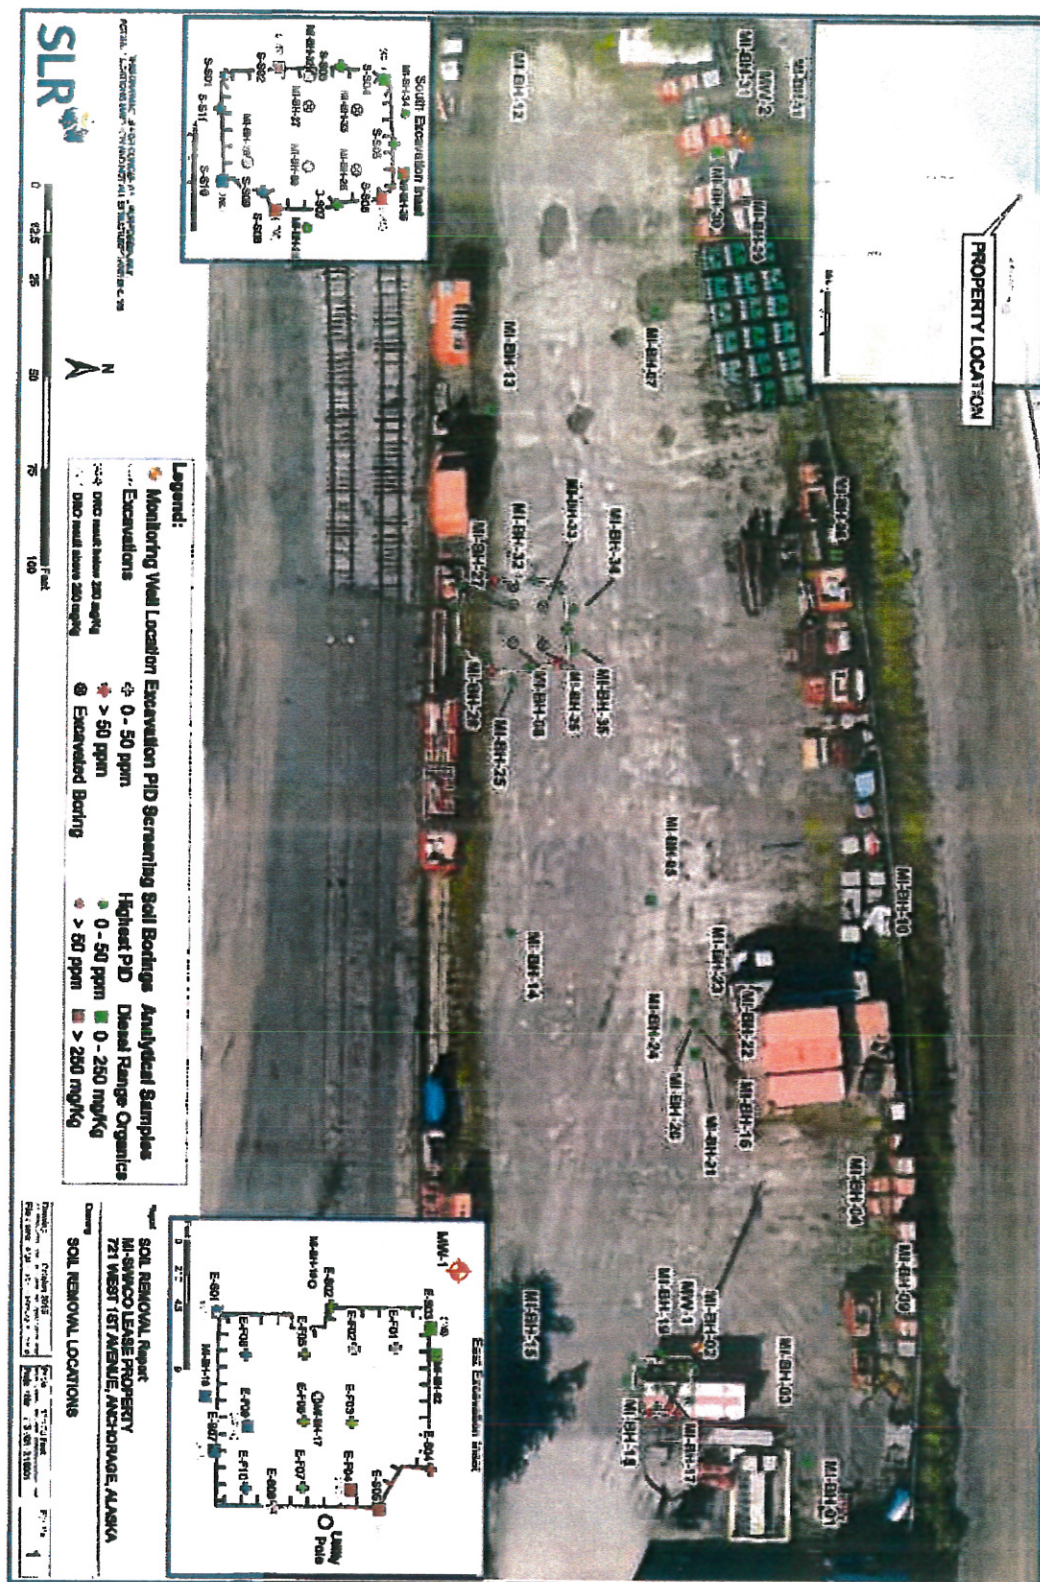
In 2015, three field efforts were conducted to determine the extent of DRO contamination and remove contaminated soil to the best extent practicable. The first investigation was conducted in April and consisted of advancing 17 soil borings and collecting eight subsurface soil samples. The second investigation was conducted in June and consisted of advancing 18 soil borings and collecting eight surface and subsurface soil samples stepping out from contaminated areas identified in April. The third investigation conducted in September involved removal of contaminated soil and advancement of two monitoring wells. Based off these investigations, three areas of DRO contamination were identified at the site. These locations include: to the west at borehole MI-BH-11, to the east at the former AST and borehole MI-BH-17, and to the south at borehole MI-BH-33 (see attachment C).

Soil samples collected from the west location borehole MI-BH-11 at the groundwater interface 6 to 6.5 feet bgs contained DRO at 473 mg/kg; surface soil samples did not contain detectable concentrations of DRO. To determine extent of contamination, a monitoring well was advanced at this location. Soil and groundwater samples collected did not contain DRO concentrations above clean up levels.

Soil samples collected from the former AST east location borehole MI-BH-17 at the groundwater interface 5 to 7.5 feet bgs contained DRO at 1,270 mg/kg; surface soil samples collected did not contain detectable concentrations of DRO. Thirty two cubic yards of contaminated soil were removed to a depth of 2 to 5.5 feet bgs and transported to ASR. The excavation was limited by a utility pole and a paved parking area. Two out of five confirmation soil samples collected from the sidewalls and bottom contained DRO up to 3,940 mg/kg. These two soil samples were collected from the east side of the excavation adjacent to the utility pole. The excavation was backfilled with clean fill. To determine extent of contamination, a downgradient soil boring was advanced and completed as a monitoring well. Soil and groundwater samples collected from the monitoring well did not contain DRO concentrations above clean up levels.

Soil samples collected from the south location bore hole MI-BH-33 at the surface 1 to 2 feet bgs contained DRO up to 3,700 mg/kg; subsurface analytical soil samples were not collected from this location. Sixty four cubic yards of soil were removed to the groundwater interface at a depth of 2.5 feet bgs and transported to ASR. The excavation was limited by a fence to the south and phone and sewer line to the north. Collection of confirmation soil samples were limited to the sidewalls due to standing water in the excavation, which contained a hydrocarbon sheen when the soil was disturbed. Three out of six soil samples collected from the sidewall contained DRO above cleanup levels up to 3,250 mg/kg. The standing water in the excavations was treated with a carbon activated filter and the excavation was backfilled with clean fill. Soil samples collected from downgradient boreholes MI-BH-06 and MI-BH-07 at the groundwater interface did not contain DRO concentrations above clean up levels.
