**PCB-CONTAMINATED SOIL REMOVAL
ACTION**

2013 FIELDWORK SUMMARY REPORT

PORT HEIDEN, ALASKA

FEBRUARY 2014

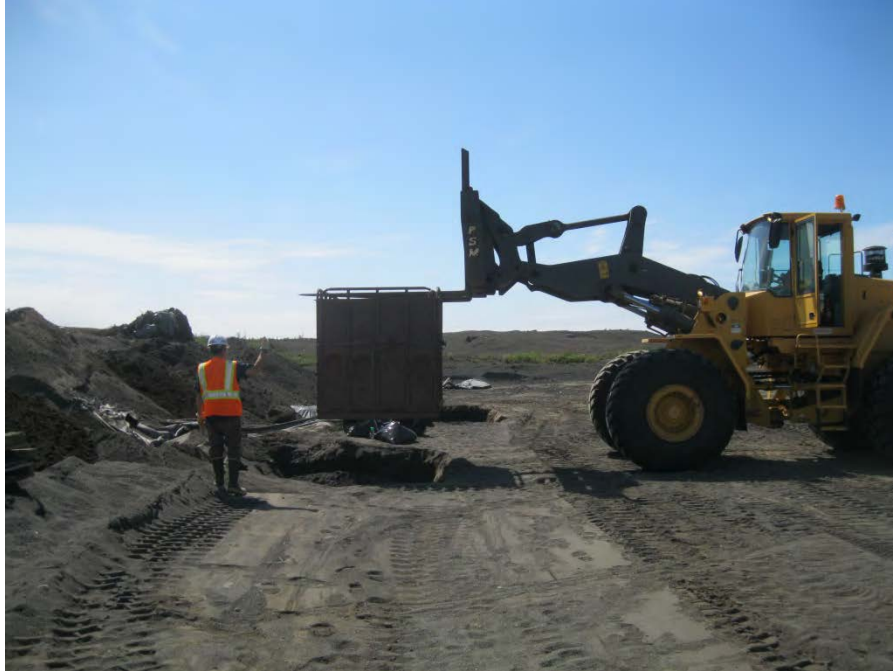
Photo No. 1 – 27 July 2013

Worker is guiding placement of frame #1 for loading bags at Storage Area CA 2, looking south.

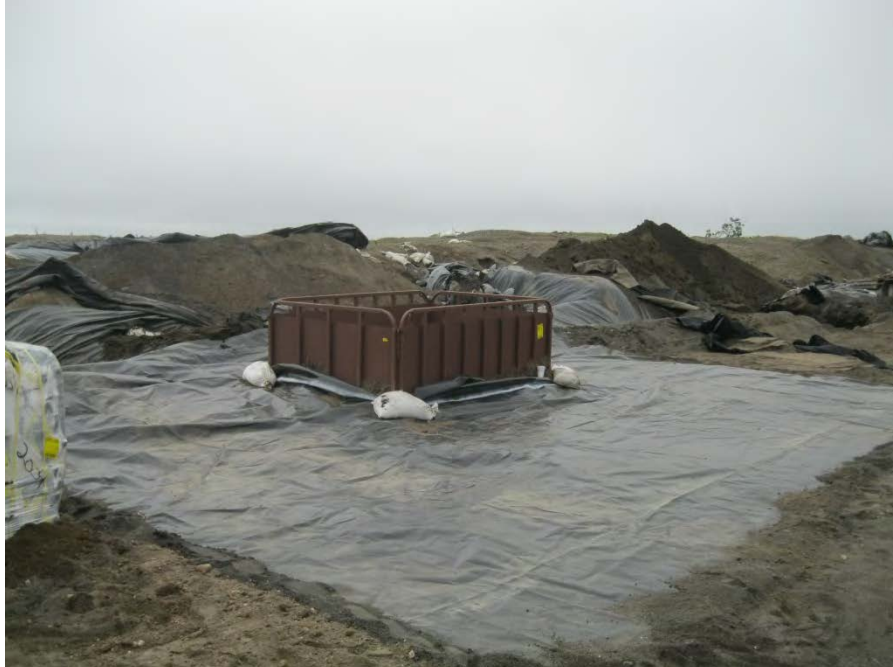
Photo No. 2 – 27 July 2013

Frame #1 in place at Storage Area CA 2 with established exclusion zone, looking southeast.

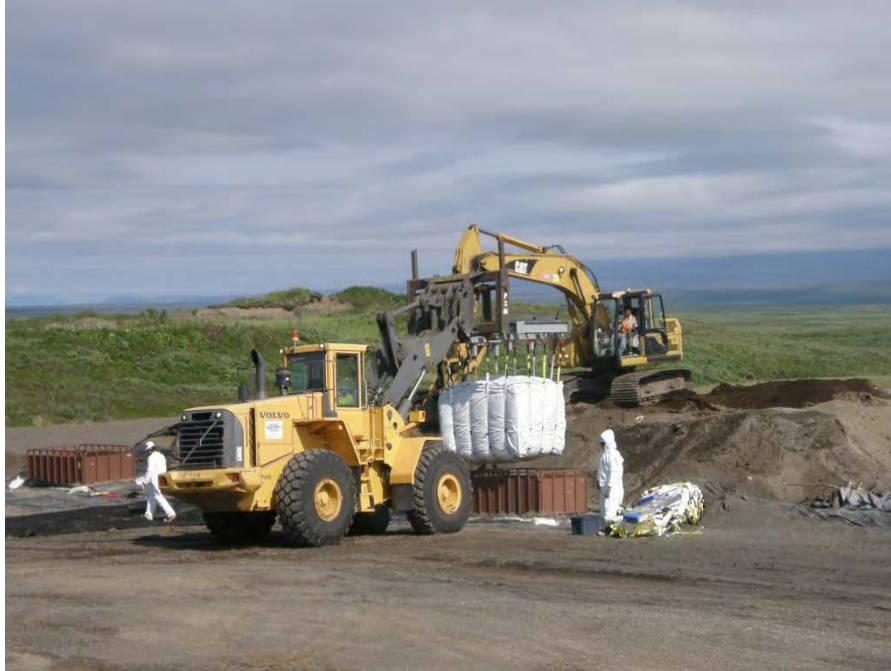
Photo No. 3 – 27 July 2013
Loader lifting a bag full of soil out of frame at Storage Area CA 1,
looking northeast.

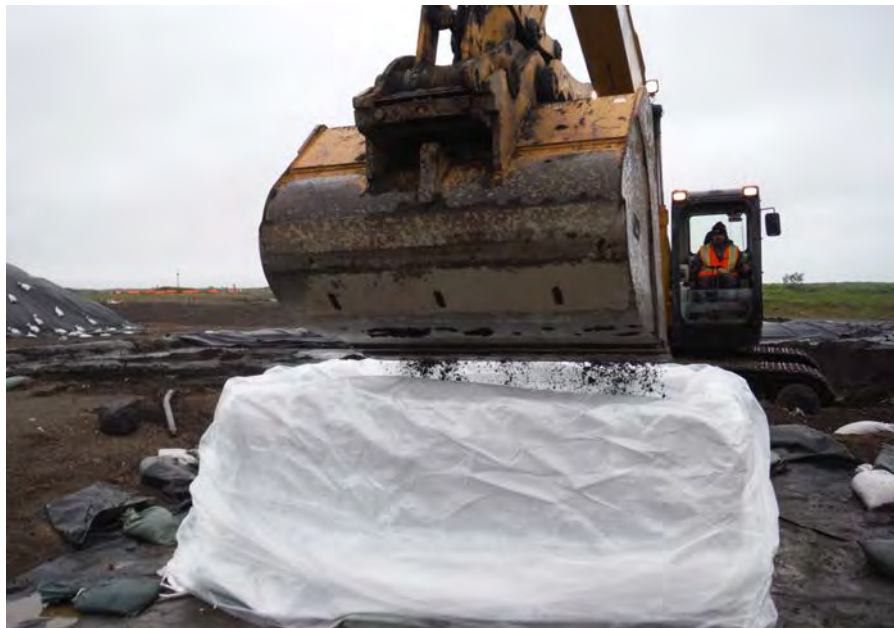
Photo No. 4 – 17 August 2013
Excavator filling bag from Stockpile J 1.4, looking west.

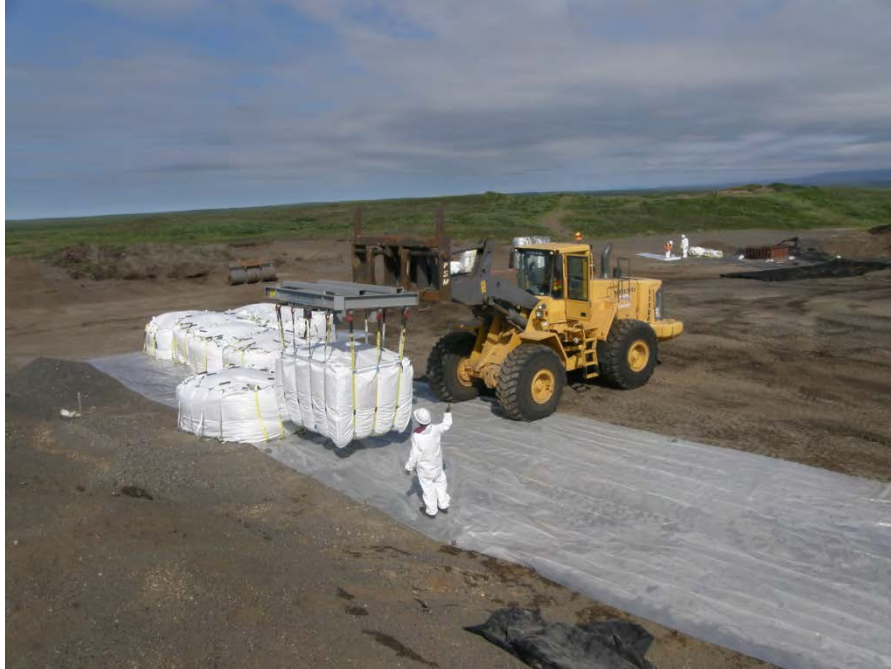
Photo No. 5 – 27 July 2013

Worker providing guidance for staging a bag on visqueen near the CA stockpiles, looking north.

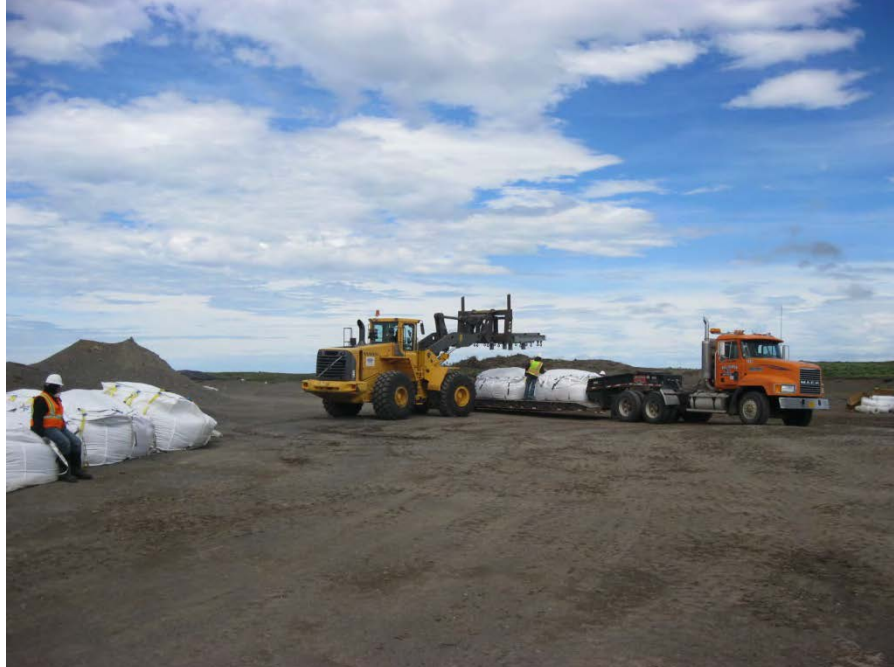
Photo No. 6 – 31 July 2013

Loader loading bags on a Lowboy near CA stockpiles, looking south.

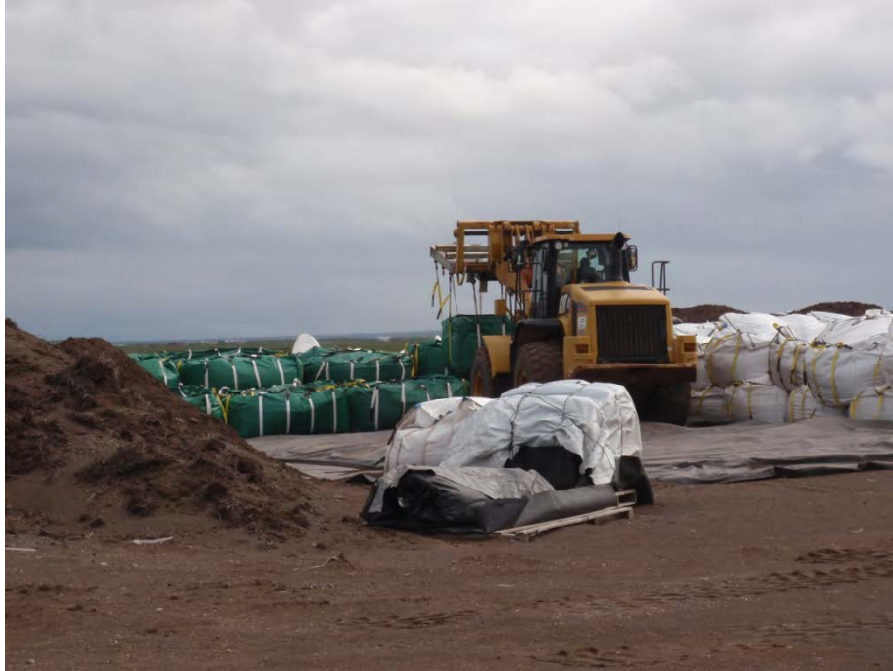
Photo No. 7 – 2 August 2013
Loader staging a bag at the barge landing area, looking north.

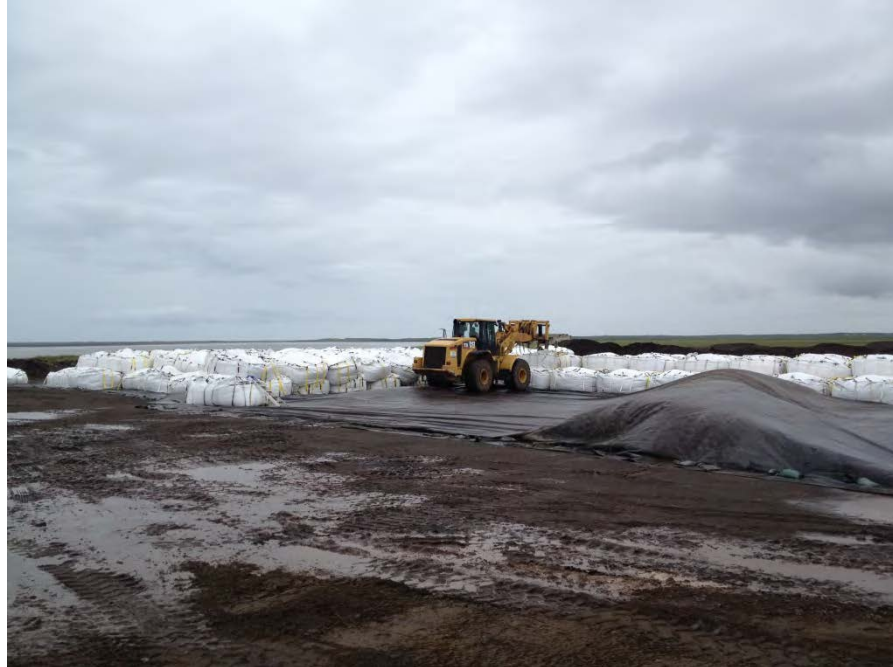
Photo No. 8 – 5 August 2013
Loader is organizing rows of bags at the barge landing area, looking north.

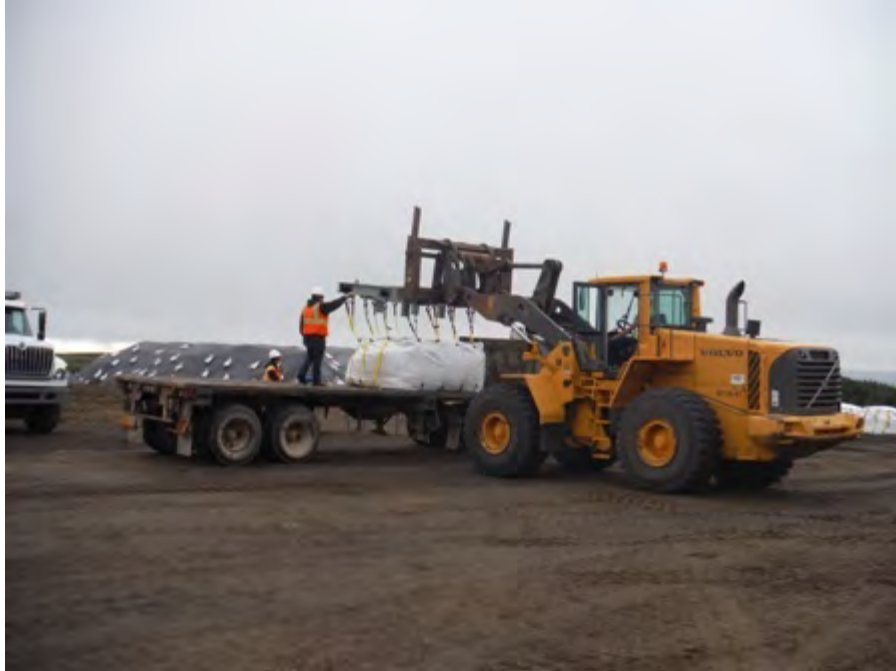
Photo No. 9 – 15 August 2013

Loader is loading bags onto Lowboy from J 1.4 stockpile, looking northeast

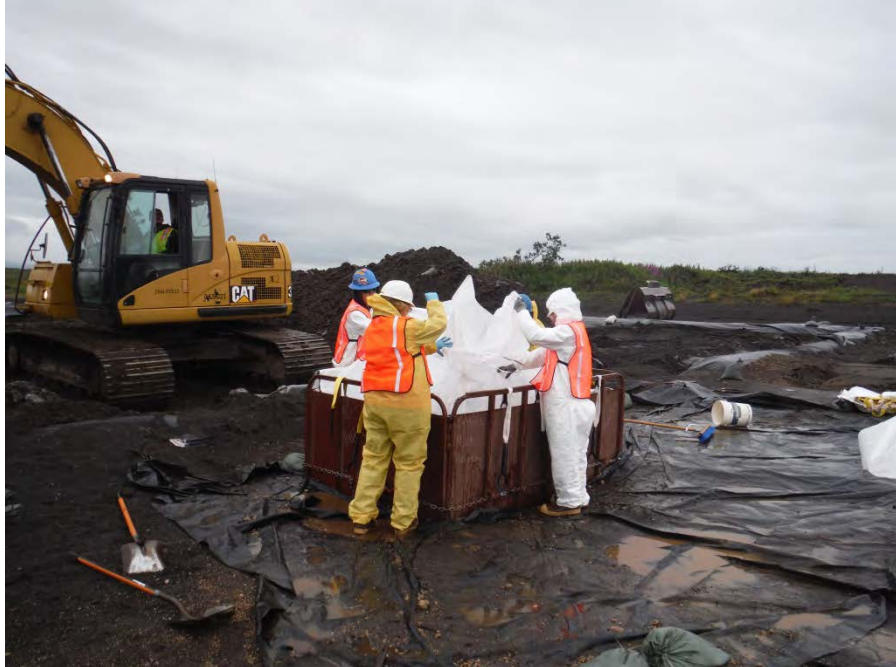
Photo No. 10 – 16 August 2013

Aniakchak crew closing/sealing a bag from Storage Area CA 1, looking southeast.

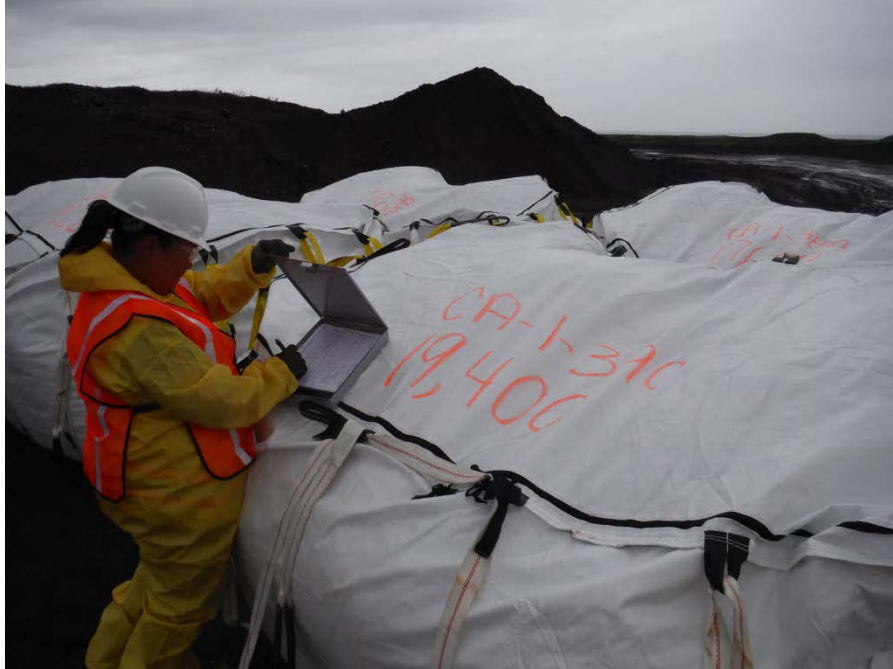
Photo No. 11 – 16 August 2013
Aniakchak crew recording Bag ID and weight at CA 1, looking northwest.

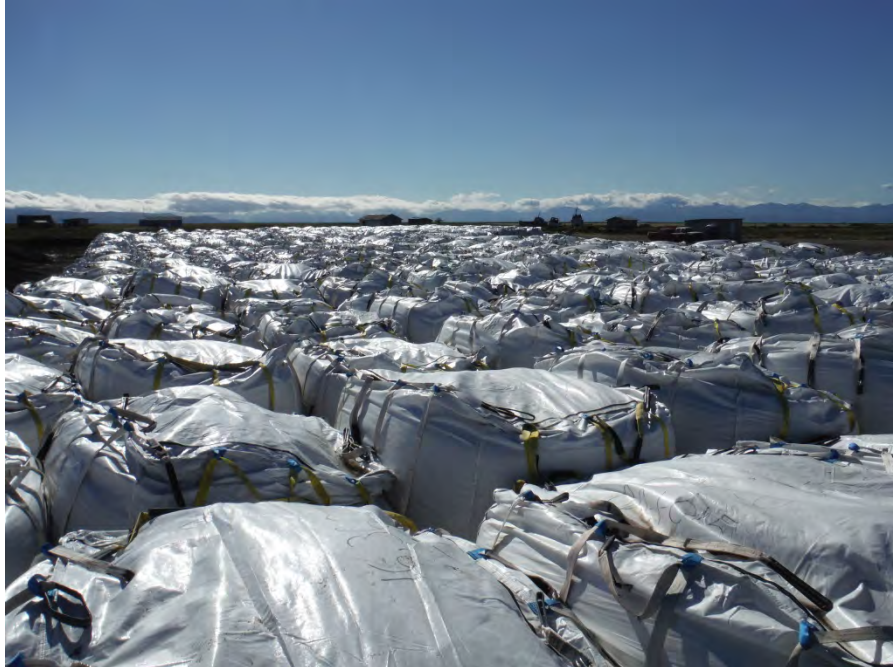
Photo No. 12 – 2 September 2013
Staged bags at the barge landing area, looking south.
