DIVISION OF SPILL PREVENTION AND RESPONSE Contaminated Sites Program

Re: Decision Document: Eagle Trading Company Cleanup Complete Determination

Site Name and Location: Eagle Trading Company comer of Adams and Front Street Eagle, Alaska 99738

DEC Site Identifiers: File No.: 200.26.007 Hazard ID.: 24582 **Regulatory Authority for Determination:** 18 Alaska Administrative Code (AAC) 75 and 18 AAC 78

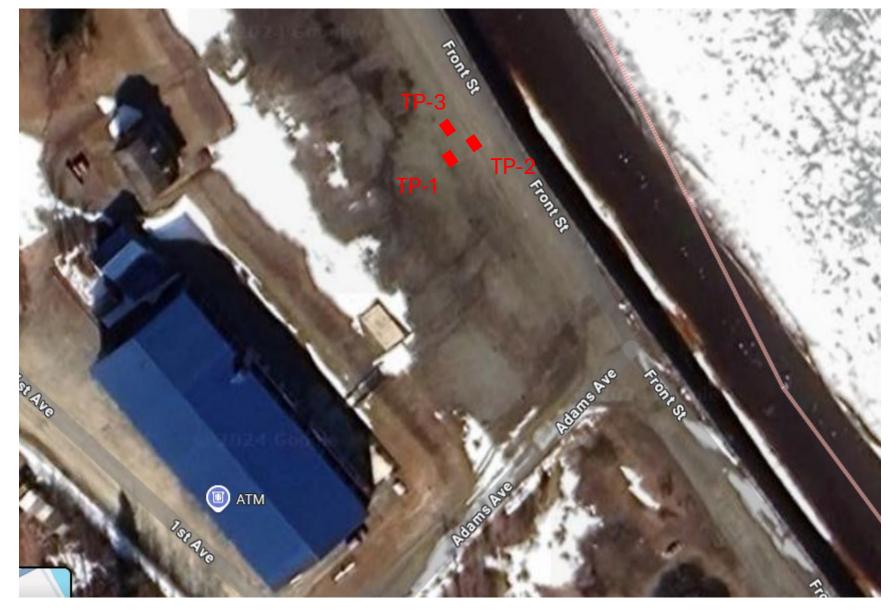
Figure 1: Eagle Trading Confirmation Sampling Test Pit Locations

In July 2024, DEC staff returned to the site to conduct soil sampling. The flood destroyed landmarks of the old gas station and no precise GPS coordinates were available, so the location of the site was dependent on the landowners' memory. Test pits were dug to 3-3.5 ft bgs using an excavator and boreholes advanced to 11-12 ft bgs within each test pit. Test pit locations are shown on Figure 1. Boreholes were field screened at multiple depths using heated-headspace photoionization detector (PID) samples and no results above 1 ppm were obtained from any borehole. No visual or olfactory evidence of contamination was observed. Analytical samples were taken at a variety of depths based on stratigraphy. Low-level detections of GRO, BTEX, and PAHs were found in all samples, but all were well below cleanup levels.
