Alaska Department of Environmental Conservation (ADEC) Solid Waste Program (Stephen Price and David Carlson) conducted a Coastal Impact Assistance Program (CIAP), Waste Erosion Assessment and Review (WEAR) site visit for Chignik on August 18th, 2014. The following narrative is a brief description of our findings during the August inspection.

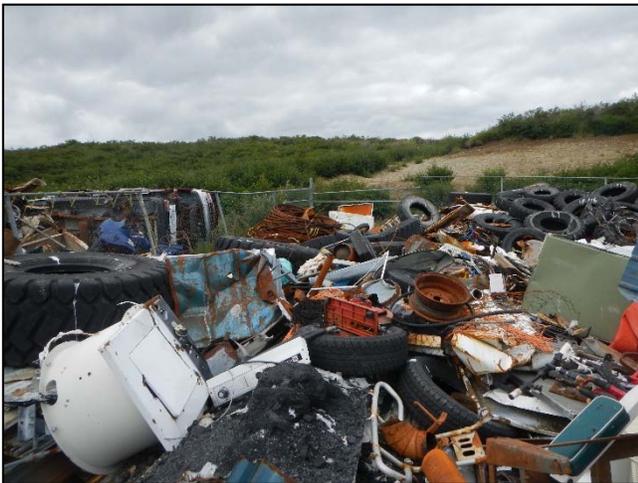
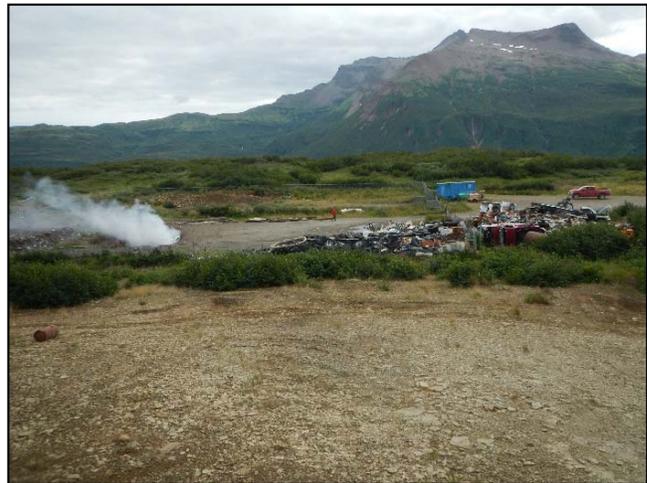
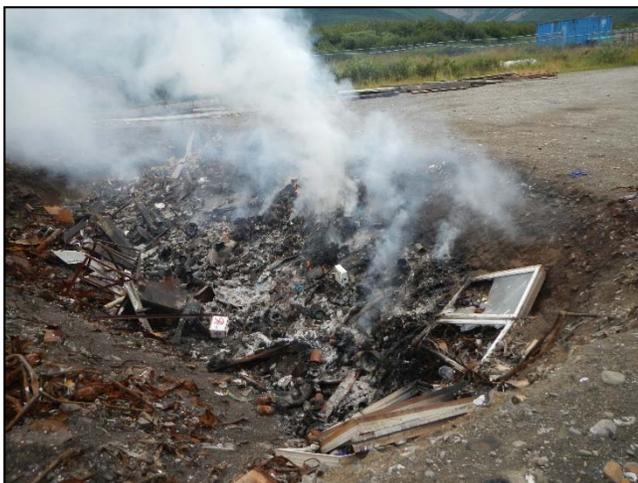
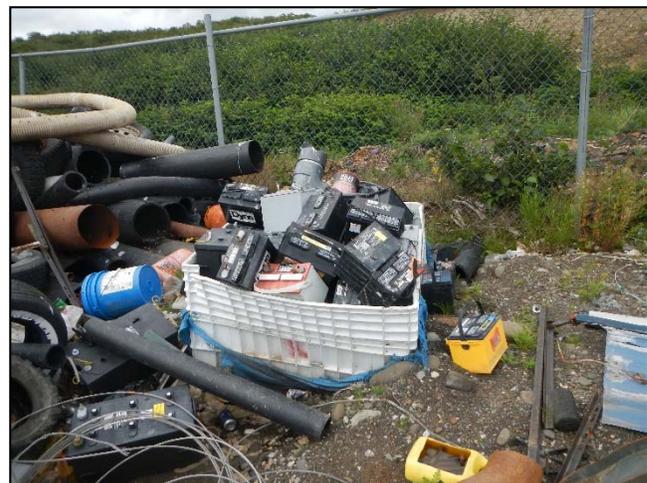
- **Landfill, 56.30661/-158.41762 (Active)** – This unpermitted landfill is operated as a trench and fill design by the City of Chignik. It has been in operation since 1996 and is approximately half an acre. The site only accepts municipal waste. The landfill has an operator hired to manage the area. The site is fully fenced; however, the gate is open and not locked at any time. There is a collection program and residents also self-haul waste to the landfill. Waste is separated, but it is all stored in the landfill. Batteries and electronics were separated, but they were uncovered and resting as part of the metals pile. Open burning is conducted in the trench. There was no active erosion reported near the landfill. This site is 1,000 feet from the west side of Anchorage Bay and 2,000 north of the main residential area.

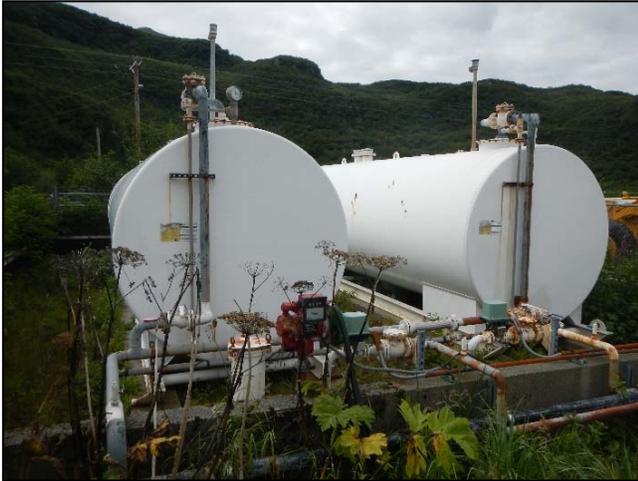
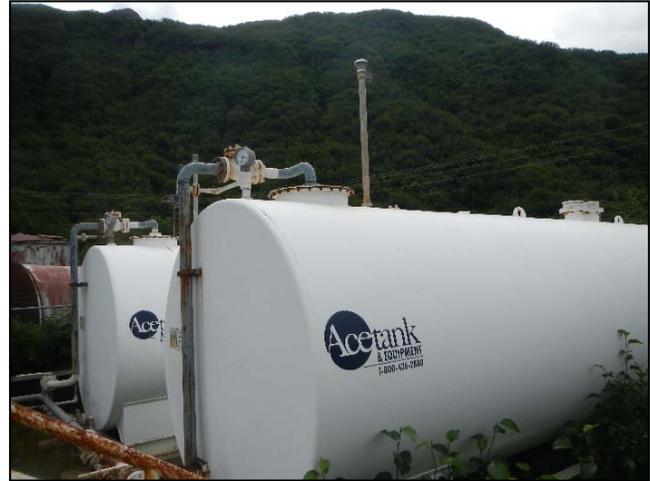
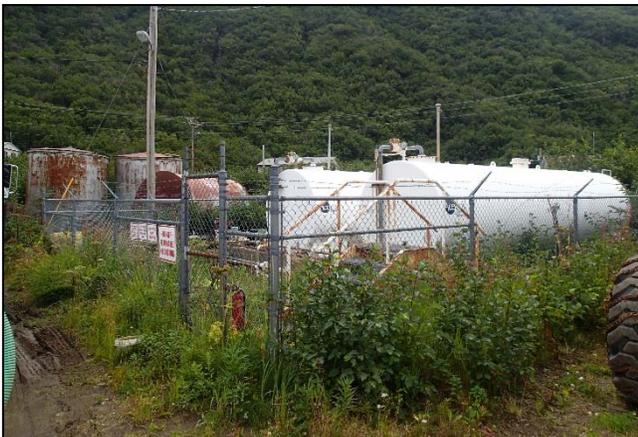
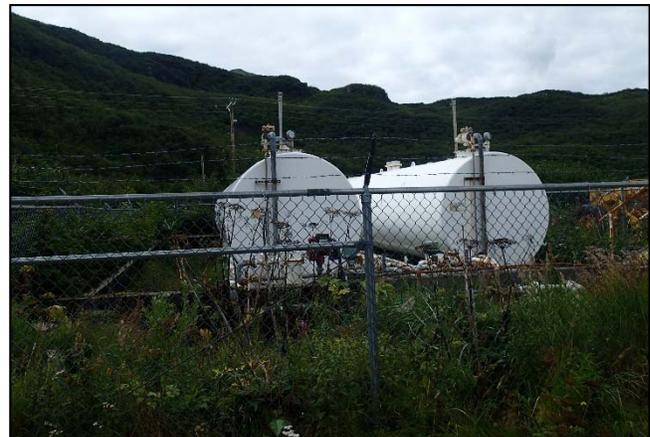
- **School Tank Farm, 56.29246/-158.40709 (Active)** – The tanks are located just behind the school and are owned by the Lake and Peninsula School District. There has been a tank farm in this location since around the 1990s. This site originally contained six vertical fuel tanks. The site was upgraded in approximately 2008, when the previous tanks were replaced with the current two horizontal fuel tanks. They are within a secondary containment area that is fully fenced. The previous tanks were moved to the Old City Tank Farm location adjacent to this site. This site is located 1,200 feet southwest of Anchorage Bay. There was no reported erosion near the tanks.

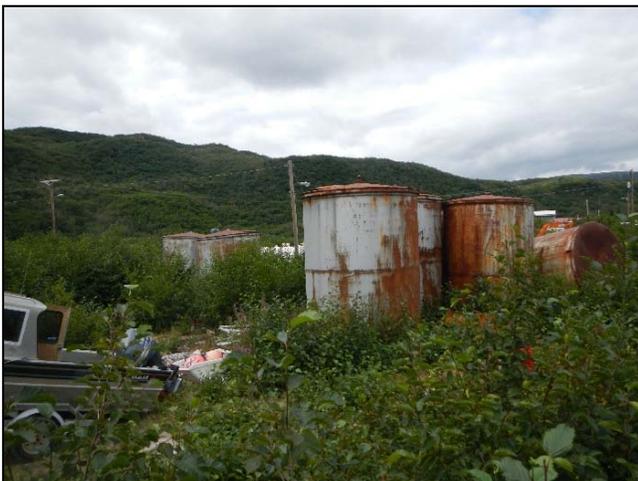
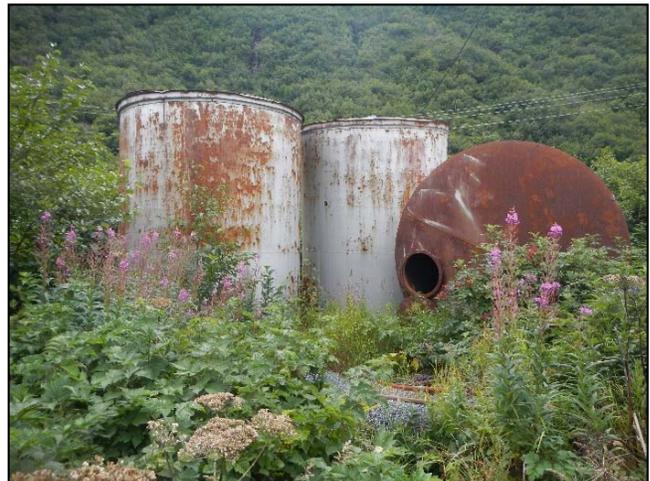
- **Old City Tank Farm, 56.29245/-158.40656 (Abandoned)** — This site is located directly next to the School Tank Farm. It contains a total of nine vertical fuel tanks: the site's original three tanks and the six tanks from the 2008 School Tank Farm upgrade. They are in a cluster of three and a cluster of six more a few feet over. The tanks are owned by the City of Chignik and are empty and disconnected. It is located 1,200 feet southwest of Anchorage Bay.

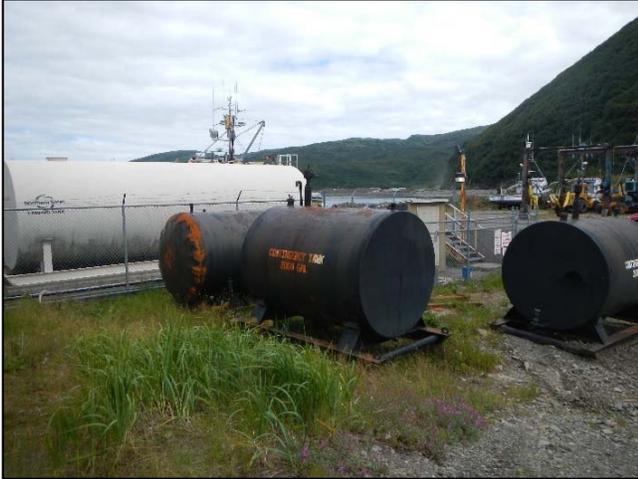
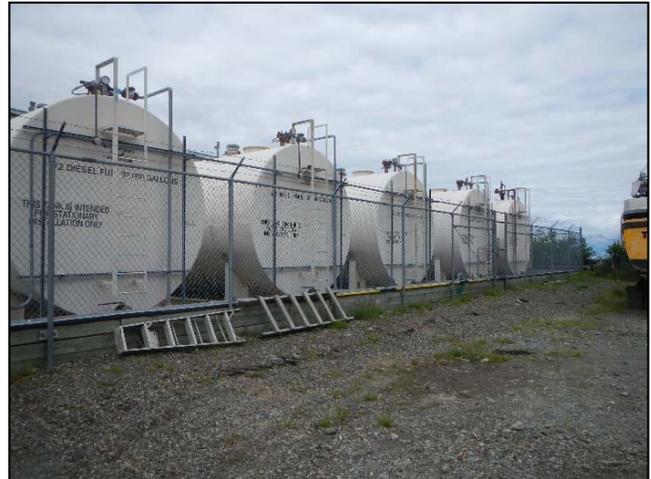
- **Trident Tank Farm, 56.29433/-158.40265 (Active)** – This site contains a total of eight tanks for the Trident Seafoods Cannery. Previously owned by Norquest, the tanks are now owned by Trident Seafoods Corporation. This tank farm was constructed in 2008 as part of a Denali Commission project. There are five 32,000 gallon diesel tanks within a fully fenced secondary containment area. They are located against the east side of the cannery building. The last three tanks are 2,000 gallon tanks that were disconnected and outside of the fence and liner. They are each labeled as ‘Contingency Tank’. The tanks are approximately 60 feet from Anchorage Bay which had no erosion reported.

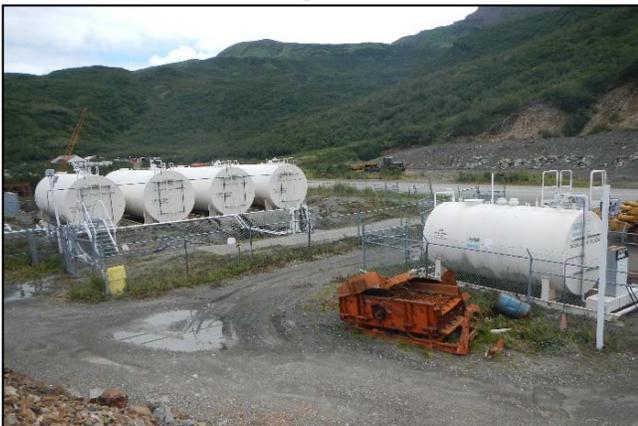
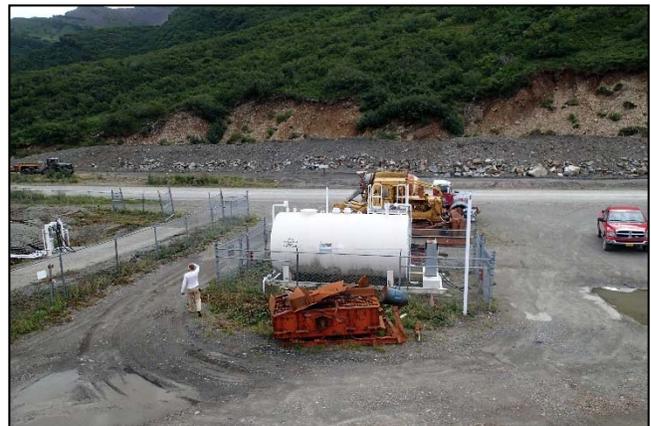
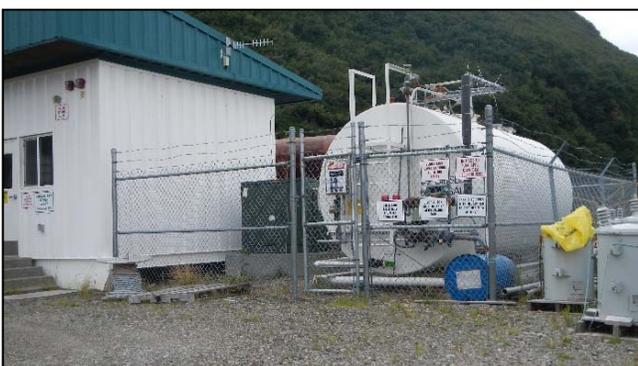
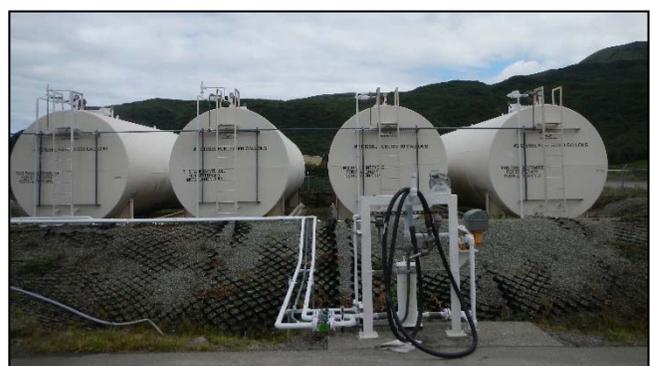
- **East Power Plant Tank Farm, 56.29514/-158.38785 (Active)** – This tank farm was constructed in 2008 through a Denali Commission project. It is owned and operated by the City of Chignik and supplies fuel to the east side power plant and is a fueling station for the community. It contains a total of six fuel tanks: four 32,000 gallon tanks and two 6,000 gallon tanks. The 32,000 gallon tanks are grouped together in an earthen bermed secondary containment area that is fully fenced. Each 6,000 gallon tank is located in separate fenced areas with no visible secondary containment. This site is located 165 feet from Anchorage Bay, which had no reported erosion.
