Alaska Department of Environmental Conservation (ADEC) Solid Waste Program (Kitrina Persson and Elizabeth Stergiou) conducted a Coastal Impact Assistance Program (CIAP), Waste Erosion Assessment and Review (WEAR) site visit for the Village of Perryville, August 3rd, 2012. Charlene Yagie, City Administrator, and Gerald Kosbruk helped coordinate our visit. This community was revisited on August 21st, 2014 by Stephen Price and David Carlson. The following narrative is a brief description of our findings during the 2012 and 2014 inspections.

WEAR Sites:

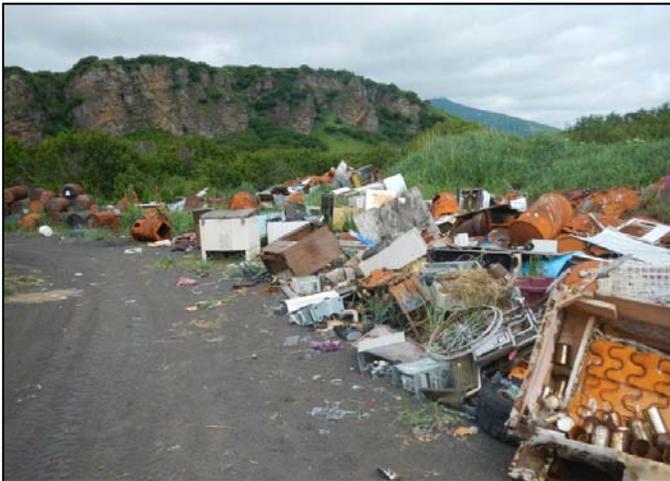
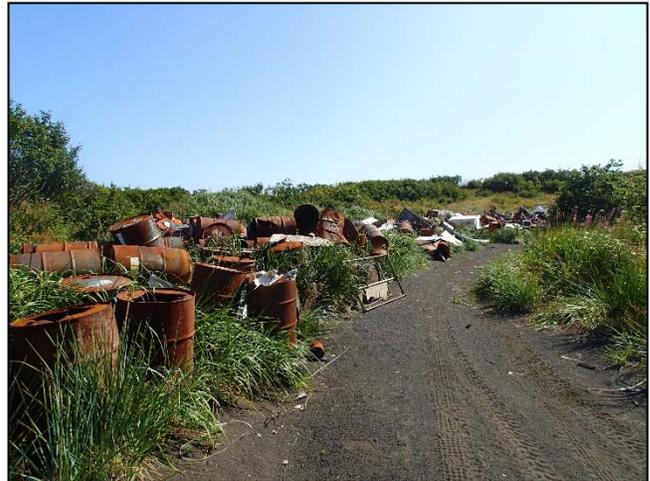
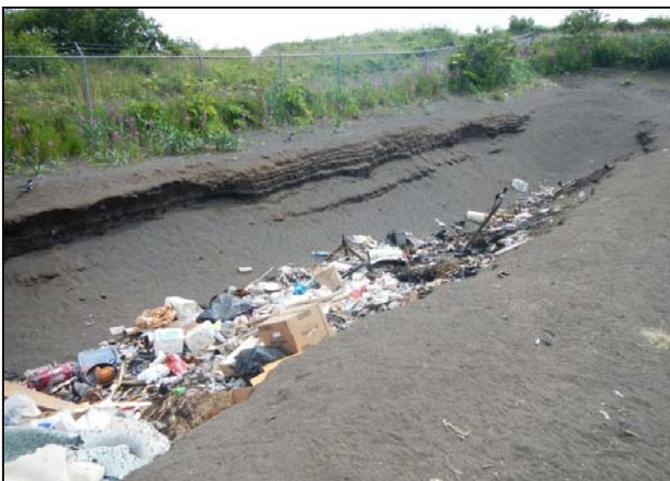
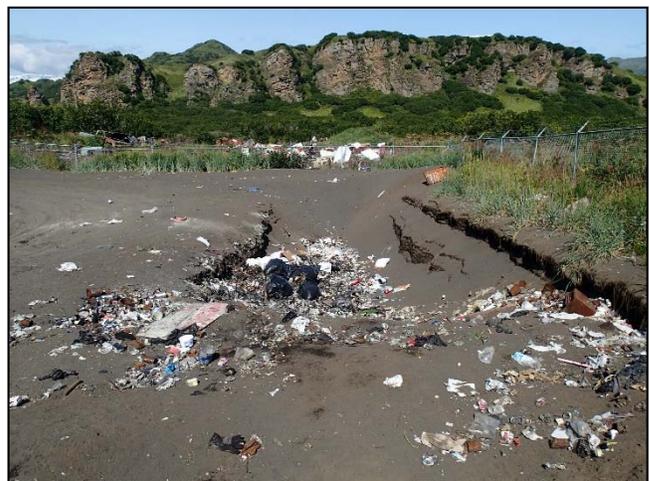
- **Landfill, 55.910866/-159.133606 (Active)** – This unpermitted, trench-and fill landfill site consists of two fully fenced, adjacent cells. The western cell was closed about 2008 and the current cell was developed at that time. The entire landfill area is approximately 1.5 acres. Residents self-haul waste to the site, where it is burned in a trench. Directly to the north of the fenced area is a non-burnable waste disposal and salvage area containing various items including, e-waste, household appliances, 55-gallon drums, furniture, tires, old vehicles and ATV's. The site is located on the north side of a 40 foot cliff overlooking the Gulf of Alaska and is approximately .25 miles from the eastern end of town. The shoreline in Perryville is not eroding at all, but instead the shoreline is building.

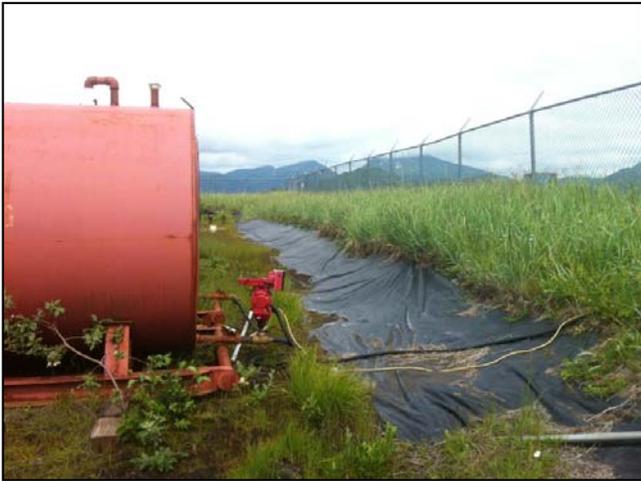
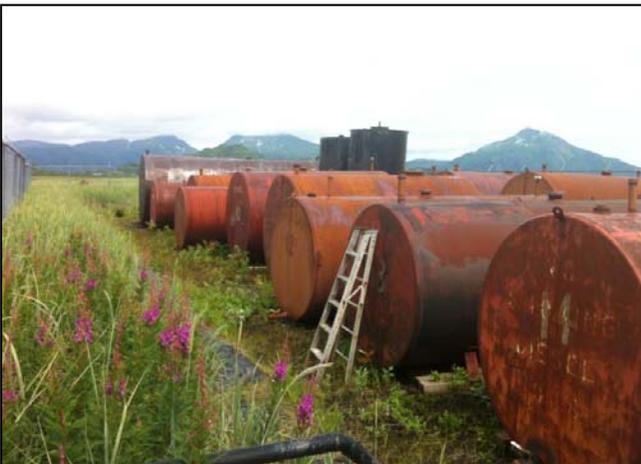
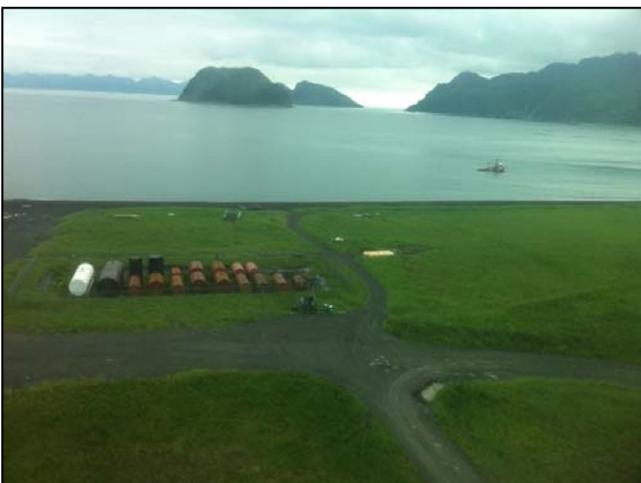
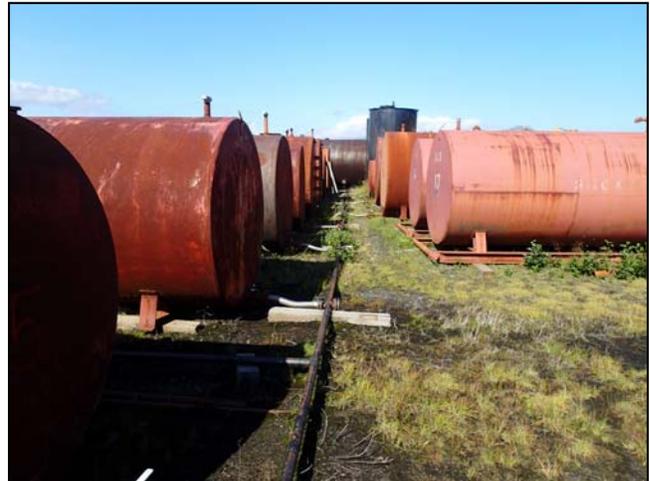
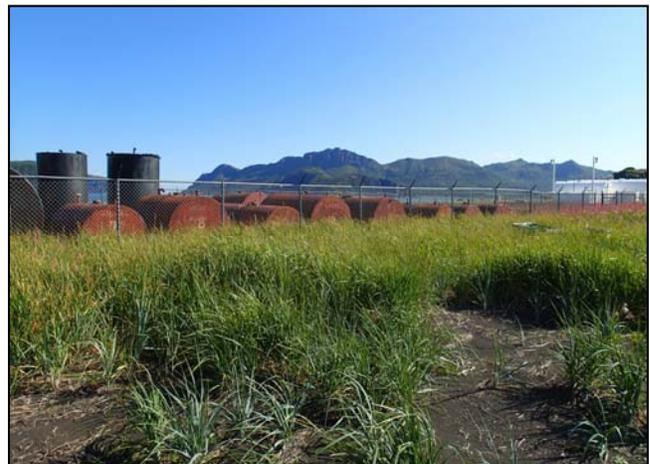
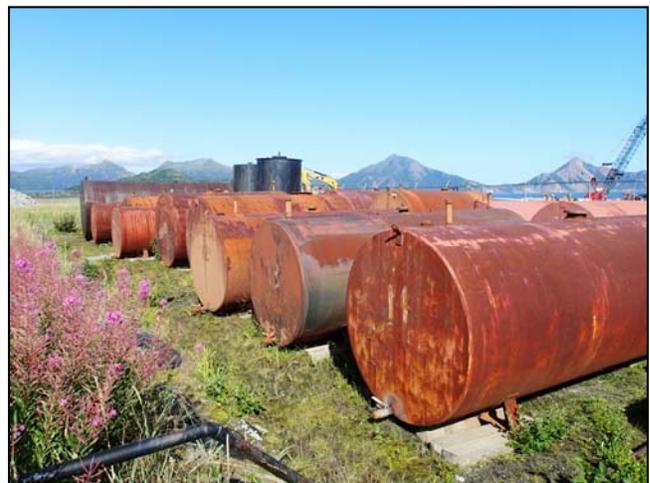
- **Old Tank Farm, 55.898937/-159.169041 (Abandoned)** – This tank farm is located along the road following the coastline approximately 1 mile southwest of the community. There are a total of 16 horizontal and 2 vertical tanks that contained diesel and gasoline. They are contained within a fenced, bermed, and lined area. Moss, willows, grass and other vegetation grow within the fenced area, intermixed with stained soil. This tank farm was in operation from around the 1970s-2013, when the new Tank Farm was completed through a Denali Commission project. This tank farm is reported to be empty and no longer in use as of 2013. It is located 180 feet from the high tide line. The shoreline in Perryville is not eroding at all, but instead the shoreline is building.

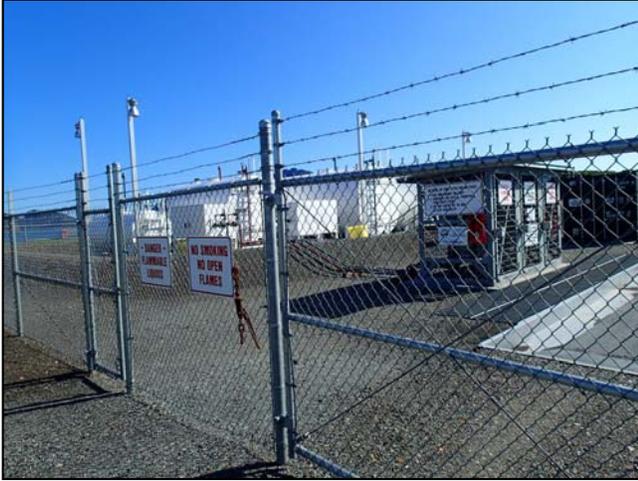
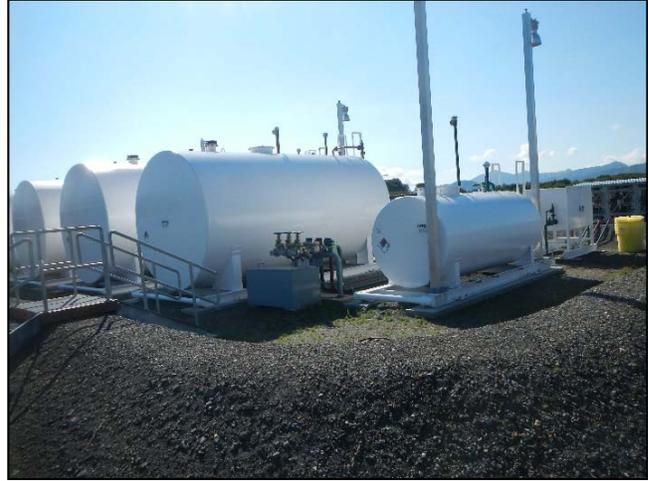
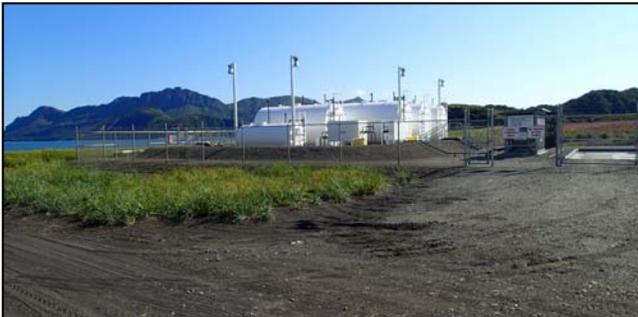
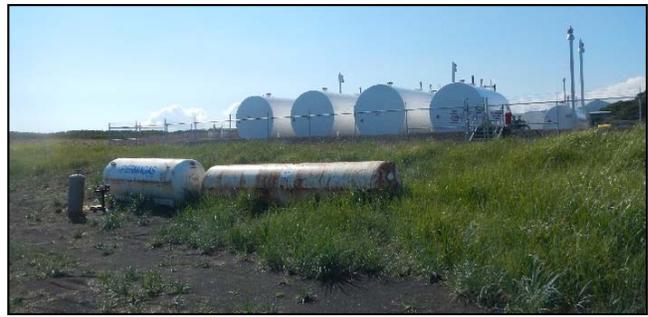
- **Tank Farm, 55.898655/-159.169209 (Active)** – This site began construction in 2013 under the Denali Commission and was completed upon our august inspection in 2014. It is owned and operated by the Native Village of Perryville and is located adjacent to the old tank farm 1 mile southwest of the community. The tank farm has a total capacity of 97,500 gallons: four 21,000 gallon diesel tanks, and one 13,500 gallon gasoline tank. The site is fully fenced with secondary containment. The tank farm is 280 feet from the shore. The shoreline in Perryville is not eroding at all, but instead the shoreline is building.

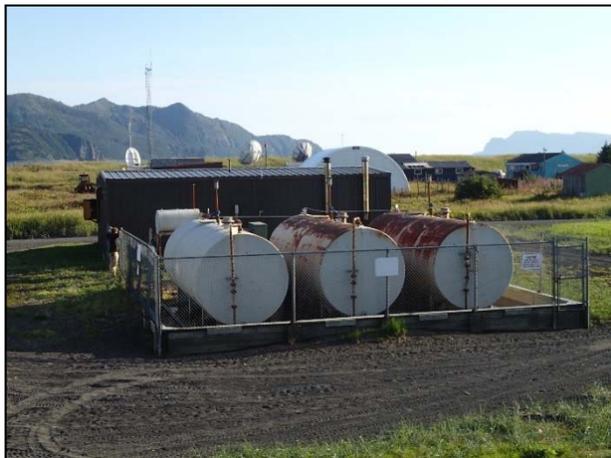
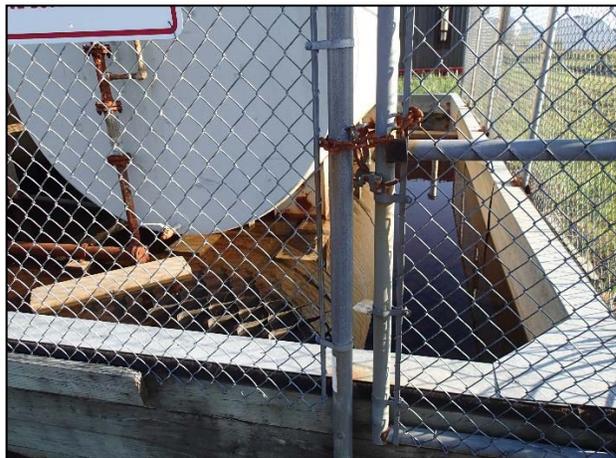
- **School Tank Farm, 55.911645/-159.144374 (Active)** – This tank farm is located next to the school in the northeast corner of the community. It has been in place since around the 1990s and is owned and operated by the Lake and Peninsula Borough School District. The tank farm consists of five tanks in total: three 7,500 gallon tanks, one approximately 1,000 gallon tank, and one approximately 300 gallon tank. The tanks are in a fully fenced area with a wooden, metal lined secondary containment. The tanks are located 1,000 feet from the shore. The shoreline in Perryville is not eroding at all, but instead the shoreline is building.
