ALASKA DEPARTMENT OF ENVIRONMENTAL CONSERVATION
Division of Spill Prevention and Response
Prevention Preparedness and Response Program
SITUATION REPORT (SITREP)

Beaver Village Diesel Fuel Release

SITREP #: 2

SPILL #: 19309900901

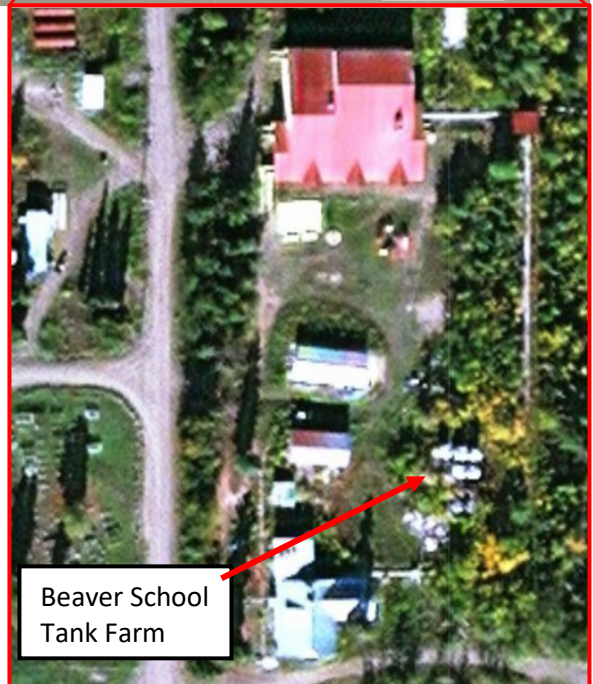
CAUSE OF SPILL: A heavy equipment operator **damaged piping leading from the tank farm to a nearby generator shack** during snow removal operations

Spill area looking south, with school tank farm on the left and generator shack on the right. Affected line visible on top of snow pile.

FUTURE PLANS AND RECOMMENDATIONS: **The Yukon Flats School district will be working with the Beaver Village Tribal Council on the cleanup efforts. The work will initially focus on hiring and training local responders, preparing and making the equipment operational and drafting the cleanup, safety and waste management plans. Secondary efforts will be to prepare the site for the snow removal. The contaminated snow will be placed into containment and allowed to melt. Once melted the fuel will be separated and the water treated and discharged. The soil removal or remediation will need to wait until the summer months.**

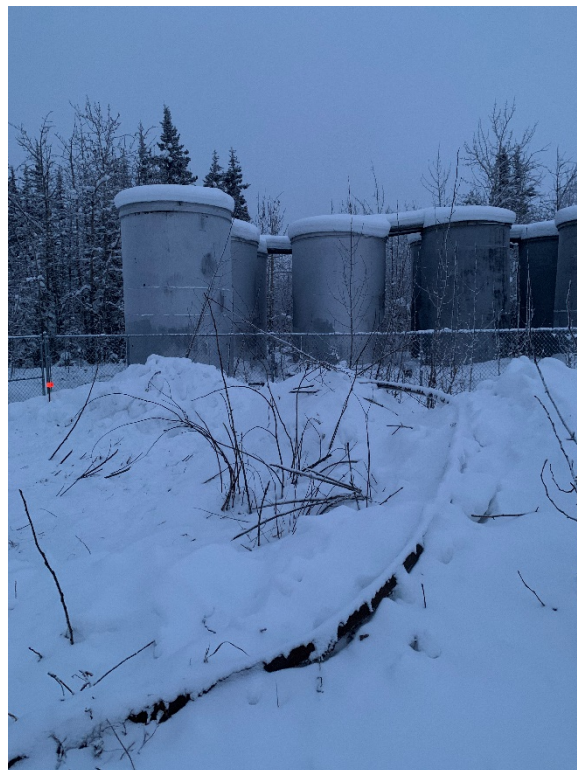
Spill site looking east, with affected line visible on top of snow pile.

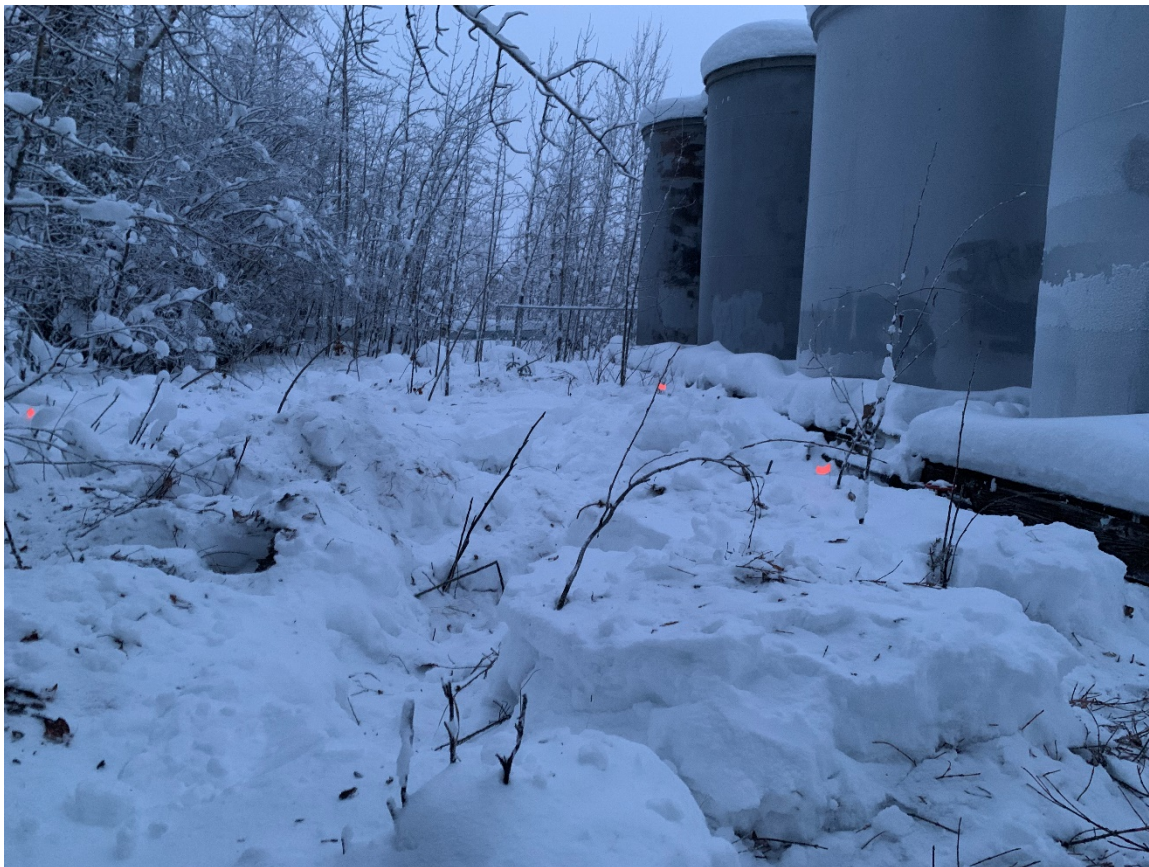
Area to the east of tanks after initial delineation effort on January 11, 2019. Pink pin flag to the left in photo shows area furthest away from release point where product has been detected (approx. 75ft).
