Geographic Response Strategies for

Northern Cook Inlet Subarea

# Wasilla Creek, NCI-11

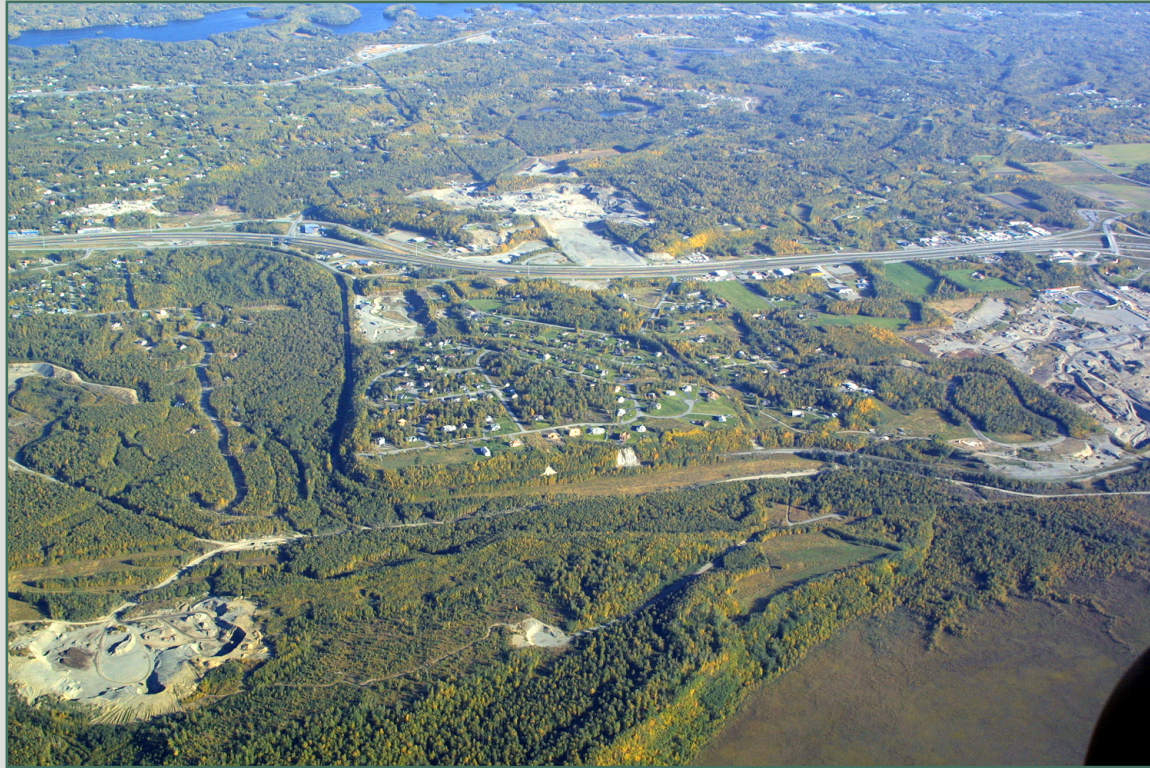
NCI-11 Wasilla Creek viewed from the south.
