DUCK CREEK WATERSHED

Management Plan

K Koski and Mitchel Lorenz
National Oceanic and Atmospheric Administration
National Marine Fisheries Service
Alaska Fisheries Science Center
Auke Bay Laboratory
11305 Glacier Hwy., Juneau, Alaska 99801

July 1999

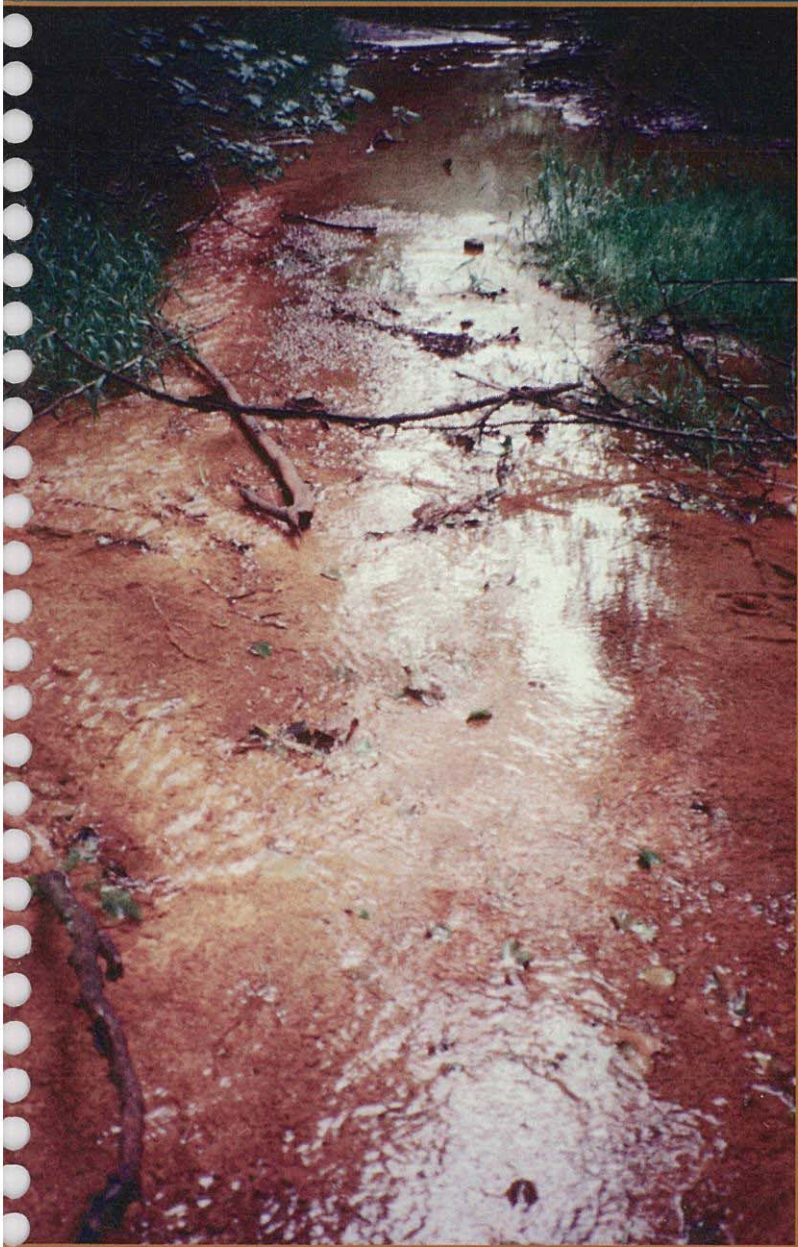
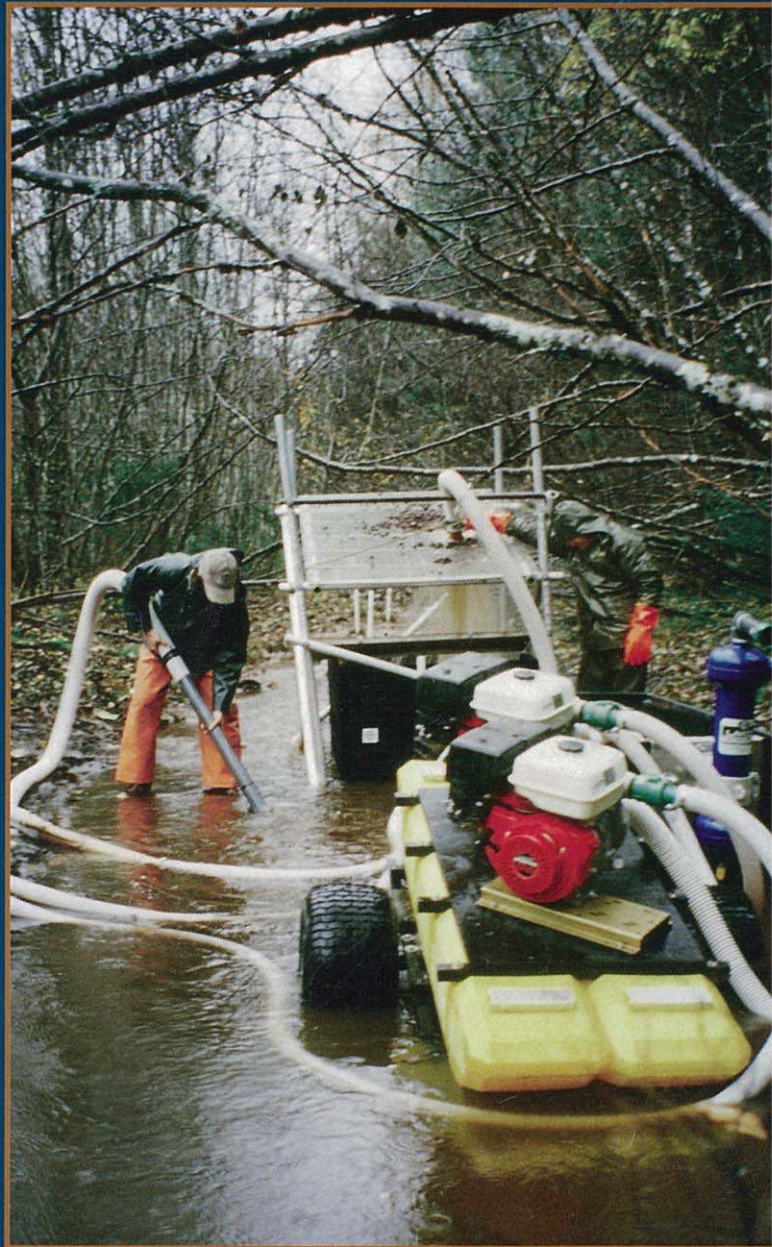
Cover: Sequence of restoring salmon spawning habitat and channel morphology in Duck Creek between Taku Blvd. and Mendenhall Blvd., Juneau, Alaska. Pictured on front cover: left, stream clogged with fine sediment and iron floc from decades of neglect and poor land-use management; right, hydraulic dredge used to remove fine sediment. Pictured on back cover: left, redefined stream channel with clean gravel bottom; right, revegetated floodplain with the redefined channel.

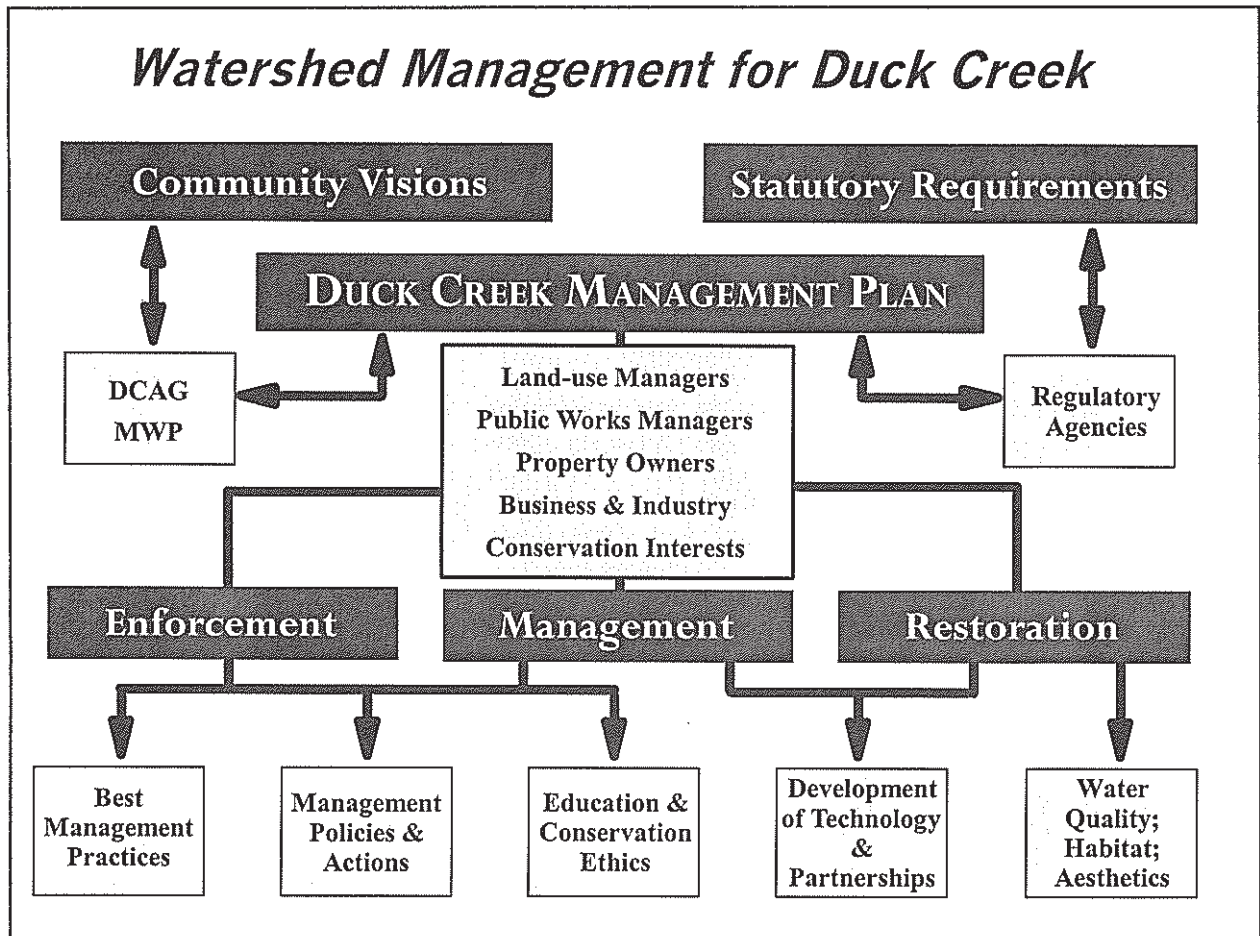
Figure 3.--Flowchart showing the framework for implementing Duck Creek watershed management.

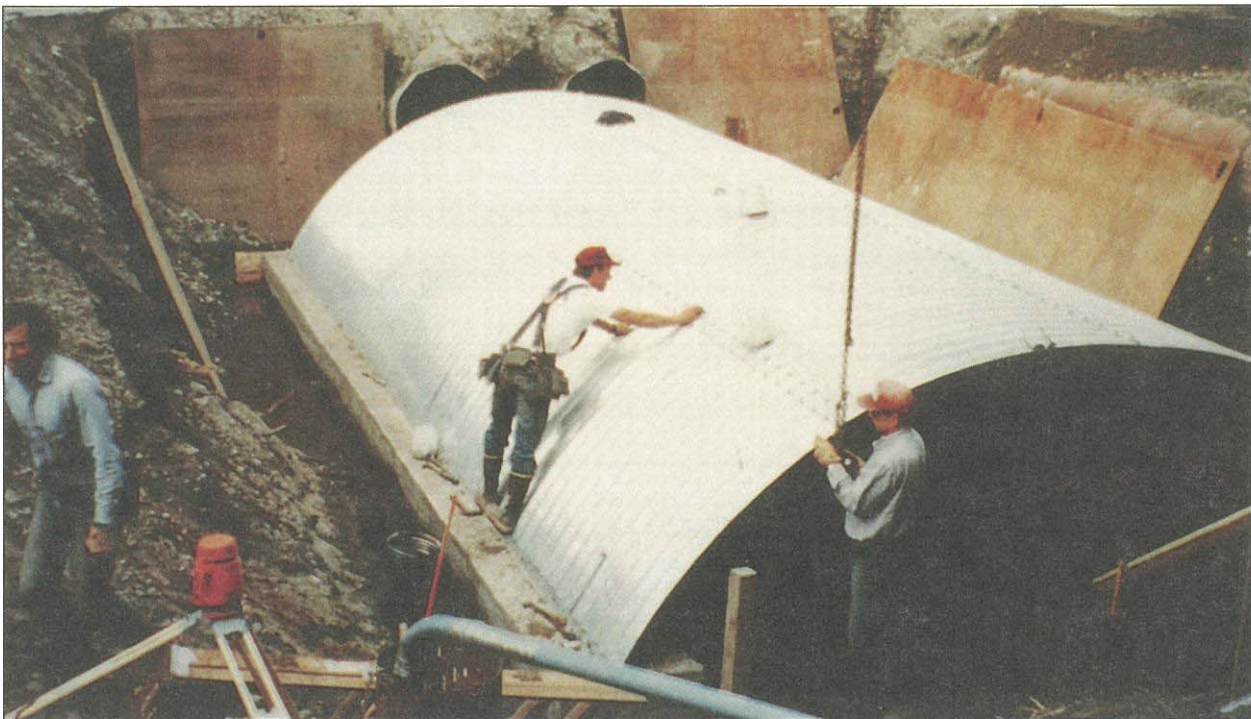
Figure 7.--Perched culverts being replaced with an arch culvert at Stephen-Richards Drive.
(Photo by Jan Caulfield, CBJ).

crossings has been 15-20% higher than design estimates for culvert crossings. The cost of a 17-ft wide arch at Stephen Richards Drive was about \$65,000 in 1995 and two attractive wood bridges on floating concrete piers were installed in 1998 at \$25,000 each. At a minimum, ten other stream crossings need replacement or improvement so that other restoration work (on fish habitat, streamflow augmentation, and channel morphology) can proceed.

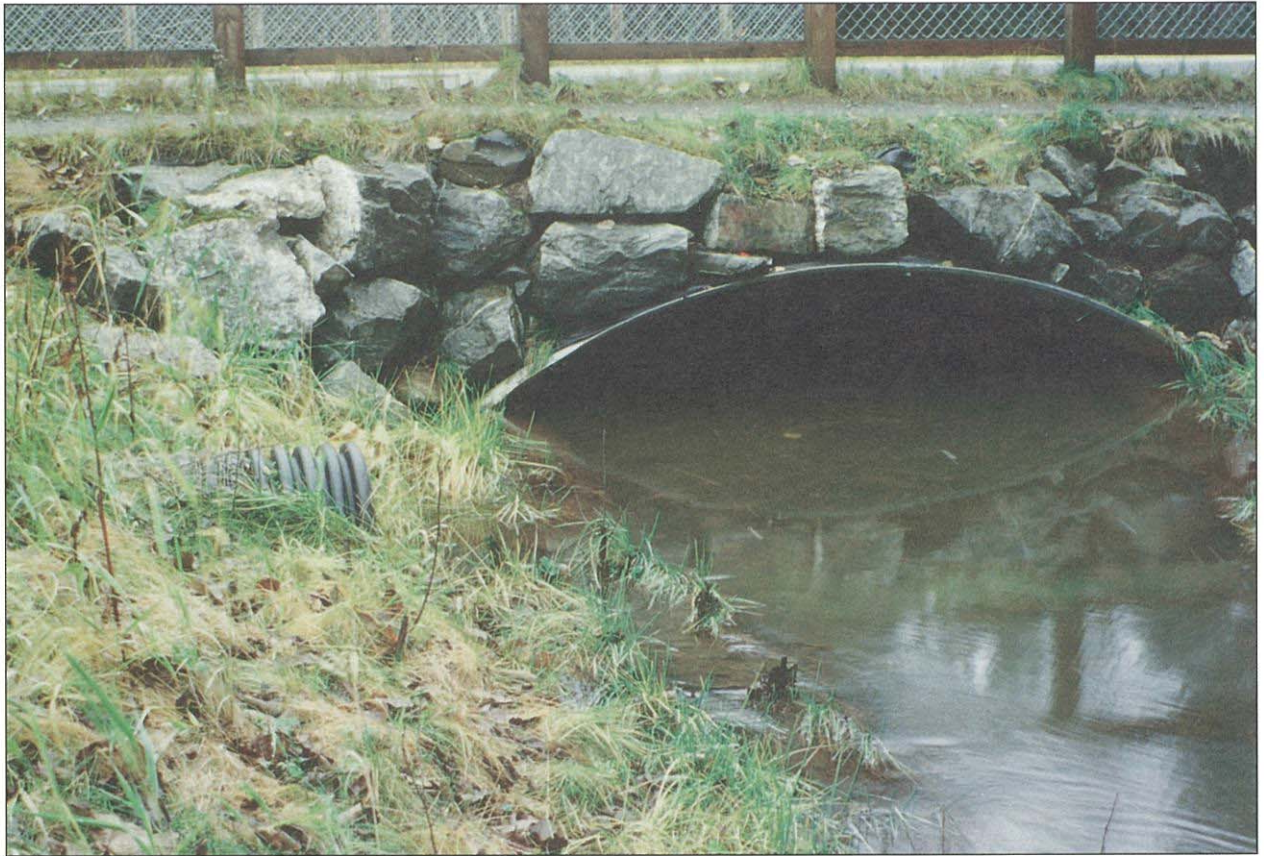
Figure 8.--Water flowing through new arch at Stephen-Richards Drive. (Photo by NMFS).

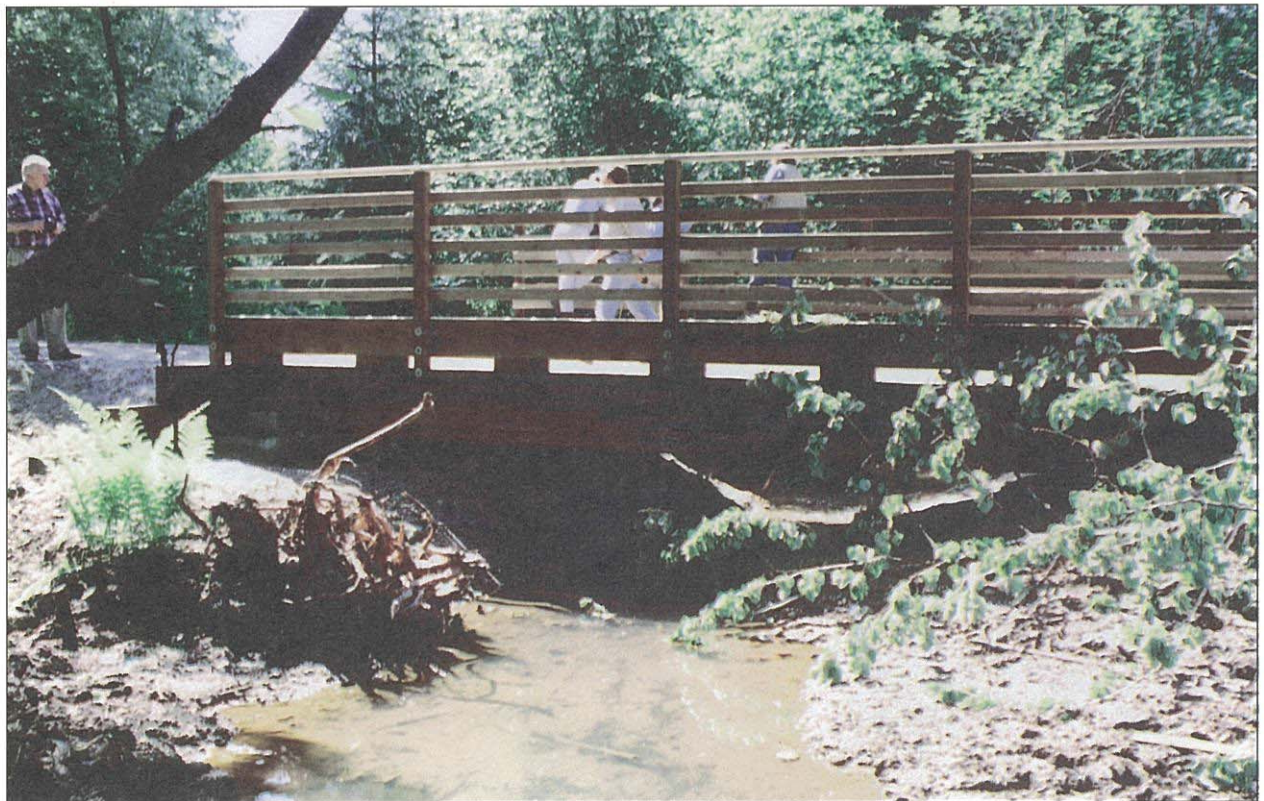
Figure 9.--Timber bridge used to replace a perched culvert on a private driveway. (Photo by NMFS).

- Kiowa Drive and south El Camino crossings of the El Camino Fork of Duck Creek were replaced with pipe arch culverts with concrete floors covered with gravel and the grade was lowered about 1 ft (structural concrete floors had to be used due to underlying sewer pipes);
- A 17-ft wide bottomless pipe arch was installed at Stephen Richards Boulevard (Fig. 7 and 8);
- The El Camino Fork crossing of Mendenhall Loop Road was enlarged and grade was lowered approximately 1 ft;
- Culverts on two private driveways downstream of Nancy Street were replaced with wooden bridges (Fig. 9).

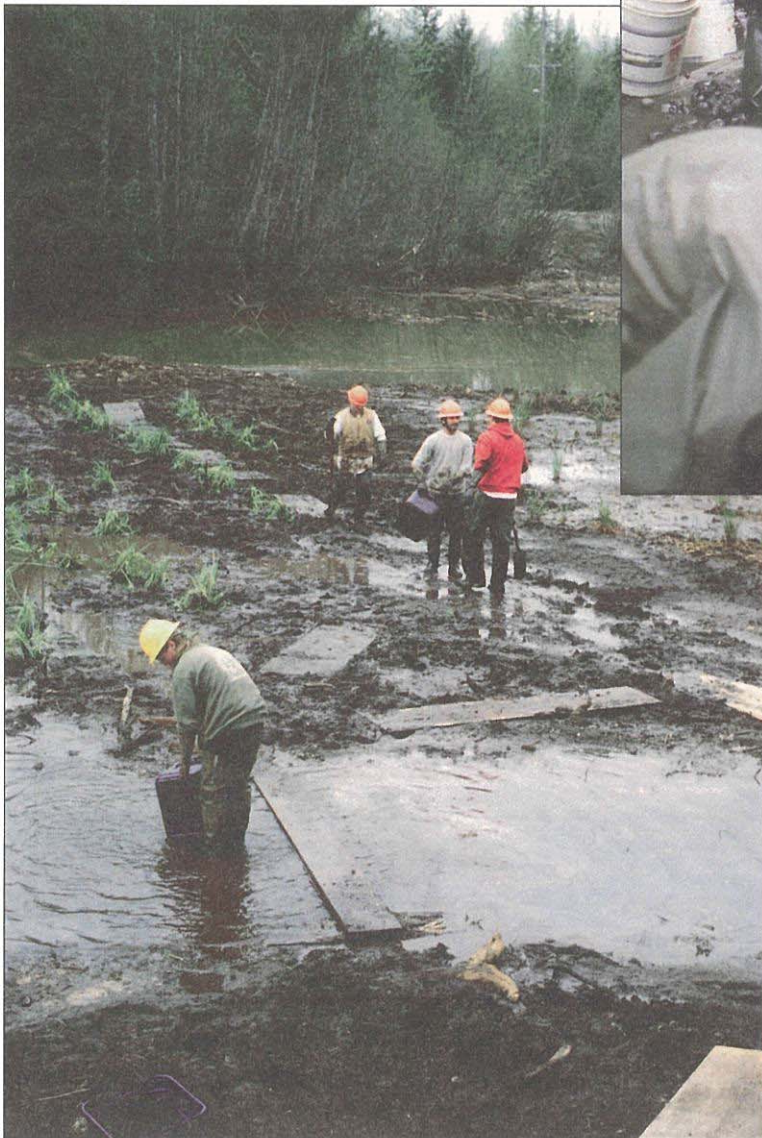
Figure 11.--Development of a stormwater treatment marsh in a dredge pond on the east fork of Duck Creek. (Photo by NMFS).

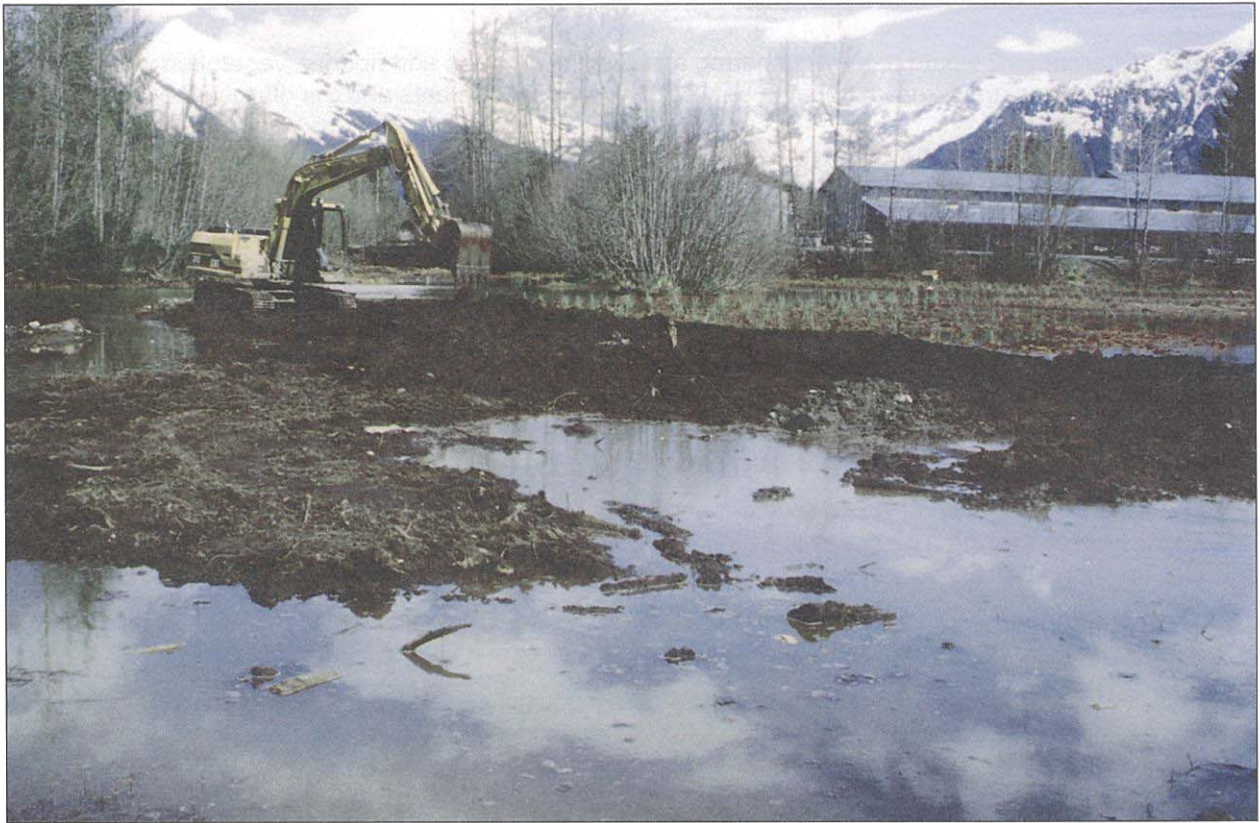
Figure 12.--The dredge pond that was developed into a stormwater treatment marsh. (Photo by NMFS).

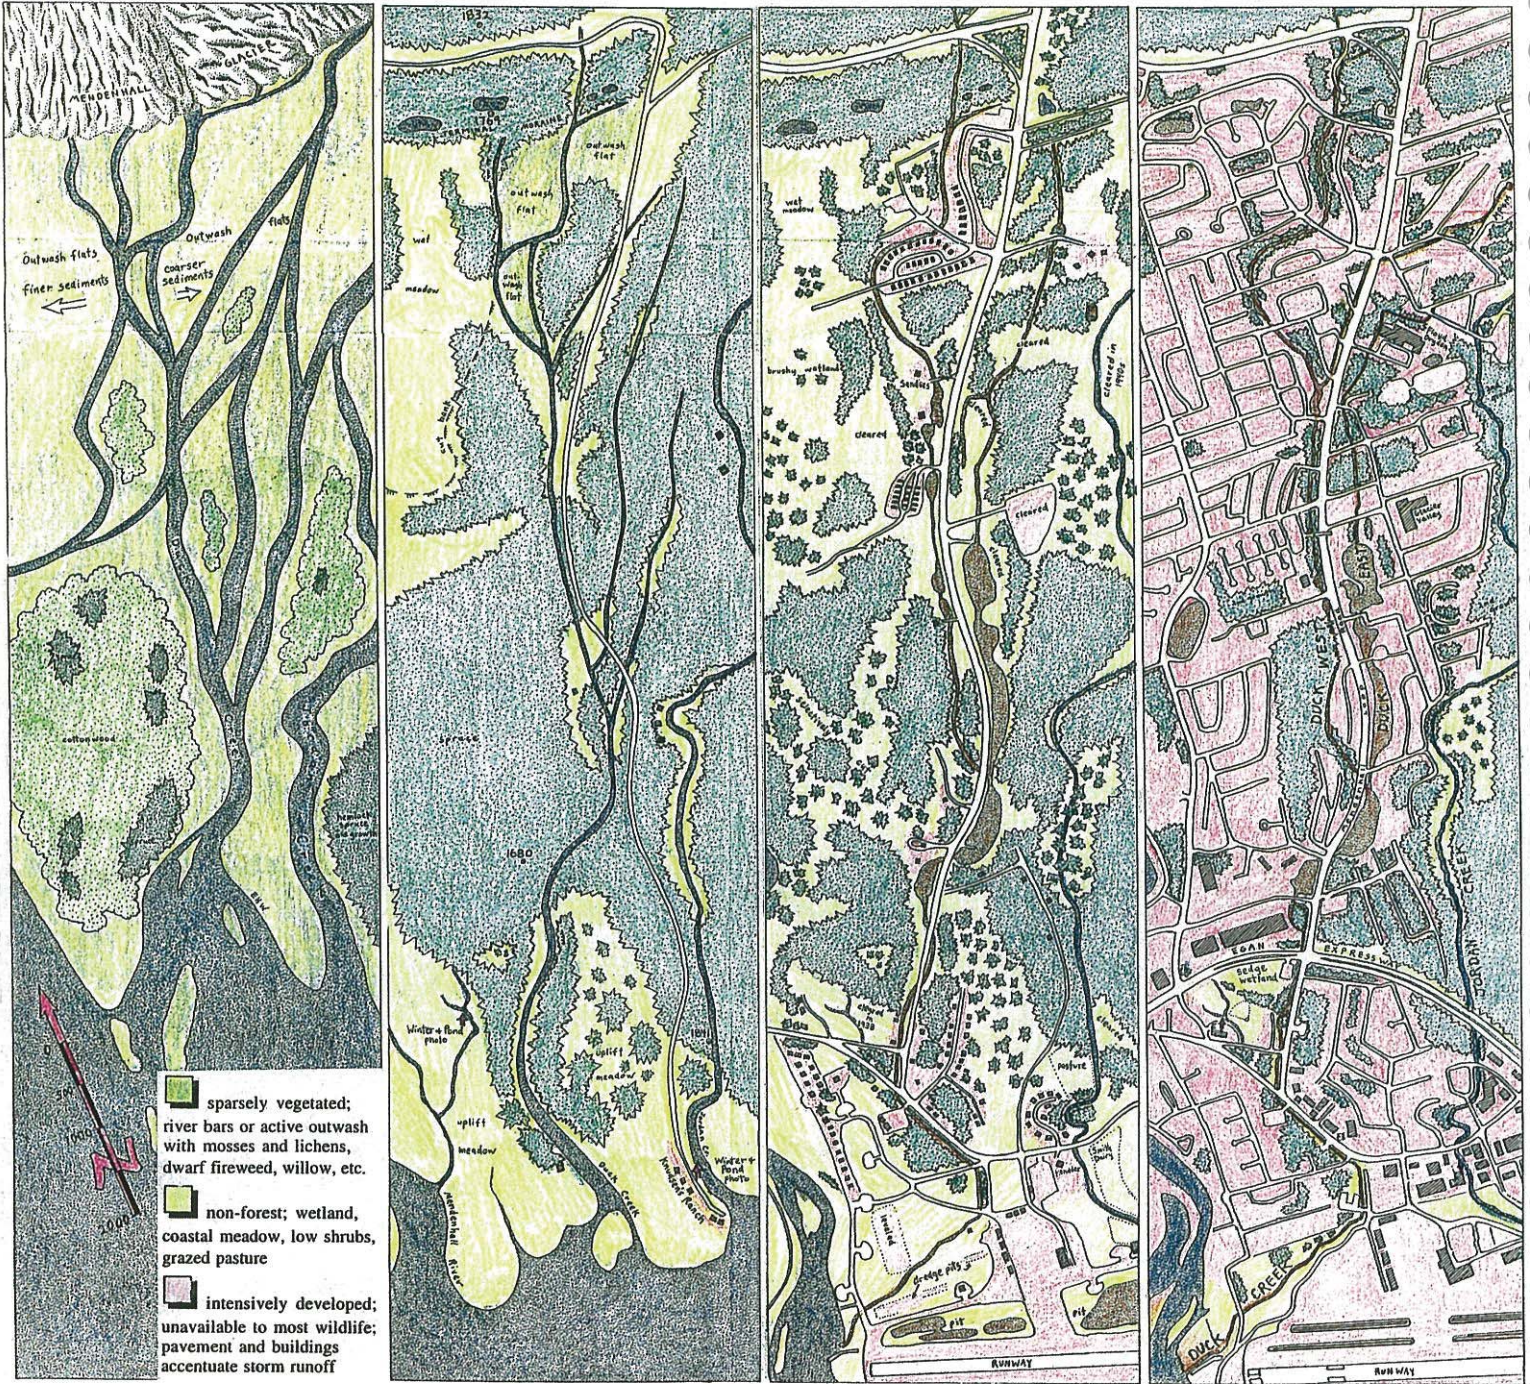
Figure 13.--Two centuries of development on Duck Creek. (Maps by Richard Carstensen, Discovery Foundation).

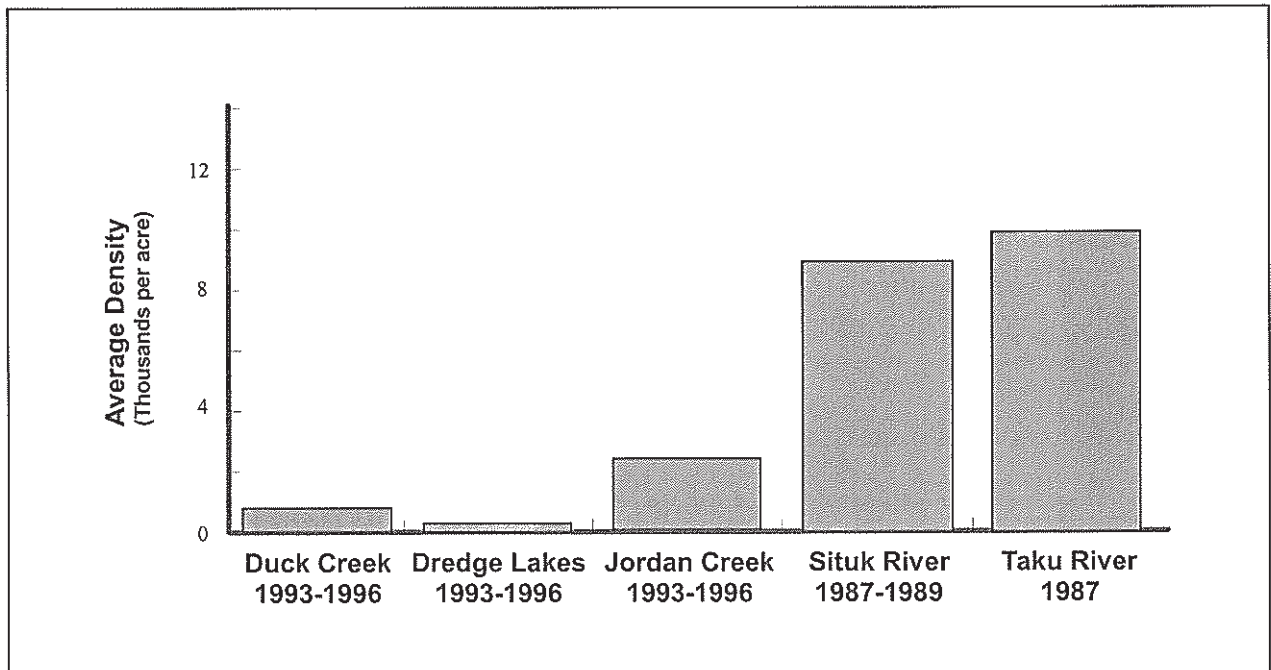
Figure 17.--Juvenile coho density during fall at five Southeast Alaska areas.

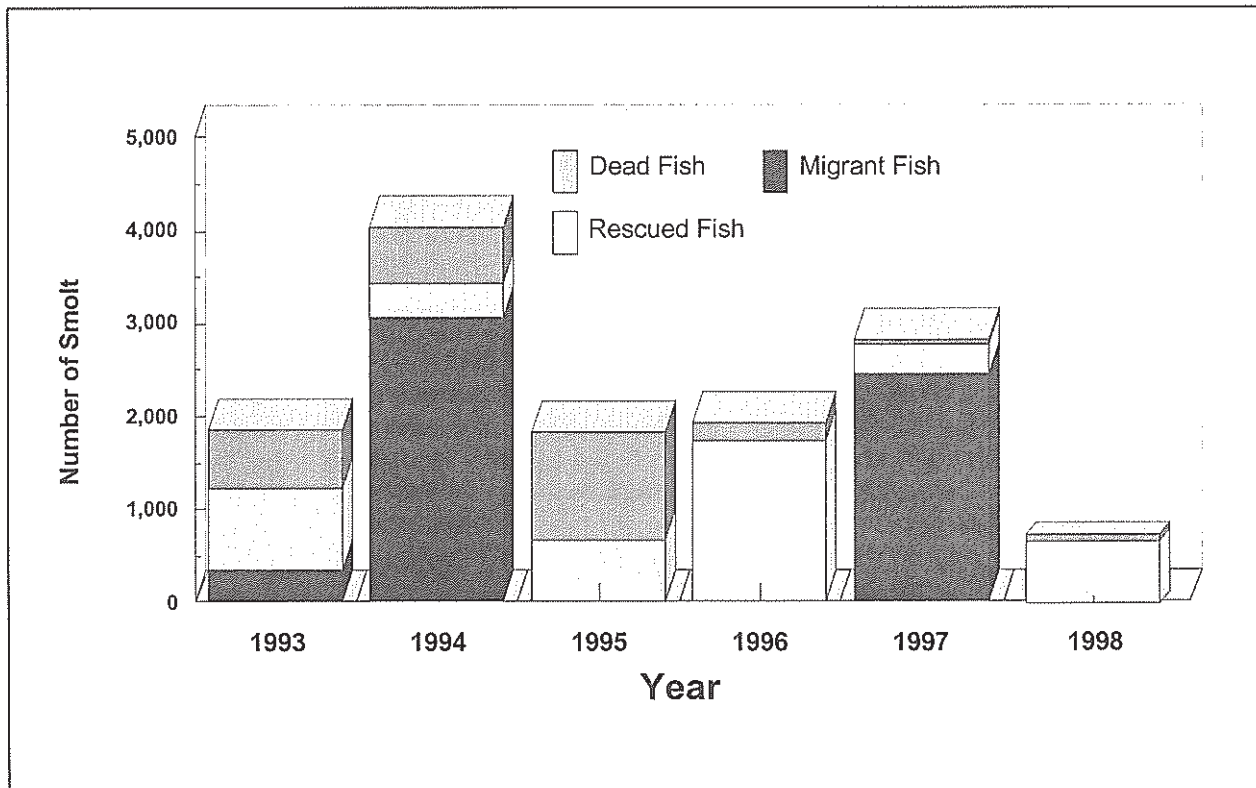
Figure 18.--Coho smolt migration in Duck Creek.

Salmonids in Duck Creek need migratory access up and down the stream for both rearing and spawning. Culverts on Duck Creek that are of wrong size or placed in the streambed at the wrong elevation affect the movement of juveniles and adult salmonids. Fish passage at both high and low flows not only impedes movement but results in mortality when fish are delayed in either their spawning or smolt migration (Fig. 18).

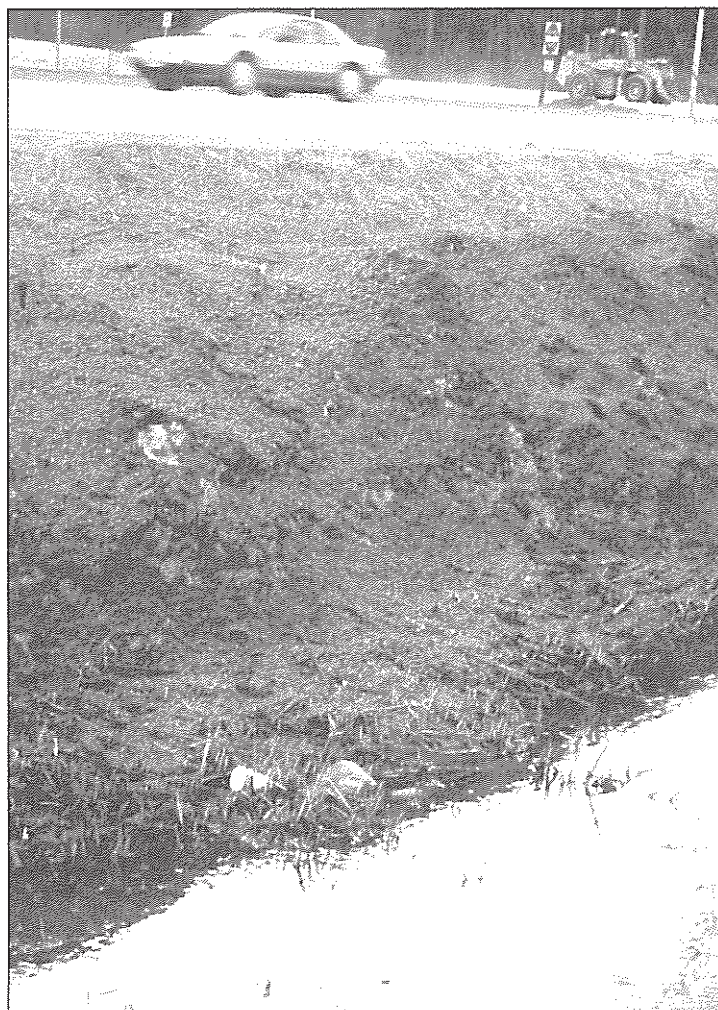
Figure 19.--Sediment (sand) entering Duck Creek in an area devoid of riparian vegetation.
