FY 2006
FINAL REPORT

PROJECT #: ACWA-06-09

**Watershed Protection and Recovery for
Duck Creek, Juneau, AK**

July 2006

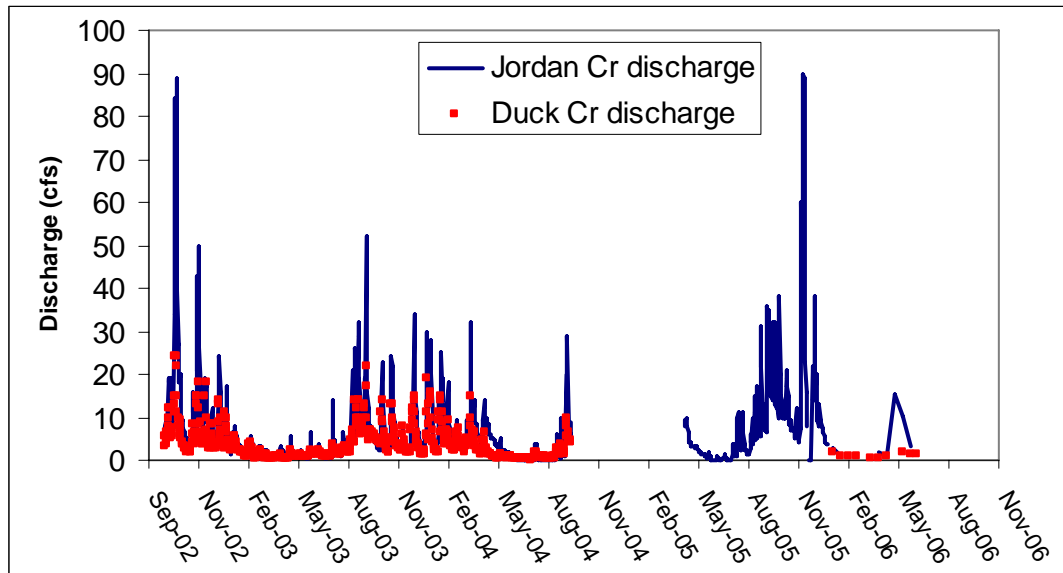
Figure 2. Discharge on Duck and Jordan Creeks. Data based on USGS stream gage data, until January, 2006. (Data from September, 2005 on are provisional). Measurements since January 2006 are based on manually gaging using a pygmy flow meter.

Although continuous discharge data were unavailable for Duck Creek, examination of historic data at the site and on neighboring Jordan Creek, as well as field observations, indicates that Duck Creek is generally a flashy stream that responds to and recovers quickly from local precipitation events. There is little seasonal variation to the stream. In contrast to the Mendenhall River, whose flow is predictably maximal during summer glacial melting, Duck Creek discharge is a reflection of precipitation in the area (Figure

2). Therefore, flows are generally lowest and least flashy during the spring and early summer, and highest and flashiest during the fall and early winter.

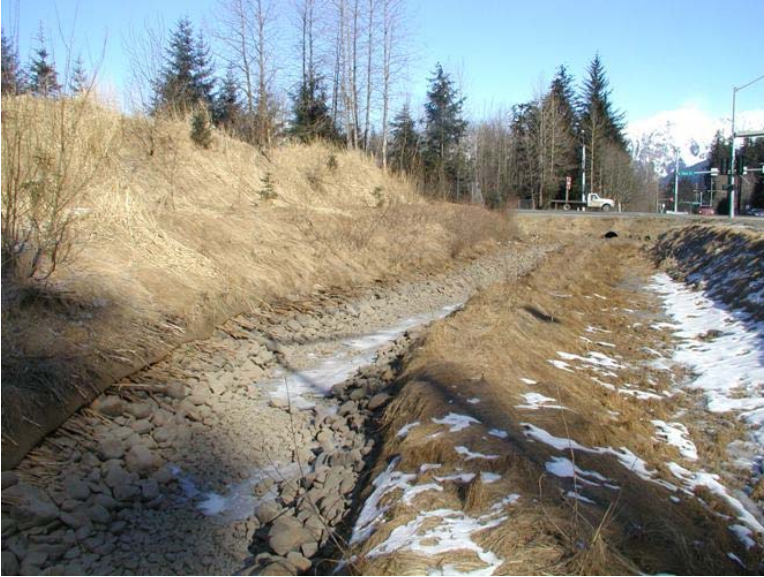
Figure 3a. Site DC-C, showing no flow, on March 15, 2006 when air temperatures reached -15°C in Juneau. No flow was observed at the site for 2 months, from late February to late April, 2006. During this no-flow period, the channel was either completely dry or contained small, stagnant ponds.

Water quantity was often higher at the upstream sites; DC-B and DC-A clearly had significant groundwater contributions that maintained consistent baseflows in the channel even during cold spells in the winter when air temperatures fell to as low as -15°C (in March, 2006) (Figures 3a-c). DC-C site had no surface flow during portions of the late spring and summer (no flow on sampling dates between late February and late April, 2006) (Figure 3a). Loss of flow is an obvious major concern for salmonids attempting to utilize Duck Creek as habitat for rearing, spawning, and egg incubation. Discharge measurement made between January and June, 2006 never exceeded a meager 2.1 cfs (at site DC-2).

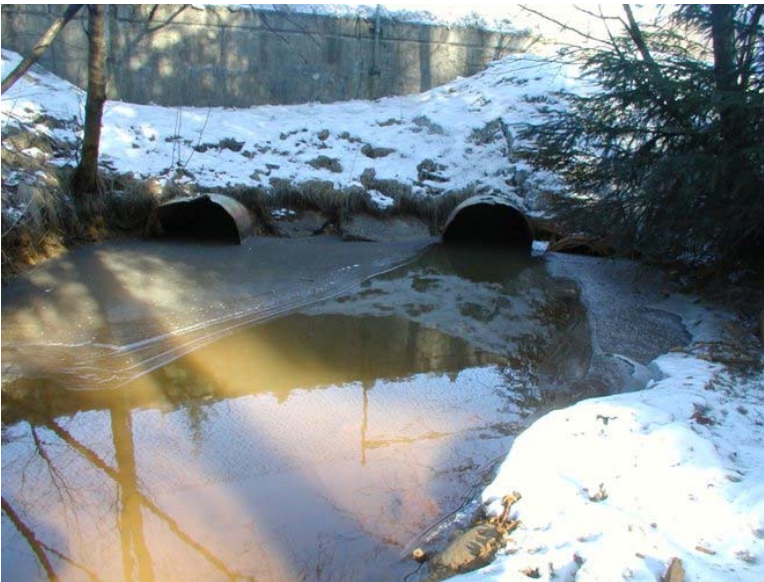
Figure 3b. Site DC-B, showing unfrozen water, indicating strong groundwater inputs while the air temperature was as low as -15°C in Juneau on 3/15/05. Water was present at the site on all sampling events.

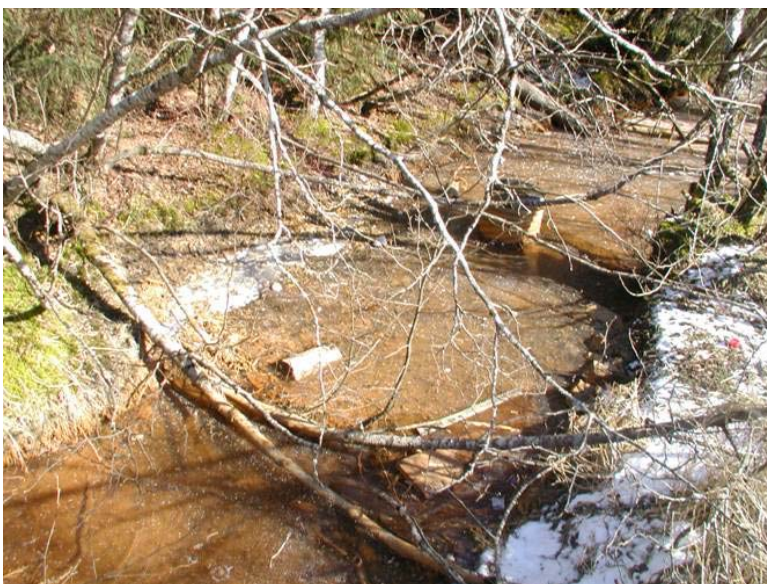
Figure 3c. Site DC-A, showing largely unfrozen water (with a thin cover of ice), indicating strong groundwater inputs while the air temperature was as low as -15°C in Juneau on 3/15/05. Water was present at the site on all sampling events. Also visible is the orange staining of the iron floc, which is particularly abundant at this upper site.

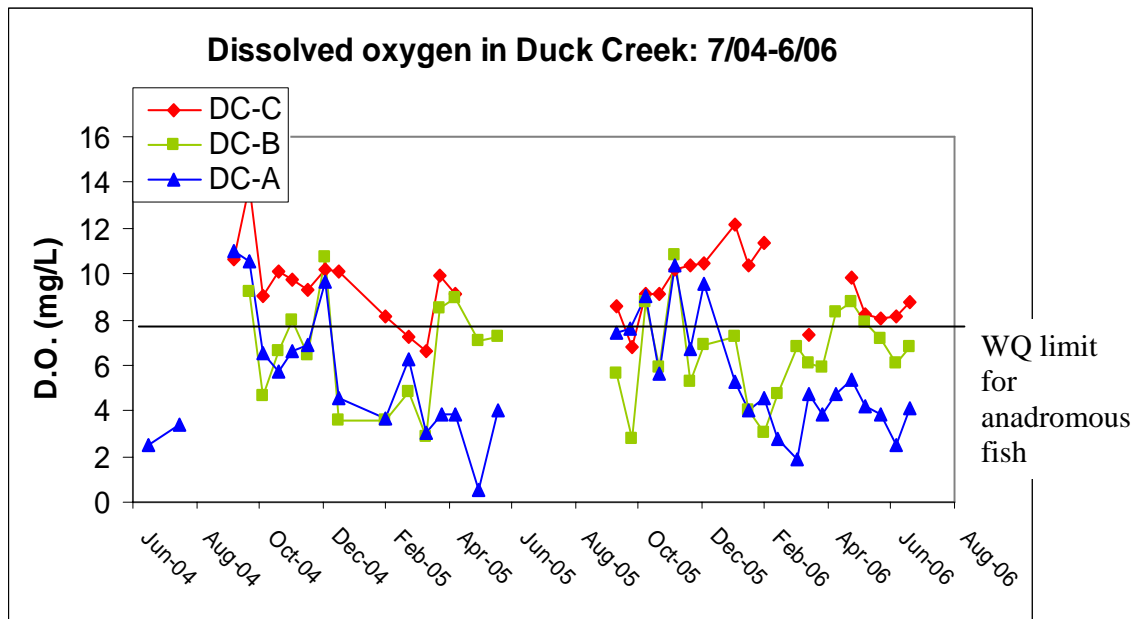
Dissolved oxygen increased from upstream to downstream (Table 2, Figure 4). At sites DC-B and DC-A, dissolved oxygen levels routinely fell below the State of Alaska water quality limit of 7.0 mg/L for the growth and propagation of fish, shellfish, and other aquatic life, and even below the water quality limit for waters not used by anadromous or resident fishes (5.0 mg/L) (DEC, 2006).

Dissolved oxygen (D.O.) has been previously identified as a parameter of concern on Duck Creek. Problems with D.O. levels meeting water quality standards exist at all three sites (Figure 4). Anaerobic groundwater from SE Alaska is typically high in dissolved ferrous iron and sulfide ion. These two species are unstable under surface conditions and quickly oxidize to ferric iron and sulfate ion, consuming significant amounts of oxygen in the process. Supporting this conclusion are the significantly higher conductivities measured at DC-A compared to the two other sites (Figure 5). Conductivity quantifies dissolved ions in the water column. The presence of the charged species, Fe^{2+} (ferrous iron), Fe^{3+} (ferric iron), S^{2-} (sulfide ion) and SO_4^{2-} (sulfate ion) is consistent with the higher conductivities measured at DC-A. Furthermore, increased acidity is a side-product of oxidation and will further increase conductivity. Time-dependent D.O. and conductivity are presented in Figures 3 and 4 for comparison.

Figure 4. Dissolved oxygen levels at the 3 sampling sites on Duck Creek. Graph includes data from year (2004-2005) prior to the current study year (2005-2006).

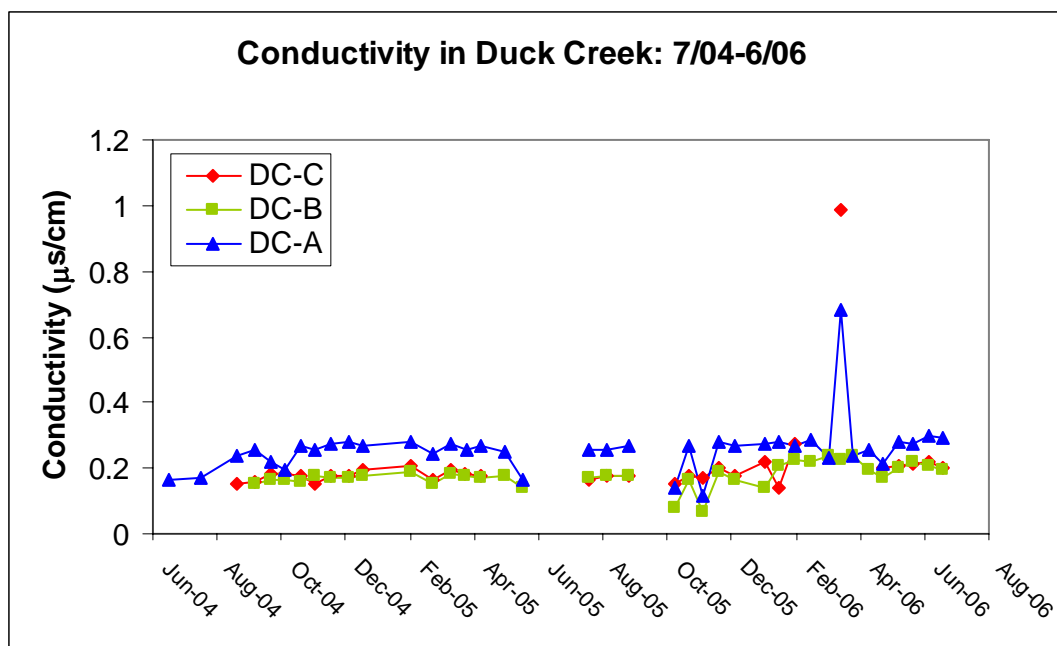
Figure 5. Conductivity values at the 3 sampling sties on Duck Creek. Graph includes data from year (2004-2005) prior to the current study year (2005-2006). The high values at DC-C and DC-A occur with high chloride concentrations and may be indicative of road salt runoff.

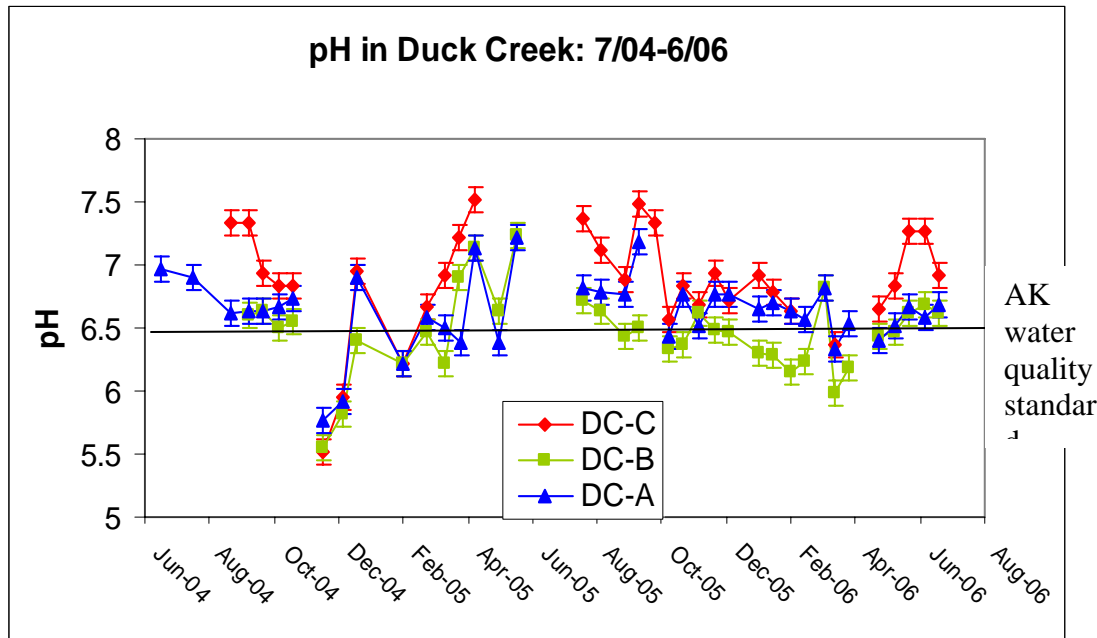
Values for pH showed significant scatter, ranging from 6.1 to 7.5 during the study period, which is generally consistent with values from the previous year (Figure 6). Lower pH values are likely caused by iron-rich groundwater intrusion, which becomes the dominant source of water during cold and dry climatic periods. pH values at DC-B routinely fell below the state water quality standard of 6.5 for the growth and propagation of fish, shellfish, and other aquatic life. At DC-A, pH values sometimes fell below the standard. The oxidation of reduced species prevalent in anaerobic groundwater produces significant acidity as a side-product (see D.O. discussion above for further details).

Figure 6. pH values at the 3 sampling sties on Duck Creek. Graph includes data from year (2004-2005) prior to the current study year (2005-2006). DC-C is least groundwater influenced and has the highest pH values.

It is important to note that stream pH variability on a diel scale can be substantial, with levels lowest during the nighttime; as a result, it is recommended that pH and D.O. levels are measured in the future both nocturnally and diurnally to better characterize the levels present in the stream during various parts of the day. Data from the mornings-only samplings (presented here) may not be accurate representation of daily average values. After the Nancy Street wetland area is constructed, the floodplain revegetated, and the channel constricted to a shallower and flowing conduit (rather than largely stagnant ponds) for the streamwater, it is likely that pH and dissolved oxygen levels at DC-B will rise. In the meantime, water quality at DC-B is degraded substantially.

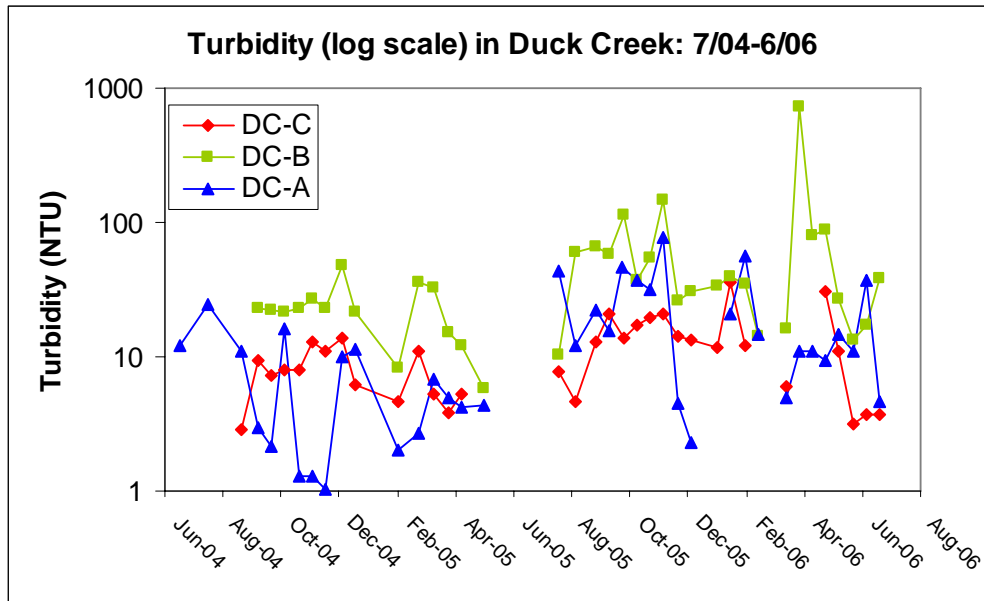
The state of Alaska water quality standards for turbidity dictate that to protect fish and wildlife, turbidity may not exceed 25 nephelometric turbidity units (NTUs) above natural background conditions. Turbidity is not a direct measurement of solids, but is related to the amount of suspended material in the water column because it is a measure of light attenuation due to absorption and reflection by solids. Turbidity can be expected to closely parallel total suspended solids (TSS). Depending on sampling date and location, Duck Creek water clarity varies significantly. Significant variation in turbidity and TSS values was observed within a single sampling location as well and this is most obvious at the site representing the unimproved section of Duck Creek, DC-A. Turbidity and TSS measurements at all three sites indicate persistent water quality problems on Duck Creek. Mean turbidity and TSS values were lowest at DC-C (Table 2), but were considerably high and in violation of the state water quality standards at DC-B and DC-A (Figure 7).

Figure 7. Turbidity (NTU) at the three Duck Creek sites. Note log scale.

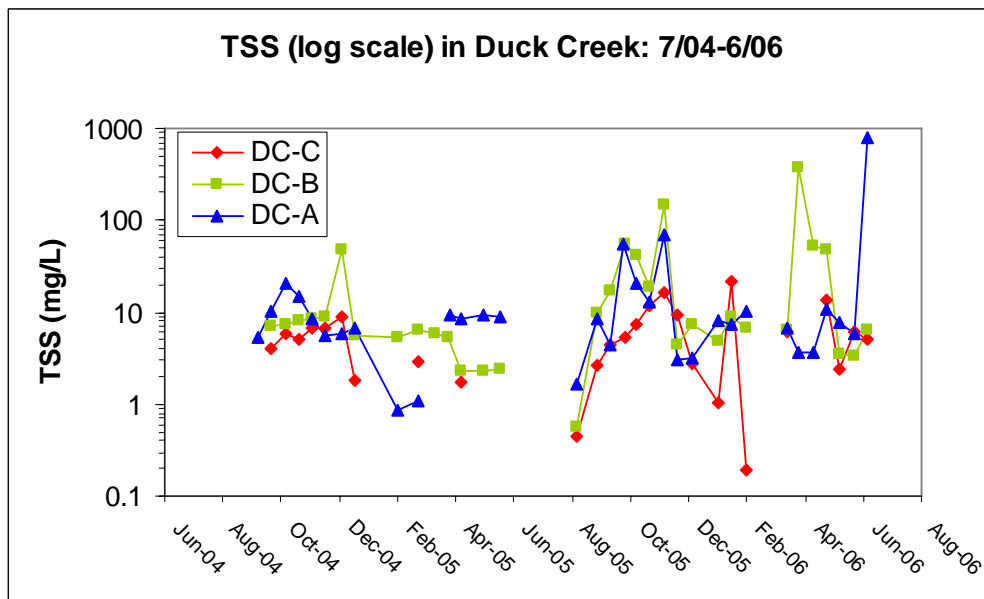
Mean turbidity values at DC-B are skewed due to the remarkably high value of 735 NTU found on 4/7/06, when immediately upstream, loose sediments were being dumped directly into Duck Creek as part of the wetlands construction project (Figures 9a and 9b). On this date, the TSS value jumped to 377 mg/L (Figure 8). These conditions were clearly violations of state standards; however, these conditions are expected to be temporary as long as construction of the wetlands continues upstream. The high TSS value collected on 6/16/06 at DC-A is likely an artifact of sampling error; the stream at DC-A did not appear particularly turbid on the date. Loose iron floc is highly abundant at the site, and the slightest physical disturbance of the streambed by the sampler can introduce large amount of floc into the sample bottle (Figure 10).

Figure 8. Total suspended solids (TSS, in mg/L) at the 3 Duck Creek sites. Note log scale.

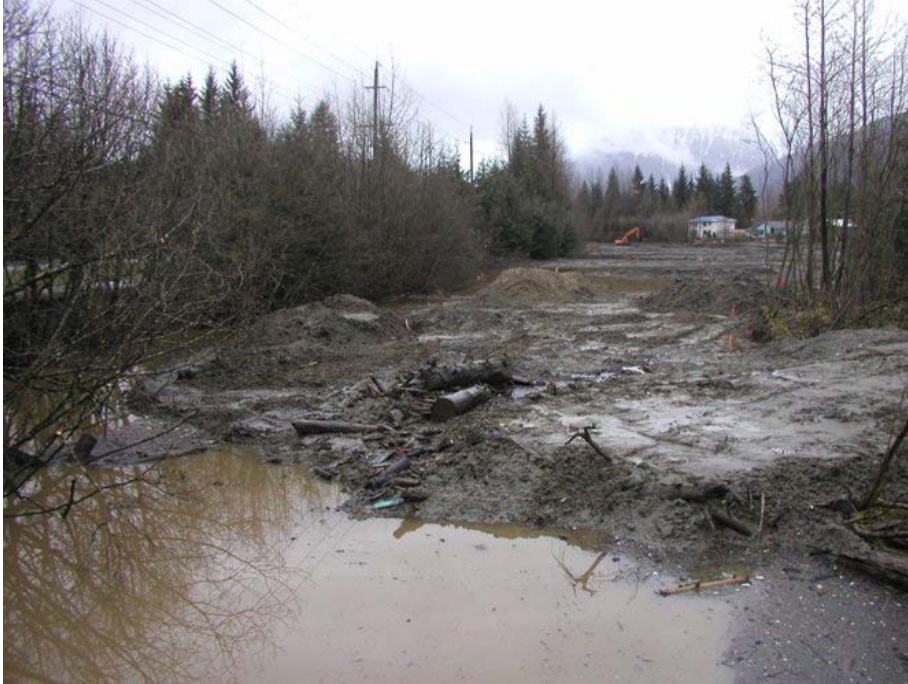
Figure 9a. Photo taken upstream of the Nancy Street bridge and site DC-B on 4/7/06, when sediment was being actively dumped into Duck Creek as part of the wetlands construction project. The activity greatly elevated turbidity and TSS levels downstream.

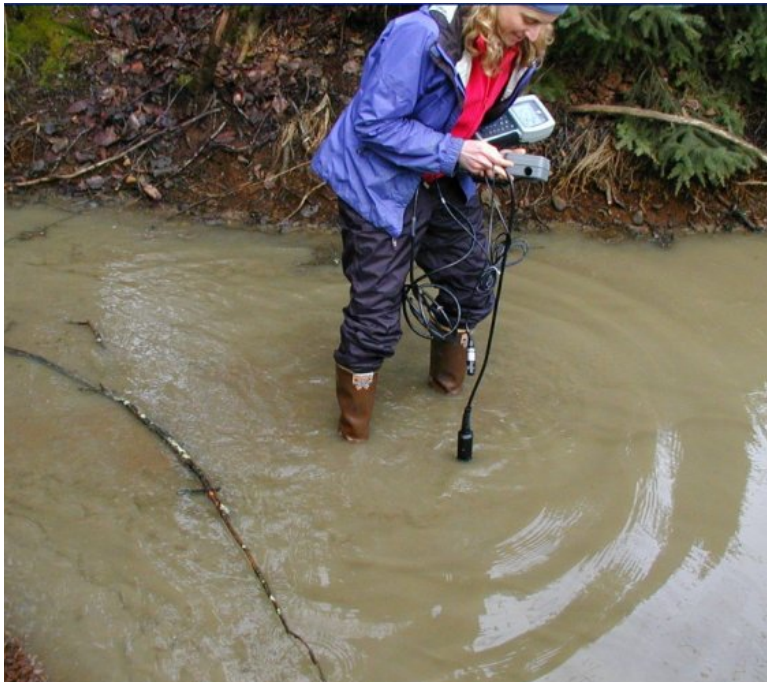
Figure 9b. Photo of sampling in situ water quality parameters in Duck Creek at site DC-B on 4/7/05 when active construction of the Nancy Street wetlands was underway immediately upstream of the site. Notice the extremely turbid coloration of the water.

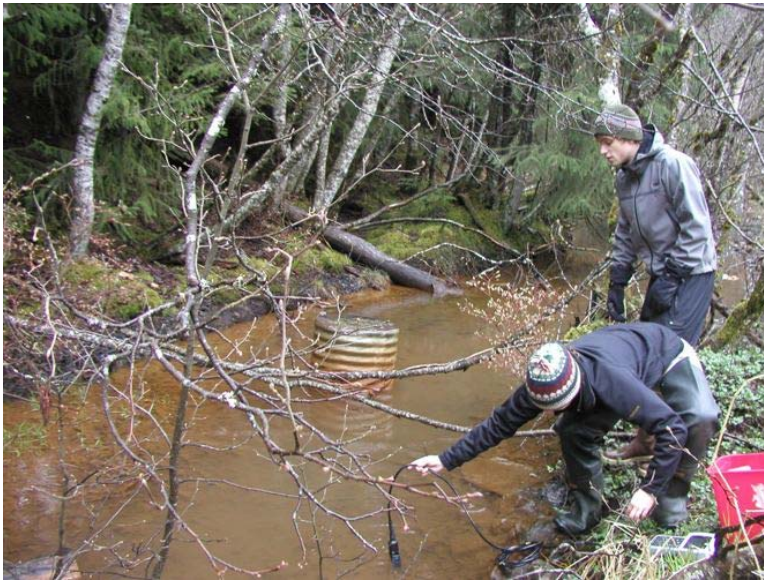
Figure 10. Sampling at site DC-A in April, 2006. The thick coating of iron floc on the streambed is easily disturbed by any activity (including sampling) in the stream. Caution is taken to avoid introducing re-suspended floc into the turbidity and TSS sample bottles, but this is not always possible.

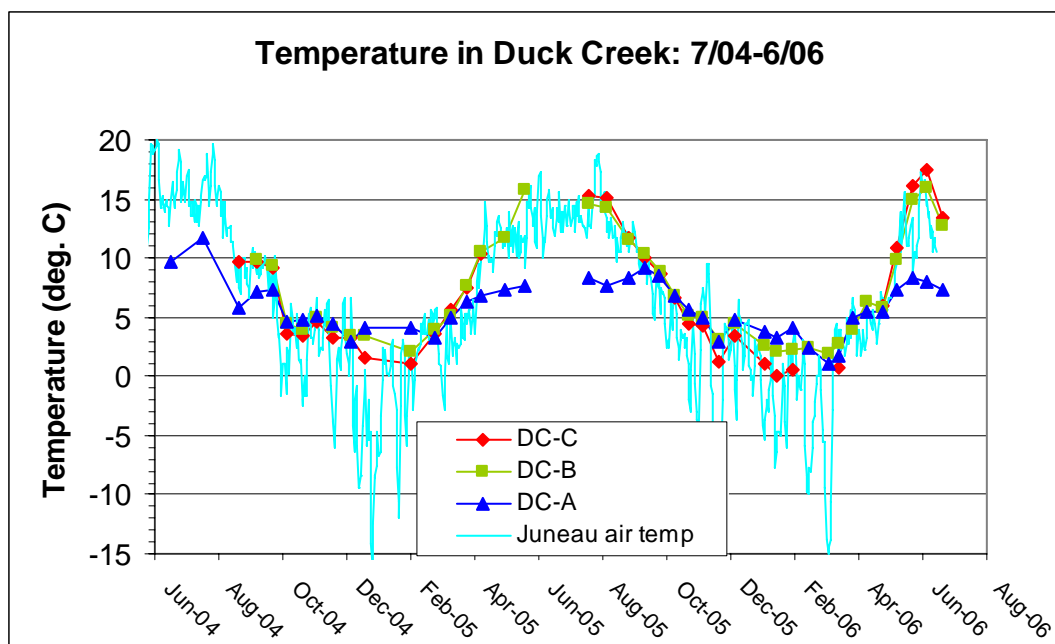
Water temperature in Duck Creek shows strong seasonal variation, despite the flashy (event-controlled) discharge patterns on the stream. Figure 11 shows the temperature at the 3 Duck Creek sites compared to Juneau air temperature. Comparison of water temperature at the three locations along Duck Creek indicates that upstream site DC-A has generally lower summertime and warmer wintertime temperatures than does DC-C (Table 2), which is further indication of the groundwater upwelling at the sites because groundwater maintains a more stable temperature than does surface water. While residential dwellings surround site DC-A, the stream cover has remained intact and is less affected by higher summer temperatures and infiltration of direct sunlight. Higher temperatures at DC-B and DC-C are consistent with the more urbanized surroundings at these sites and lower proportional baseflow input. On some dates, temperatures observed at DC-B and DC-C exceed the 13°C limit for egg and fry incubation and spawning, and the 15°C limit for migration routes and rearing areas (DEC, 2006).

Figure 11: Water temperature at the three sampling locations on Duck Creek, with Juneau airport air temperatures overlain to show the close relationship between air and water temperatures. Data shown include data collected in FY 05 as well as FY 04.

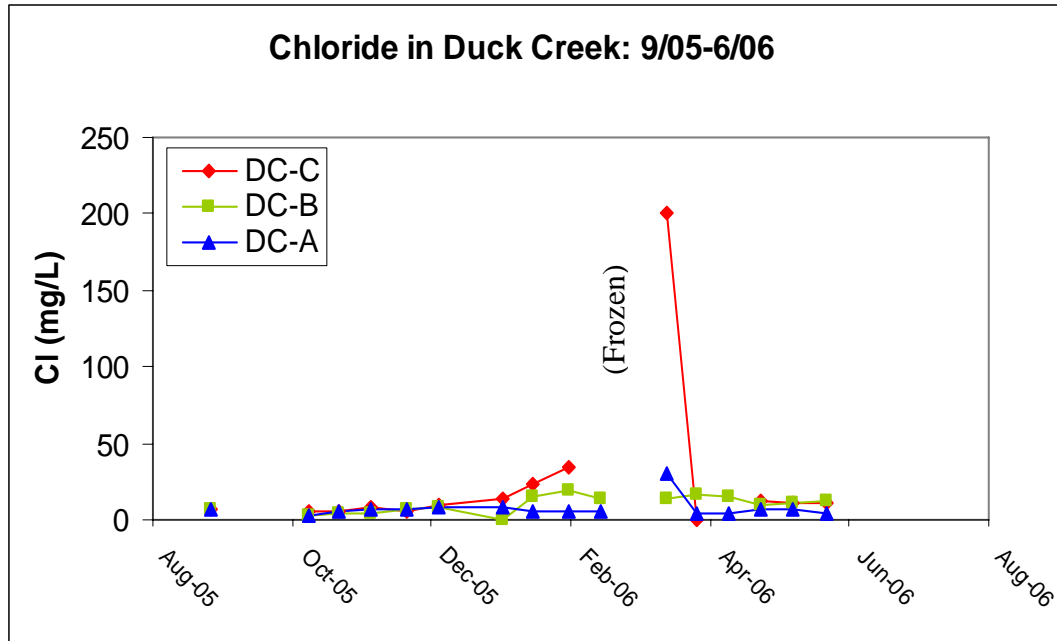
The extent to which the application of salts on roads in the Mendenhall valley may be affecting water quality was evaluated by examination of dissolved ion data (presented to Appendix B). Road salts used in the City and Borough of Juneau include NaCl, and MgCl₂; therefore Cl, Na, and Mg concentrations should be good indicators of the salting. During March, 2006, when air temperatures and water levels were extremely low (or stagnant in isolated pools, in the case of DC-C), some high levels of salt were found in the water samples (Figure 12). While Cl levels ranged between 5-12 mg/L during the fall and early winter, the concentration increased to 24.0 mg/L on 1/27/06; to 34.6 mg/L on 2/11/06; and on 3/25/06 shot up to 200 mg/L. The high value found in the 3/25/06 sample is currently being returned for laboratory analysis at a diluted level; its readback on the Ion Chromatograph was at the end of the calibration range of the instrument. The exact value of this concentration will be reported to the DEC when they become obtainable; in the meantime, the 200 mg/L should be treated as an approximate concentration level. The sample was clearly not contaminated because in situ conductivity measurements at this site also indicate a spike in value on this date (Figure 5). It is important to note the Duck Creek was not flowing at the site on this date; the sample was obtained from one of a series of stagnant, ice-covered small pools in the channel that likely formed as a result of recent rain. It appeared that the rain event was not sufficient to create in-stream flow at DC-A, but was sizable enough to wash out road salts into the channel and create a few small pools of water rich in road salt ions. The US Environmental Protection Agency sets the secondary maximum contamination level for chloride at 250 mg/L, the chronic freshwater criterion at 230 mg/L, and the acute freshwater criterion is 860 mg/L. Therefore, although Cl levels rose sharply, they did not

exceed water quality standards, although the maximum concentration found (an approximate value) did approach the chronic freshwater standard.

Figure 12. Cl concentrations at the 3 Duck Creek sites. Notice the high concentration at DC-C on March 25, 2005, which followed a dry spell in the creek and record low temperatures in Juneau that likely coincided with increased use of road salt in the valley. DC-C is the lowermost site of the 3, downstream of major roads and the Egan Drive-Mendenhall Loop Road Intersection. Na concentration patterns are nearly identical to Cl patterns; indicate a strong likelihood of NaCl salt inputs into the stream.

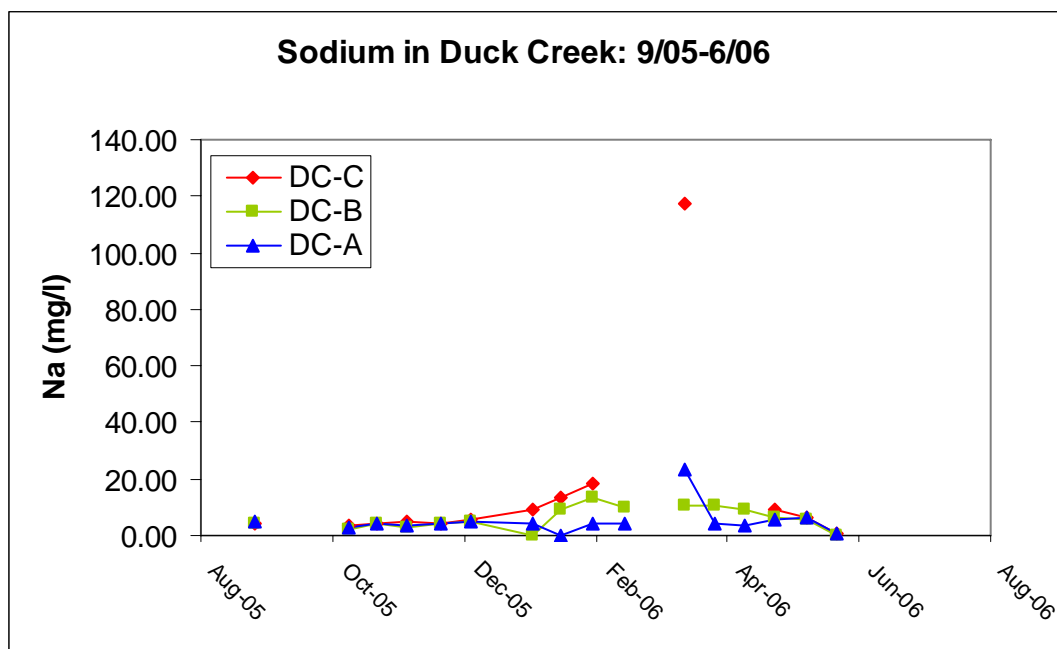
Further evidence that Cl levels in the stream rose due to road salt is seen in the sodium data for DC-C (Figure 13). Concentrations of Na were between 3.8 and 5.5 in the summer and fall, but rose to 18 mg/L by 2/11/05 and jumped to 117 mg/L on 3/25/06. Mg concentrations on 3/25/05 were also approximately 4 times their fall and winter concentrations (Appendix B). There are no water quality standards for Na and Mg concentrations.

Figure 13. *Na concentrations at the 3 Duck Creek sites. Notice the high concentration at DC-C on March 25, 2005, which followed a dry spell in the creek and record low temperatures in Juneau that likely coincided with increased use of road salt in the valley. DC-C is the lowermost site of the 3, downstream of major roads and the Egan Drive-Mendenhall Loop Road Intersection. Na concentration patterns are nearly identical to Cl patterns; indicate a strong likelihood of NaCl salt inputs into the stream.*
