**Technical Report No. 01-7**

# **Chester Creek Stream Condition Evaluation**

**Jeffrey C. Davis and Gay A. Muhlberg**

Alaska Department of Fish and Game

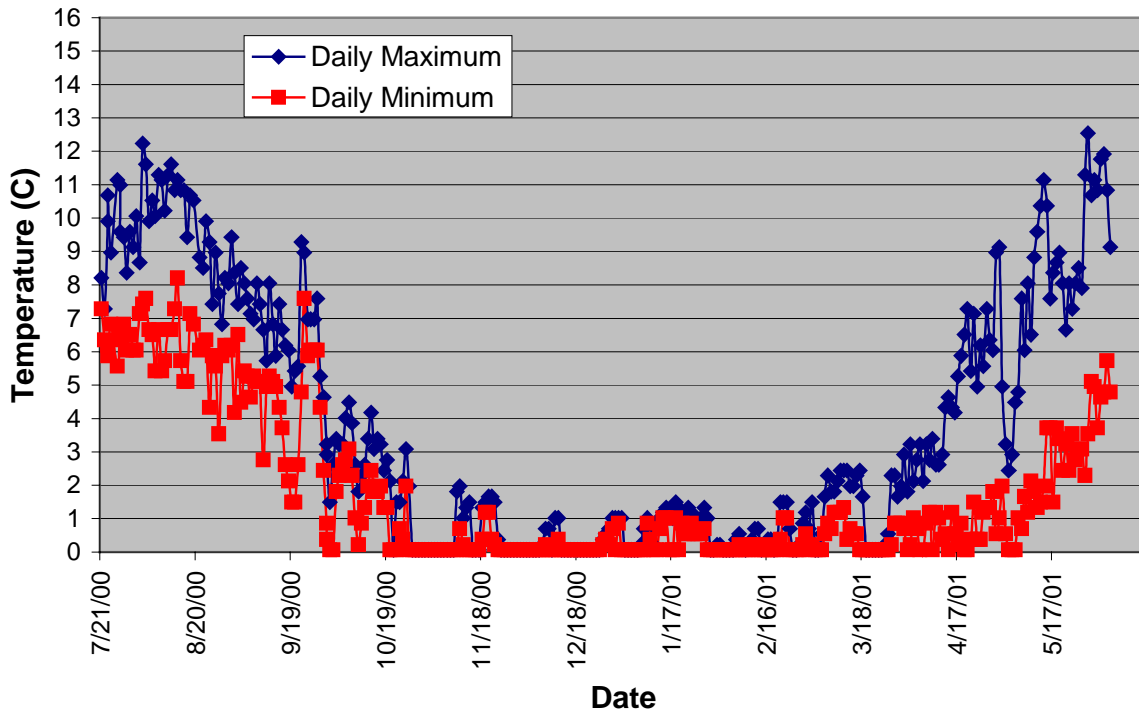
Figure 4. Station 2 annual stream water temperatures.

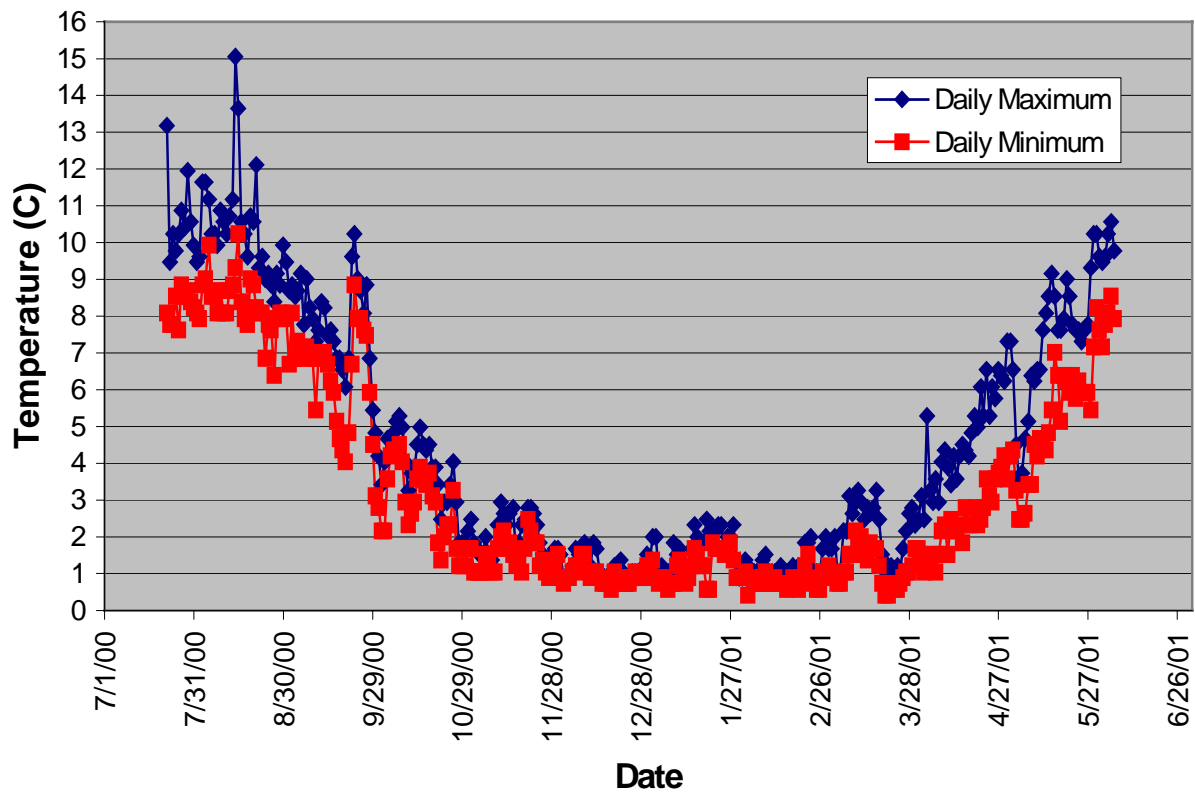
Figure 5. Station 4 annual stream water temperature.

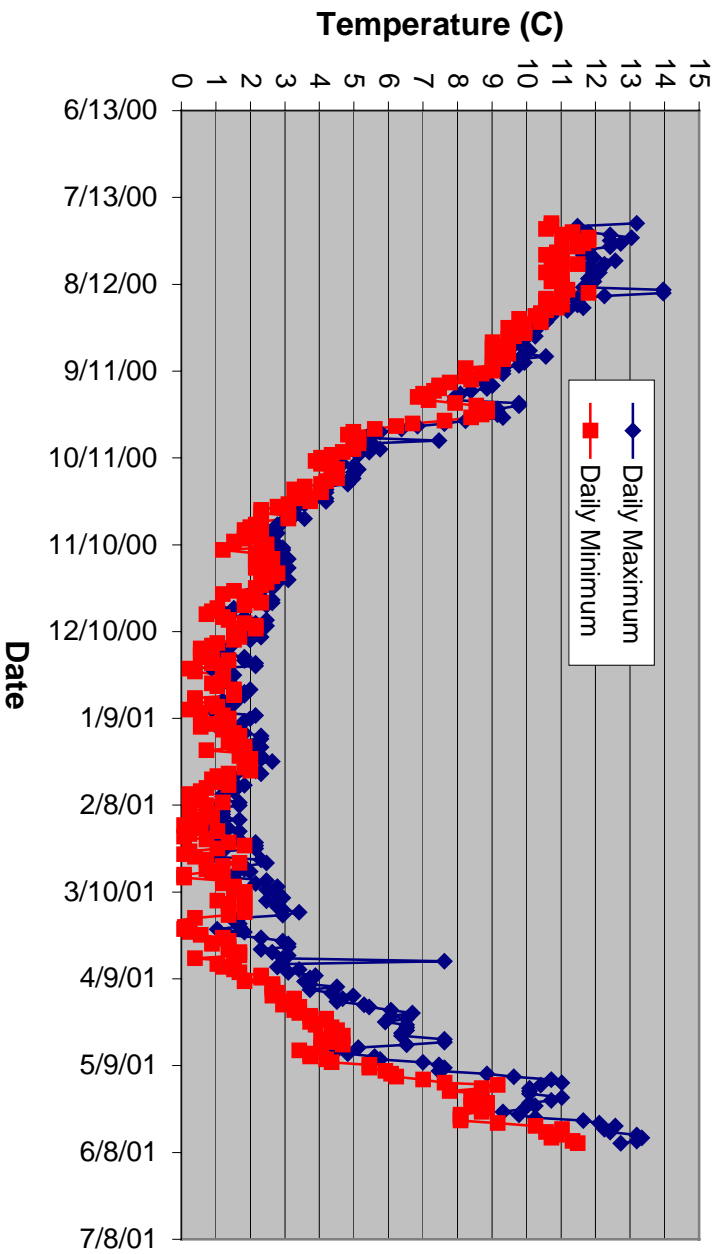
Figure 6. Station 6 annual stream water temperature.

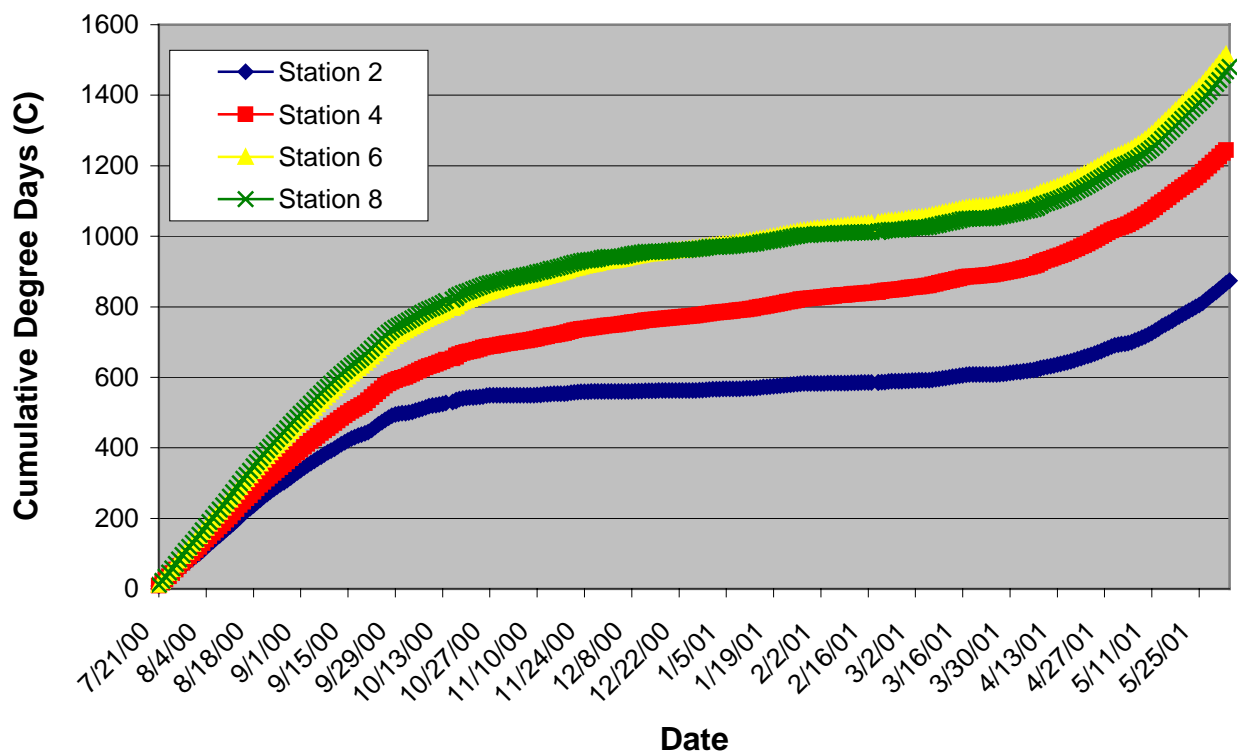
Figure 8. Cumulative degree days for the sampling Stations.

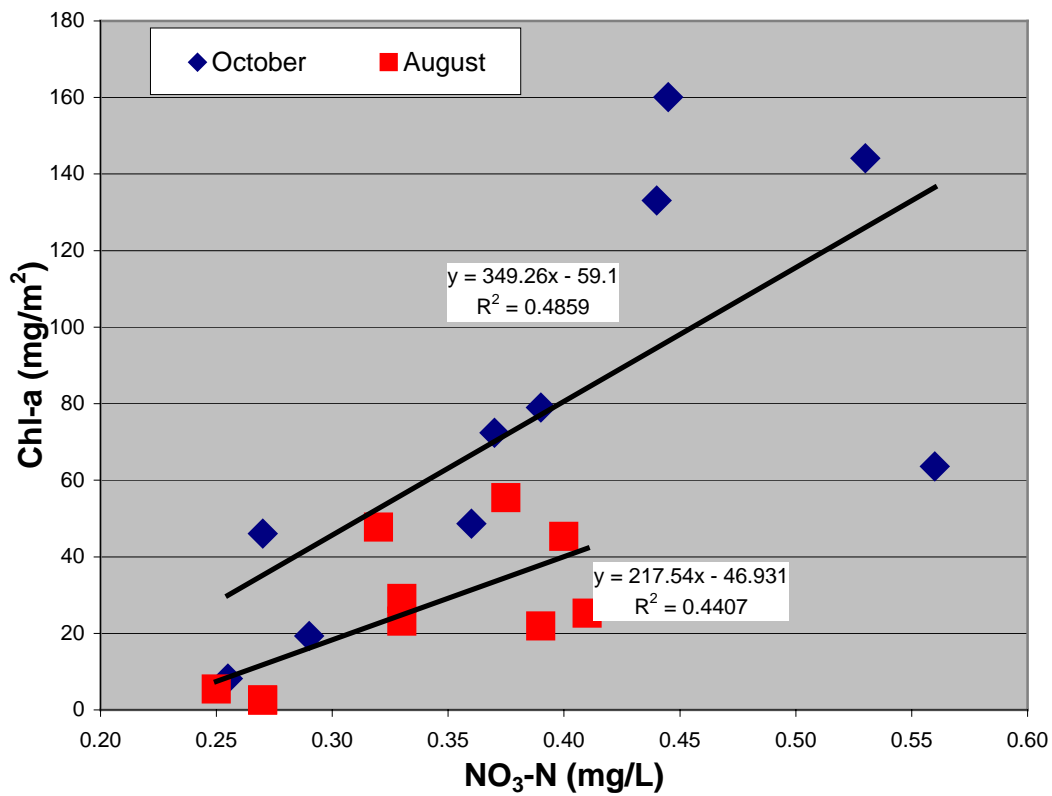
Figure 10. Chlorophyll-*a* concentrations as a function of nitrate nitrogen.

Although both nitrogen and phosphorus concentrations increased downstream and were weakly correlated with periphyton chlorophyll-*a* concentrations, these nutrients are most likely above concentrations that saturate algal production. Therefore, differences in periphyton chlorophyll-*a* are more likely due to differences in sunlight. Previous studies have shown that algal productivity can be limited by low concentrations of nutrients. The nutrients most often determined limiting are nitrogen and phosphorus. Algae have been found to be limited by instream nitrogen concentrations below 0.10 to 0.55 mg/L (Grimm and Fisher 1986, Lohman et al. 1991). These concentrations are well below concentrations measured in Chester Creek. Similarly, phosphorus has been found to be limiting below concentrations of 0.006 mg/L (Mulholland et al. 1990; Bothwell 1989) which are an order of magnitude lower than measured Chester Creek concentrations.
