ALASKA DEPARTMENT OF ENVIRONMENTAL CONSERVATION
Division of Spill Prevention and Response
Prevention Preparedness and Response Program
SITUATION REPORT (SITREP)

2020 VMT Sump Oily Water Spill

SITREP #: 2

INCIDENT LOCATION: 58-SU-3 Admin Sump, Valdez Marine Terminal

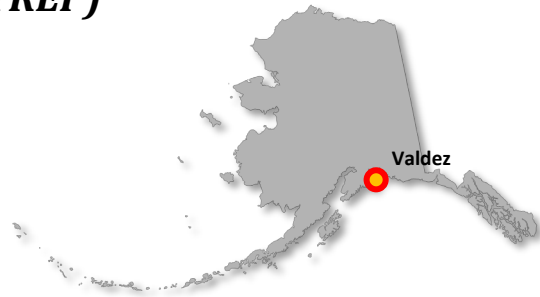
RESPONSE ACTION: The oil traveled beneath the snow covered surface and came out near the head of Berth 4 into Port Valdez. A tanker was loading at Berth 5 at the time of the incident, but was not affected by the spill. Sheen has been seen east of Berth 4 to the VMT small boat harbor. Most of the sheen is contained behind the Berth 4 area with sorbent boom and sweeps, and two layers of hard yellow boom. Oily water is being skimmed from a corralled 30ft by 30ft area inside the boom. Two Current Buster boom systems are being deployed outside of the boomed area, with trained fishing vessels to catch any escapement. Overflights and vessel surveillance of the area are ongoing. Crews are working to determine the amount of contamination in and around the sump. The USCG and ADEC have been on scene to observe Alyeska's response actions.

An additional layer of bigger boom was deployed outside of the hard yellow boom to enhance the containment of sheen. Boom has been deployed to protect the Solomon Gulch Hatchery and the Valdez Duck Flats. Oil skimming operations have continued and as of 4:00 PM today 423 bbls of oil water mixture has been collected. Spill delineation near the sump (spill source) has shown heavy snow contamination, and delineation activities

and snow removal are still under way. Steps have been taken to make sure that Berth 5 remains clear of sheen to ensure that tankers can be loaded safely.

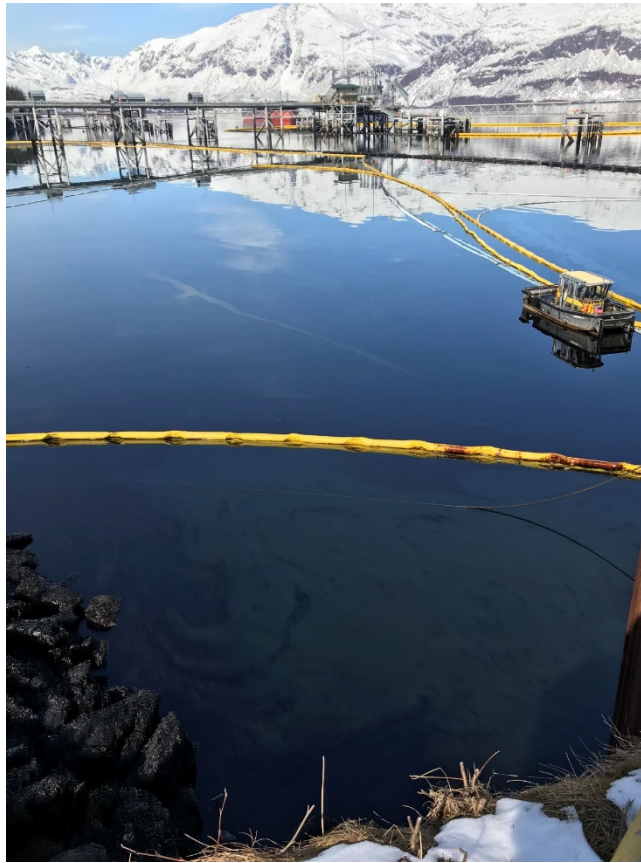
Figure 1. Spill containment and recovery activities at the VMT on April 14, 2020. Courtesy ADEC
