ALASKA DEPARTMENT OF ENVIRONMENTAL CONSERVATION
Division of Spill Prevention and Response
Prevention Preparedness and Response Program
SITUATION REPORT (SITREP)

2020 VMT Sump Oily Water Spill

SITREP #: 4

INCIDENT LOCATION: 58-SU-3 Admin Sump, Valdez Marine Terminal

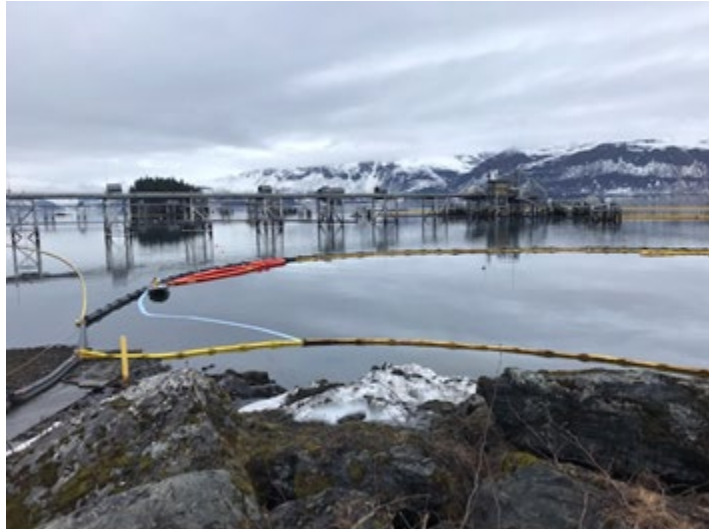
Figure 1. Containment boom looking west at the VMT on April 21, 2020. Courtesy ADEC
