ALASKA DEPARTMENT OF ENVIRONMENTAL CONSERVATION  
Division of Spill Prevention and Response  
Prevention Preparedness and Response Program  
**SITUATION REPORT (SITREP)**

## Savoonga AVEC Tank Farm Diesel Oil Release

**SITREP #:** 3

**SPILL #:** 21389906001

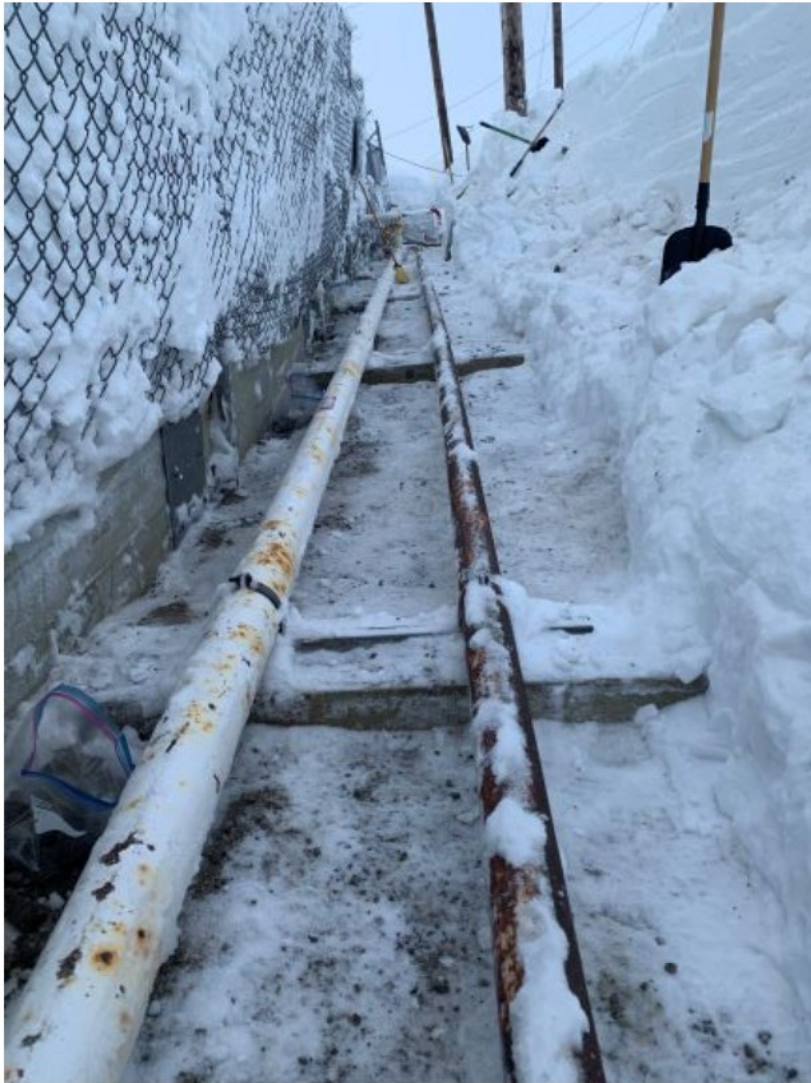
Photo 1. Snow removal on the west wall outside of secondary containment of the tank farm to check for additional contamination. (Photo provided by Scott Stiker, March 24, 2021)

**RESPONSE ACTION:** AVEC has assembled an on-site cleanup crew. The crew has been continuing to collect diesel from both outside and within secondary containment. Snow from around the entire exterior perimeter of the tank farm has been excavated to delineate the extent of the fuel that migrated outside of the secondary containment, and three discrete locations were identified. There is no indication that the contamination outside the secondary containment is a result of containment failure. Contaminated snow that was collected from outside the secondary containment has been bagged and moved to within the secondary containment area.

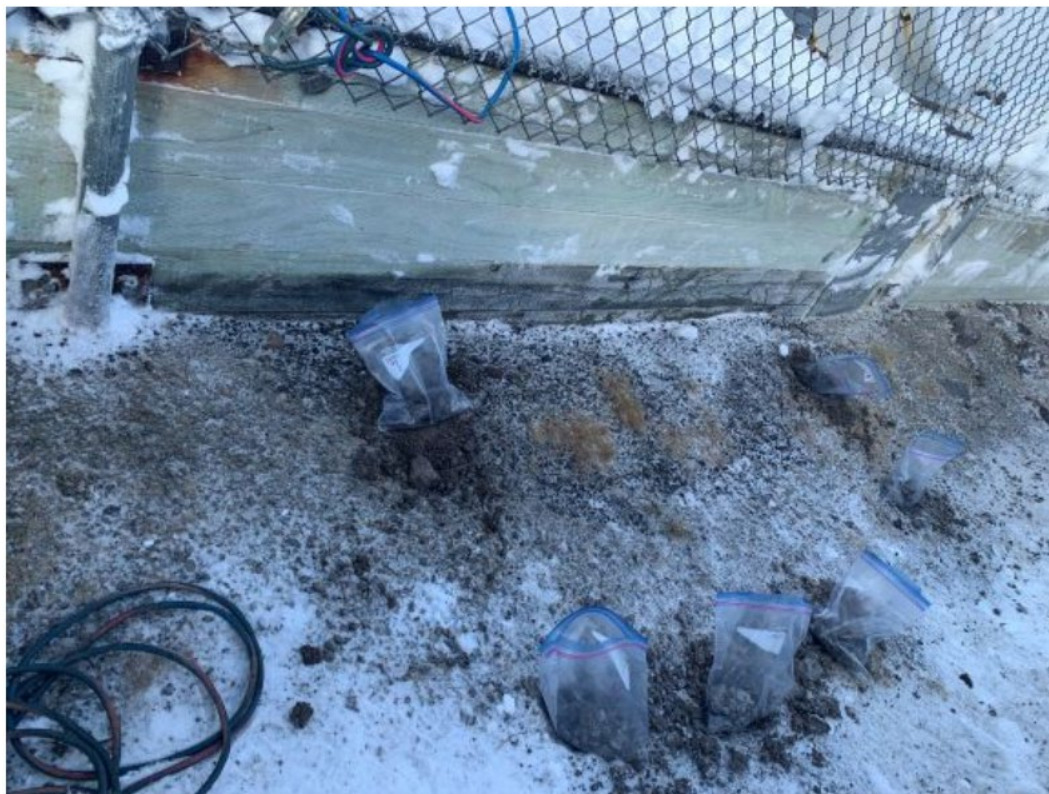
Photo 2. Soil samples collected on the east wall where diesel was found outside of secondary containment. (Photo provided by Scott Stiker, March 18, 2021)

Soil samples have been collected and screened with a photoionization detector (PID) to determine impacted areas outside of containment. A jackhammer is being used to chip out impacted soil from around the outside of the containment, and then the soil is placed in fish totes. Approximately 9 cubic feet of soil have been removed, and the fish totes are housed in a connex onsite.
