ALASKA DEPARTMENT OF ENVIRONMENTAL CONSERVATION

SITUATION REPORT (SITREP)

F/V St. Patrick Womens Bay Release

SITREP #: 2

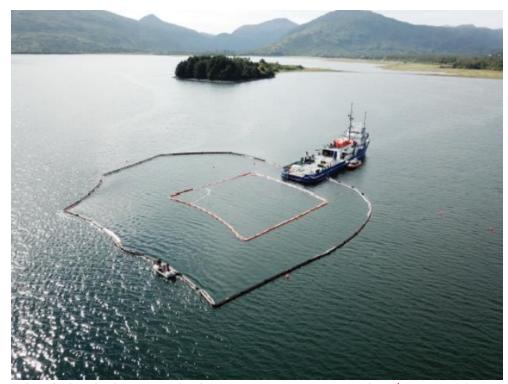
(Photo Credit: Alaska Chadux Network – boom in Womens Bay over the F/V St. Patrick on August 21)

At the request of the USCG, Global Diving & Salvage, Inc (Global), Alaska Chadux Network, and Paradigm Marine, LLC mobilized to the site on August 7, 2021. Containment and absorbent boom were deployed around the area of the wreck. Since August 10, 2021 daily diving operations have continued. Those efforts have included

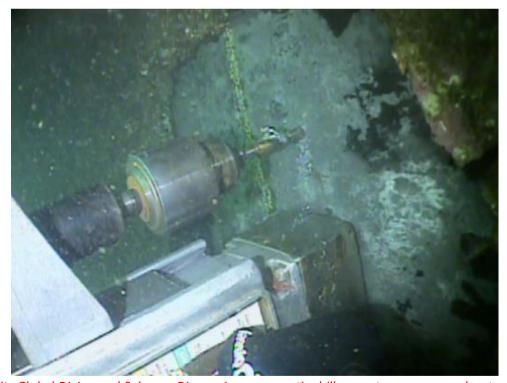
(Photo Credit: Global Diving and Salvage: Diver using a magnetic drill press to open an exploratory hole in the hull - 8/20)

Divers have penetrated the hull of the vessel using specialized drilling equipment in multiple locations to collect oil that was accumulated in internal spaces. As holes are drilled, any oil observed is immediately recovered using suction. During these operations, additional information was collected to inform the response crew about the possible internal structures of the vessel, as well as the condition of the metal hull. Response crews continue to maintain double boom, lined by absorbent boom to recover any oil that escapes from the vessel. Booming has been effective but swell and chop and strong currents have compromised the effectiveness of the containment boom at times. The crews continue to make adjustments to maximize the effectiveness of the booming operations.
