**ALASKA DEPARTMENT OF ENVIRONMENTAL CONSERVATION**  
**Division of Spill Prevention and Response**  
**Prevention Preparedness and Response Program**  
***SITUATION REPORT (SITREP)***

## **Port Williams Shuyak Island Bunker C Spill**

**SITREP #:** 2

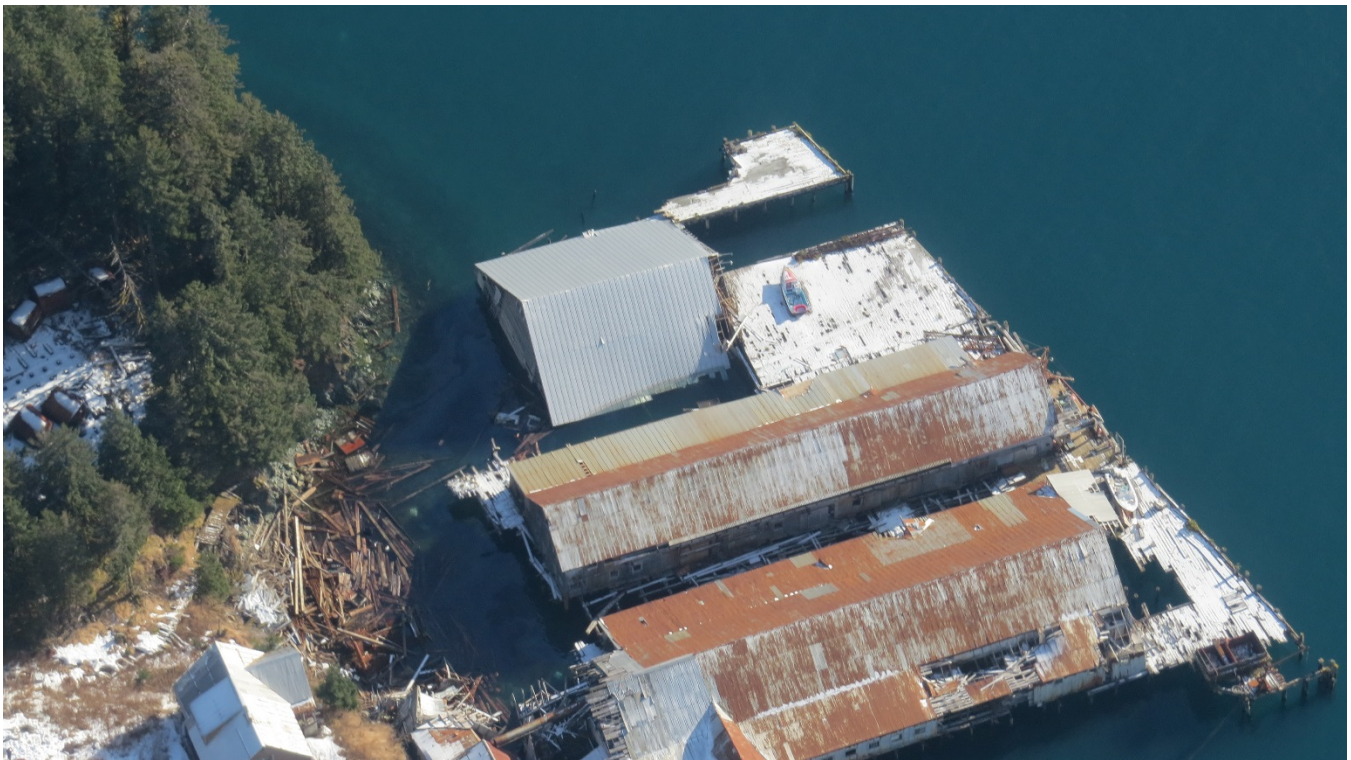
**Photo taken March 1, 2018 Photo credit: Alaska Department of Fish and Game. The building at the top center of the photo shows the roof of the building that was resting on the dock that collapsed. This photo was taken from an overflight by ADF&G while on a mission not associated with this spill.**

**CAUSE OF SPILL:** It was previously reported that wind gusts exceeding 80 mph pushed a building with the fuel bladder off a dock, causing the 3,000 gallon capacity fuel bladder to rupture and release its contents. Upon further investigation it has been determined that the dock structure supporting the building collapsed. This caused much of the building, along with the fuel bladder, to fall to the shoreline and water below.
