ALASKA DEPARTMENT OF ENVIRONMENTAL CONSERVATION
Division of Spill Prevention and Response
Prevention Preparedness and Response Program
SITUATION REPORT (SITREP)

Port William Shuyak Island Bunker C Spill

SITREP #: 6

SPILL #: 18249905701

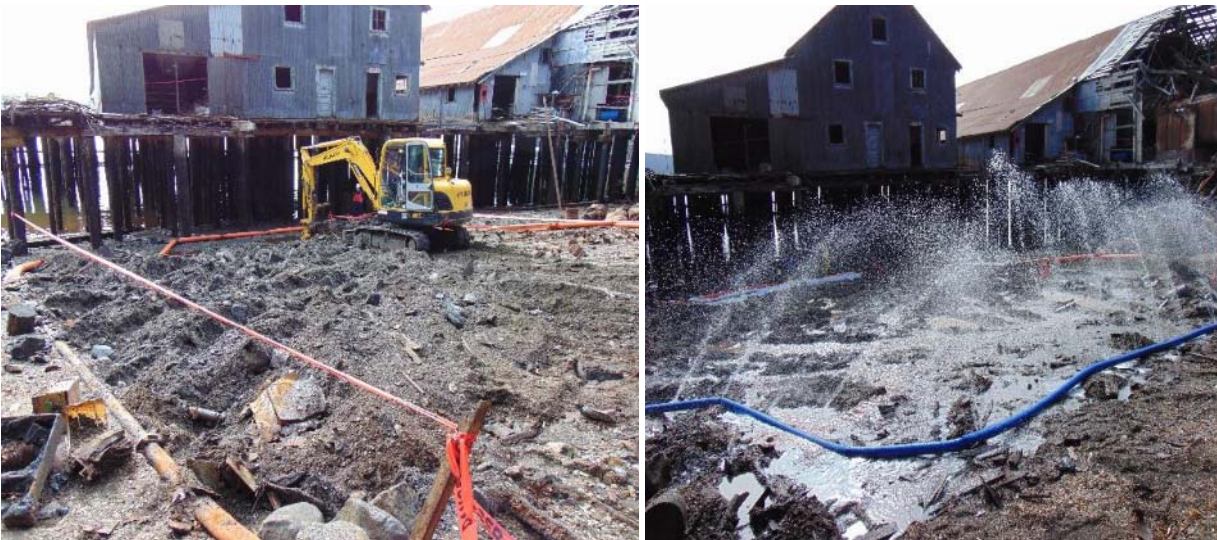
Photo of beach tilling and deluge. Taken April 5 to 7, 2018. Photo credit: Alaska Chadux Corporation

of the SCAT team, crews at the site removed oiled debris from affected shorelines. Additionally, recommended beaches were tilled and deluged to mobilize product to collect in absorbent pom-poms and boom. Pressure washing proved successful to remove product that was adhered to rock surfaces. The Unified Command visited the site on April 13, 2018.

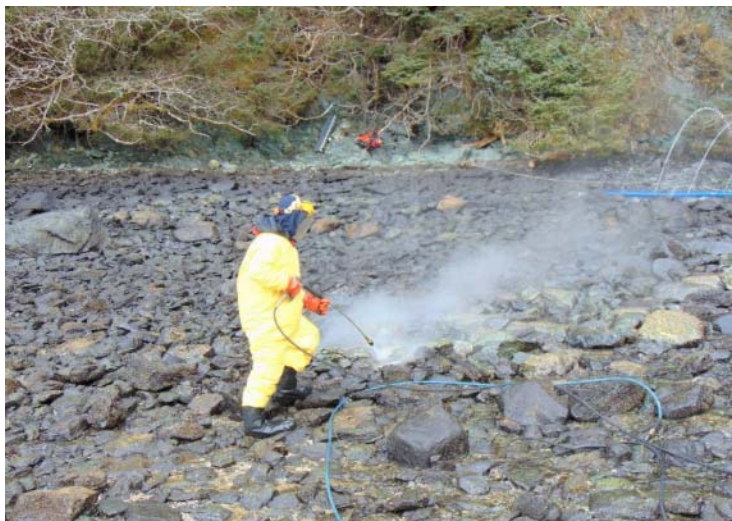
Pressure washing rocks on the beach. Taken April 14, 2018. Photo credit: Alaska Chadux Corporation

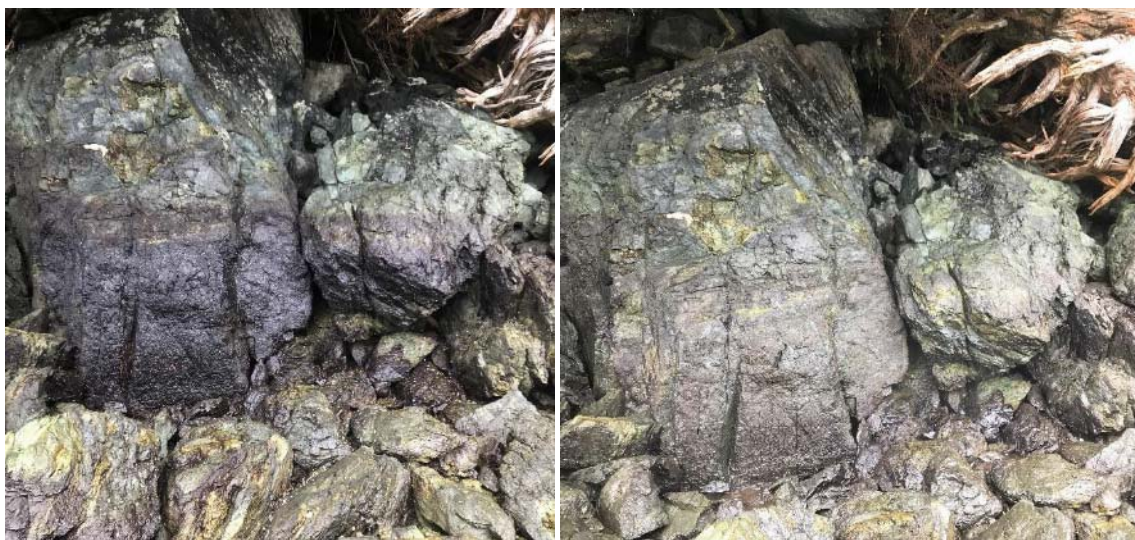
Before and after pressure washed rocks. Taken April 9-10, 2018. Photo credit: Alaska Chadux Corporation

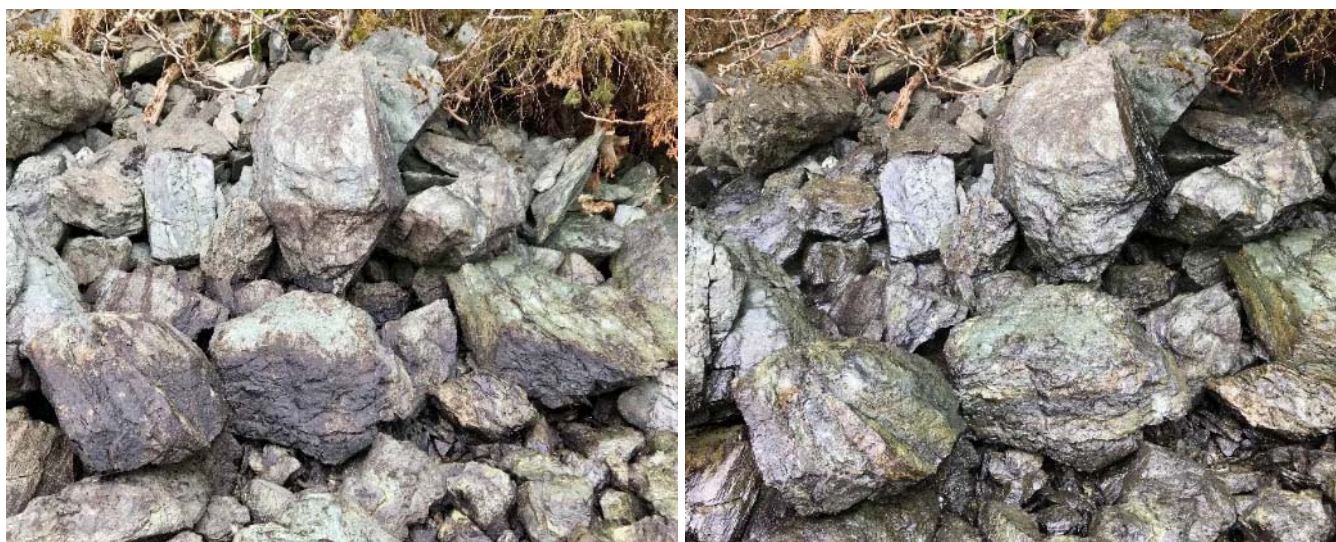
Before and after pressure washed rocks. Taken April 8, 2018. Photo credit: Alaska Chadux Corporation
