CIAP WEAR Trip Report  
Atmautluak (population 302)  
May 7, 2013

Alaska Department of Environmental Conservation (ADEC) Solid Waste Program (Doug Huntman and Rebecca Colvin) conducted a Coastal Impact Assistance Program (CIAP), Waste Erosion Assessment and Review (WEAR) site visit for the Village of Atmautluak on May 7, 2013. Louisa Pavilla and Joann Paul participated on the site visit. The following narrative is a brief description of our findings during the May inspection.

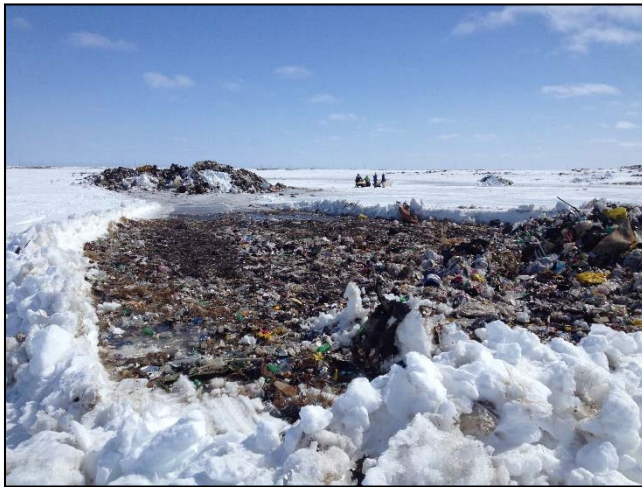
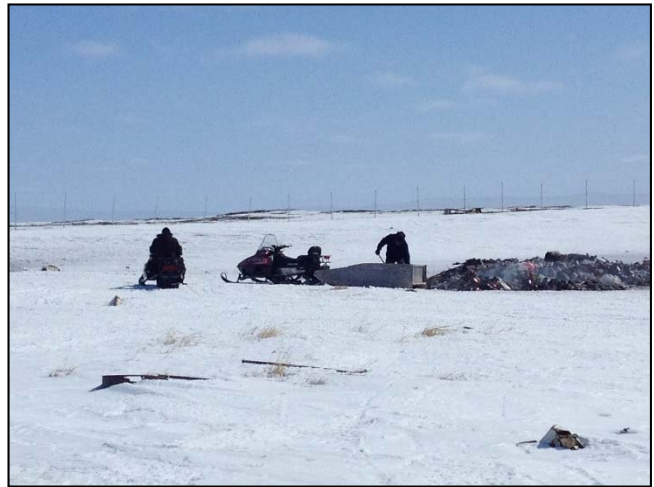
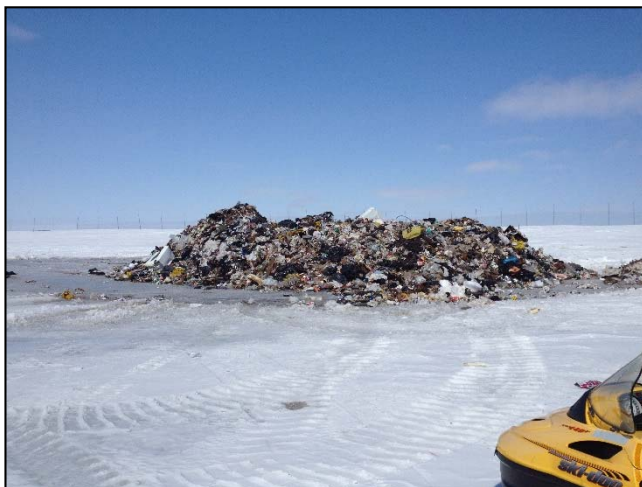
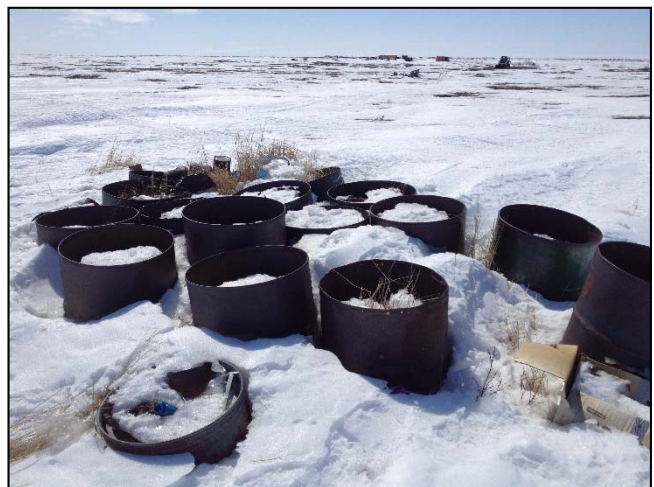
- **Landfill, 60.886144/-162.262077 (Active)** – This unpermitted Class III landfill is located approximately one mile upriver of the runway on the east bank of the Pitmiktakik River. This self-haul landfill is only accessible by boat in the summer and snowmachine in the winter. The 4 acre site has been in operation since the early 1970's and partially utilizes a tundra pond for winter waste disposal. Problems with the site include: open burning, no screening for prohibited wastes, and difficulty accessing the landfill during break-up and freeze-up of the river. The perimeter fence at the site was observed in poor condition and the landfill boardwalk was partially burned from open burning on the ground at the landfill. Management of the site is challenging as there are no sources of locally available landfill cover and equipment usage is only seasonal due to soggy tundra in the summer months around the landfill. It is located approximately 510 feet from the Pitmiktakik River.

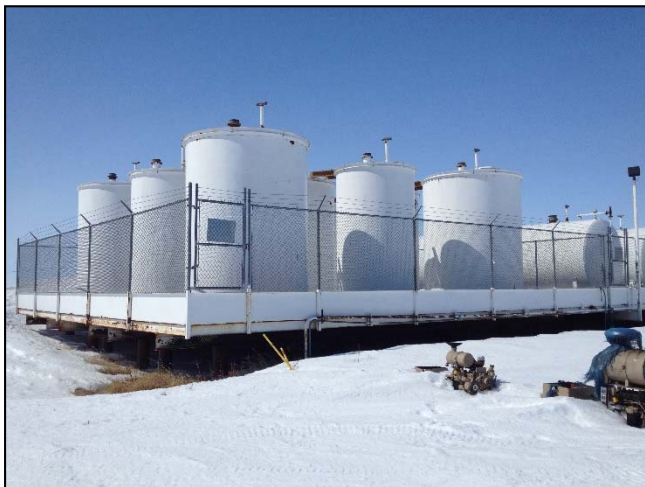
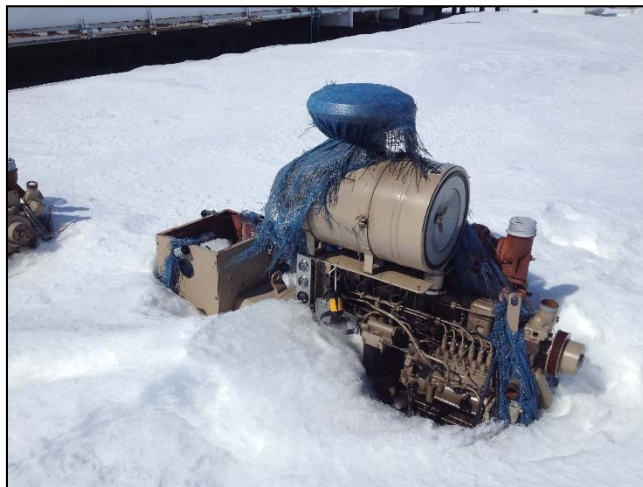
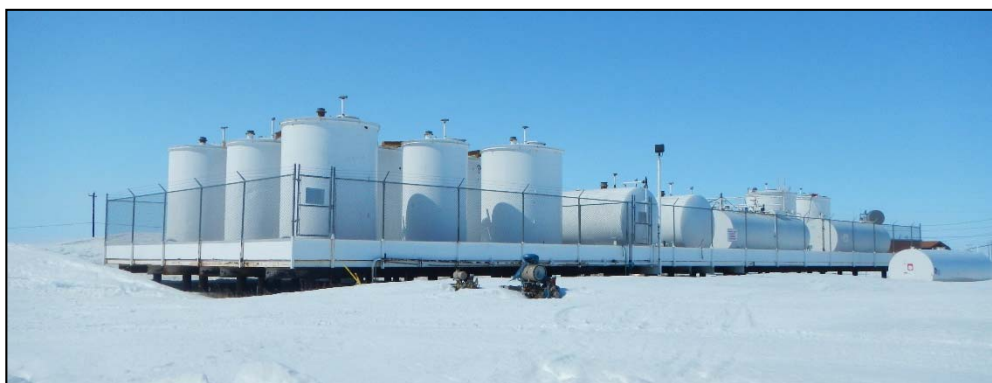
- **Tank Farm, 60.857365/-162.279894 (Active)** – The tank farm is centrally located in town near the power plant and contains 9 vertical, BIA-style fuel tanks and 7 horizontal fuel tanks of unknown sizes. The tank farm is constructed on a raised platform supported by metal pilings and is fully fenced. Old generator equipment was observed outside the tank farm containment. This equipment had not had the fluids removed prior to storage and oil stained soil was observed as a result of the old generators. The site is 503 feet west of the school and 765 feet west of the Pitmiktakik River.

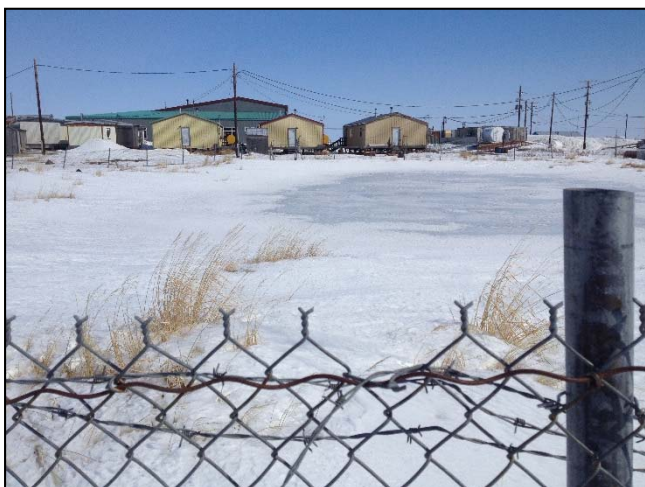
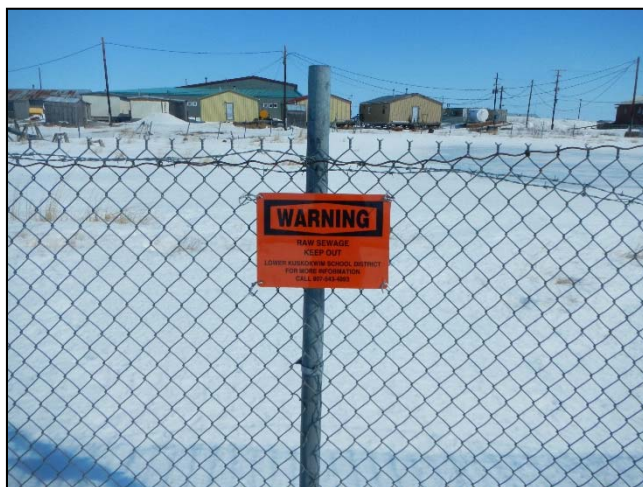
- **School Sewage Lagoon, 60.857122/-162.278171 (Inactive)** – This site is the former sewage lagoon for the Joann A. Alexie Memorial School in the Lower Kuskokwim School District. It was replaced by a sewage composting system at the school. The lagoon had a perimeter fence but, it was in poor condition and falling down in places. This lagoon did not appear to have been used in some time, but had not been closed according to ADEC Solid Waste regulations. It is located 180 feet west of the school and 384 feet west of the Pitmiktakik River.
