CIAP WEAR Trip Report  
Chuathbaluk (population 118)  
September 17, 2014

Alaska Department of Environmental Conservation (ADEC) Solid Waste Program (Doug Huntman and Sarah Durand) conducted a Coastal Impact Assistance Program (CIAP), Waste Erosion Assessment and Review (WEAR) site visit for the Village of Chuathbaluk, September 17<sup>th</sup>, 2014. The following narrative is a brief description of our findings during our September inspection.

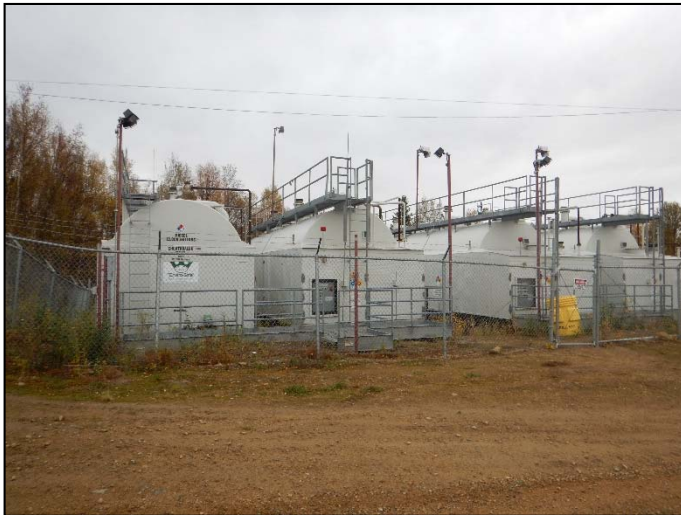
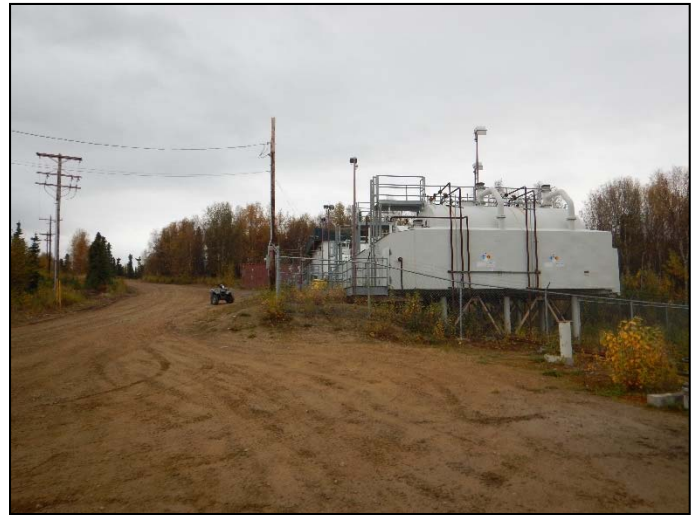
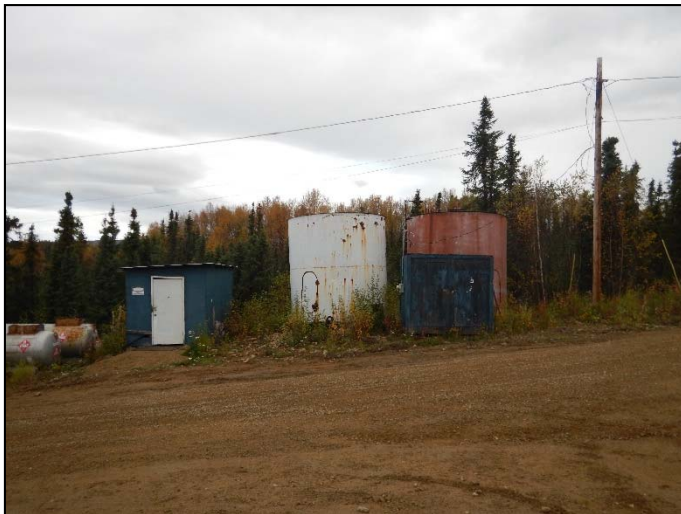
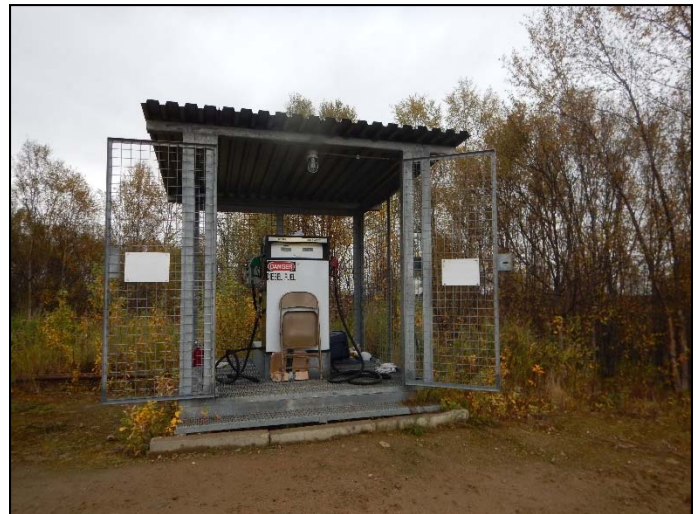
- **Tank Farm, 61.57107/-159.24212 (Active)** — The tank farm is an engineered facility owned by Middle Kuskokwim Electric Cooperative (MKEC) and the City of Chuathbaluk. It was constructed in 2006 through a Denali Commission project. It consists of 4 horizontal, double-walled tanks with a total capacity of 64,000 gallons: 2-12,500 gallon tanks and 2-20,000 gallon tanks. They are each elevated on 5 foot metal pilings as they are constructed on a hillside. The facility is fenced with an unlined containment area underneath. There is also a diesel fueling station across the road for the public. The tank farm is located up on a hillside outside the 100 year flood mark, approximately 300 feet northeast from the Kuskokwim River. Old tanks previously used at this site are stored across the street and at the landfill.

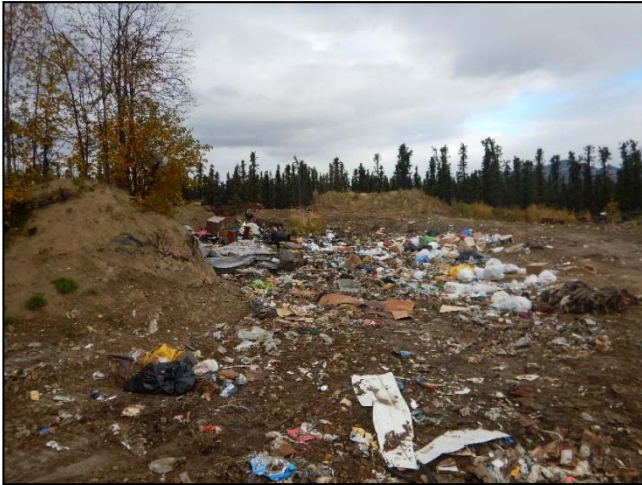
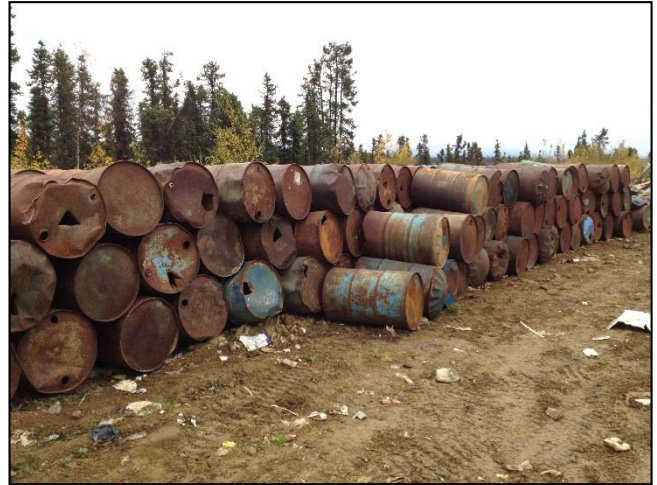
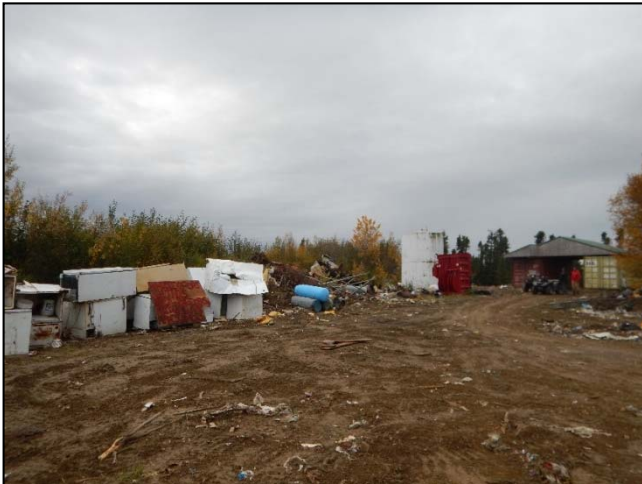
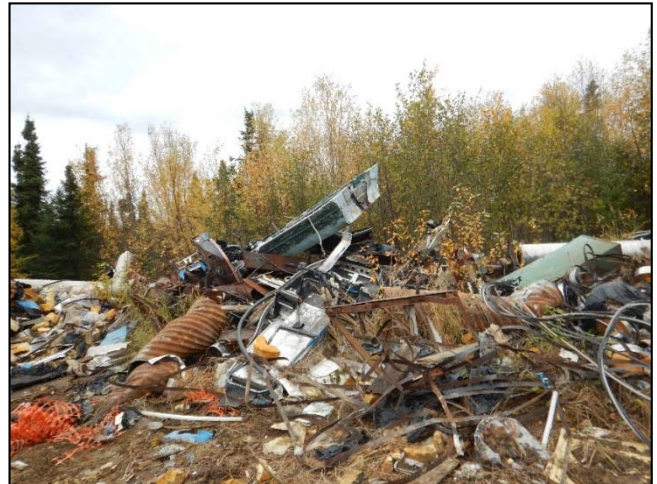
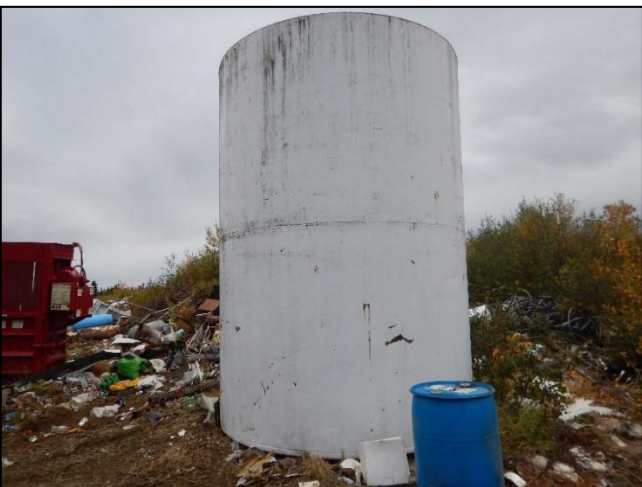
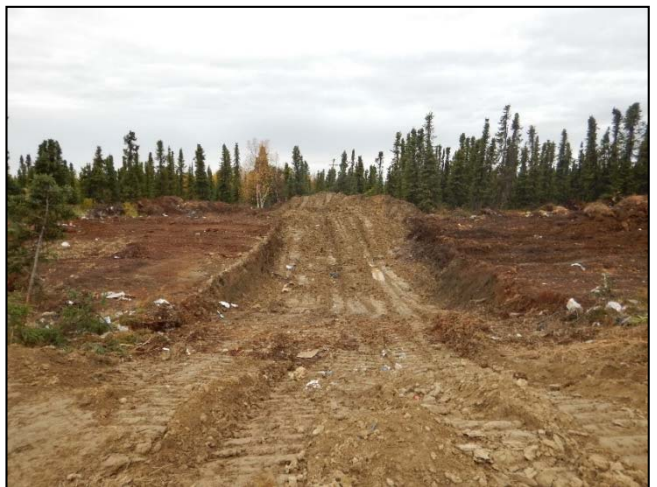
- **Landfill, 61.572624/-159.238262 (Active)** – This unpermitted landfill is operated by the City of Chuathbaluk and is 1 acre in size. It operates as a trench and fill landfill with no fences or berms. It accepts municipal waste and construction and demolition debris. Excavation of a new trench is currently underway. A baler is onsite, but it has never been connected to power and used. There is a large stack of empty drums with holes in them at this site. The local IGAP Coordinator manages a comprehensive recycling and backhaul program. The landfill is located on a hillside approximately 950 foot north of the Kuskokwim River.
