Alaska Department of Environmental Conservation (ADEC) Solid Waste Program (Trisha Bower and Rebecca Colvin) conducted a Coastal Impact Assistance Program (CIAP), Waste Erosion Assessment and Review (WEAR) site visit for the Village of Deering, July 23rd, 2012. Bonita Barr, the Village Tribal Administrator helped coordinate our visit. The following narrative is a brief description of our findings during the July inspection.

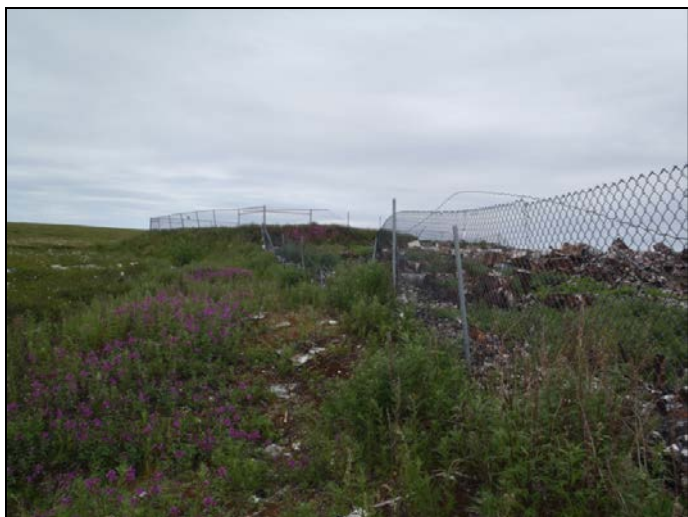
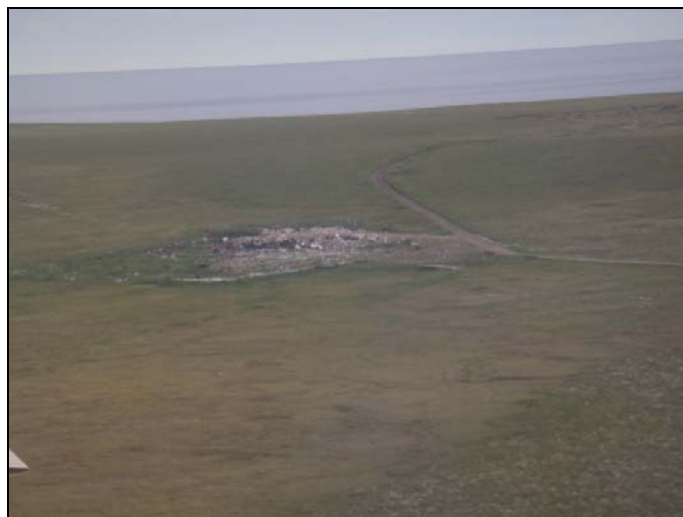
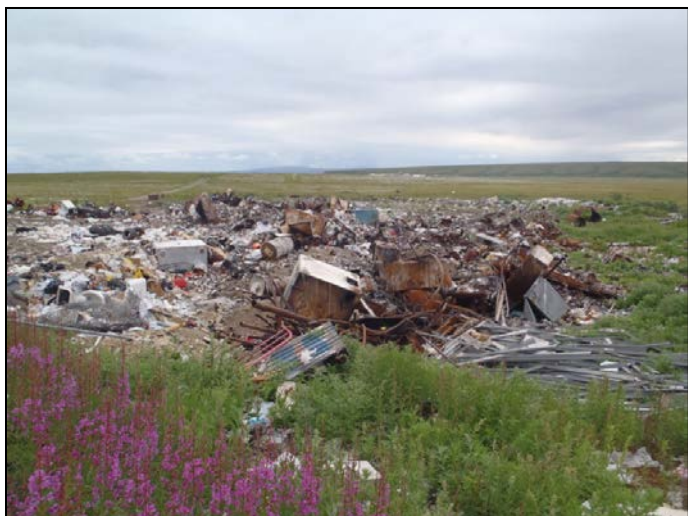
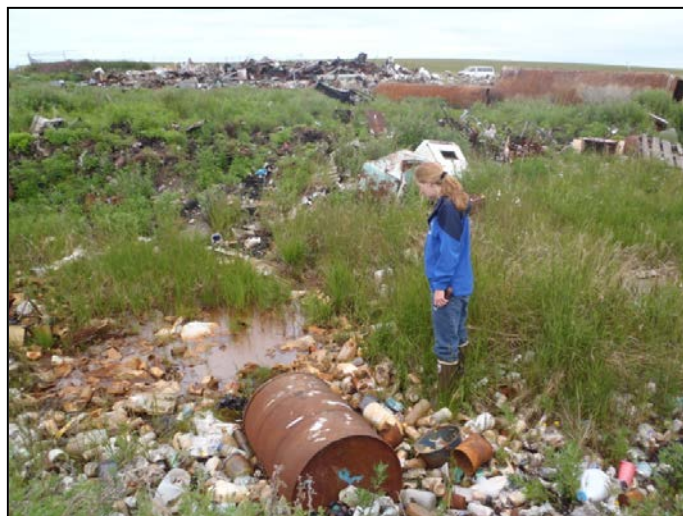
- **Landfill, 66.084456/-162.754956 (Active)** — The landfill is a partially fenced area fill landfill. There is currently a Landfill Operator hired occasionally to manage the landfill. There is inadequate waste separation and diversion and limited recycling/backhaul in Deering. The majority of the community's waste is brought to the landfill by self-haulers. At the time of the inspection both of the IGAP positions were vacant, but they have since been filled and the new staff are using the 2011 inspection as a starting point for making improvements at the landfill. The current landfill is located approximately 1,200 feet inland from the Kotzebue Sound in an elevated area.

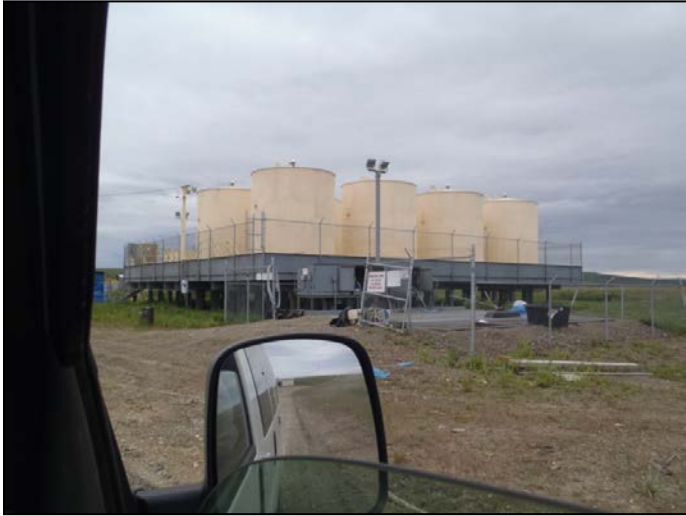
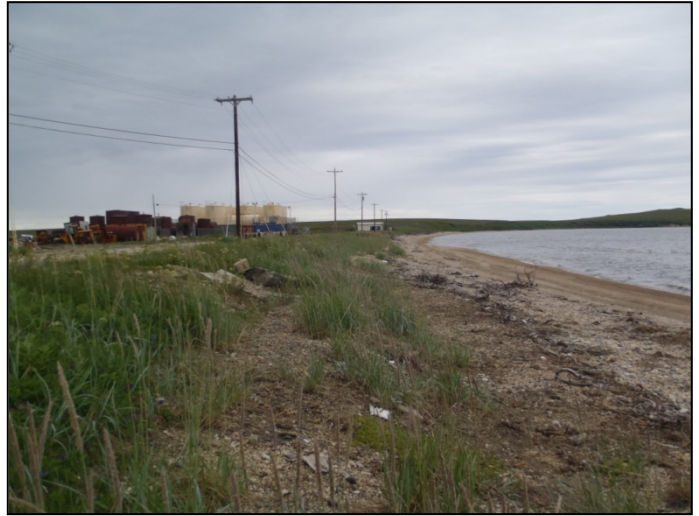
- **Tank Farm, 66.080126/-162.738236 (Active)** – The main tank farm is an engineered facility built in 2005 that includes secondary containment. It is located on a raised pad and is contained within a fenced area. The tank farm is approximately 150 feet from Kotzebue Sound and 1,350 feet from Smith Creek, a tributary of the Inmachuk River. It is protected by concrete pavers installed in the beach near the Kotzebue Sound. However they do not have any erosion control measures installed to prevent erosion from Smith Creek.

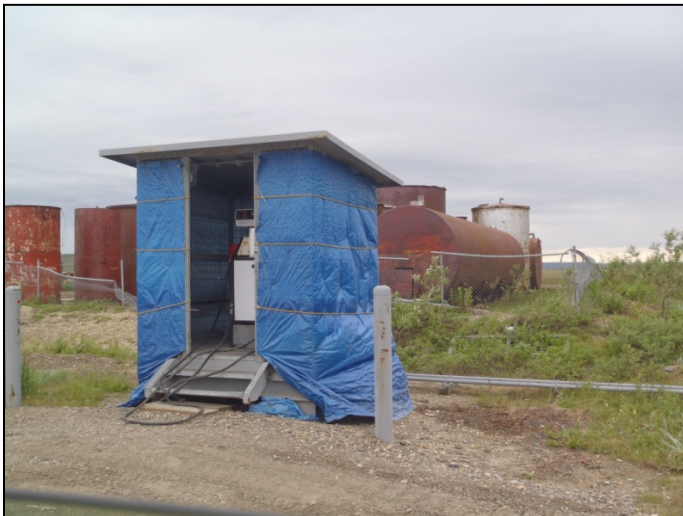
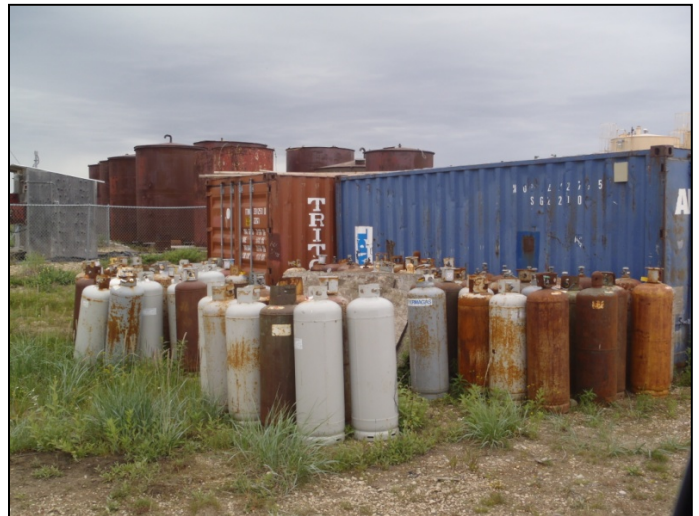
- **Old Tank Farm, 66.079865/-162.737887 (Inactive)** – The old tank farm is located approximately 180 feet from Kotzebue Sound. These are decommissioned tanks that are waiting to be salvaged or backhauled. From 2003-2005 funding was provided by the Denali Commission to construct the new tank farm and decommission this tank farm. It is also protected by concrete pavers installed in the beach near the Kotzebue Sound. However they do not have any erosion control measures installed to prevent erosion from Smith Creek.

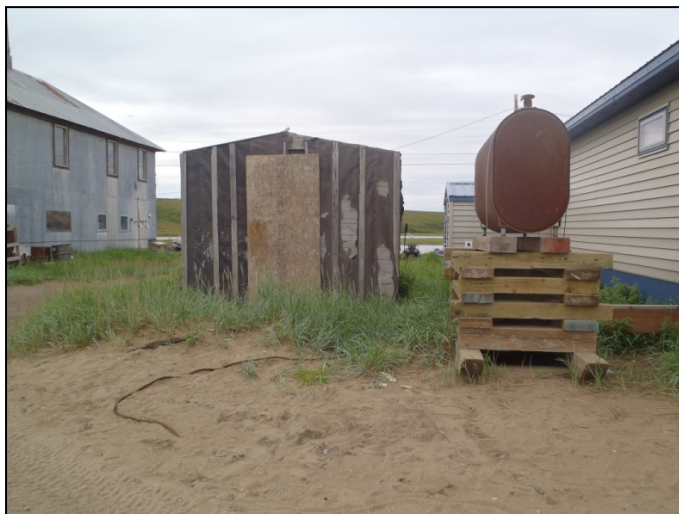
- **Old Generator Building, 66.073944/-162.713710 (Inactive)** – There is a decommissioned generator building located centrally in Deering that was reported to be contaminated with fuel, but has not been characterized according to the Tribal Administrator. The building is located approximately 140 feet from Kotzebue Sound and is located adjacent to the teacher housing, the local store, and a resident's home. The building has been boarded up and is currently not being used.

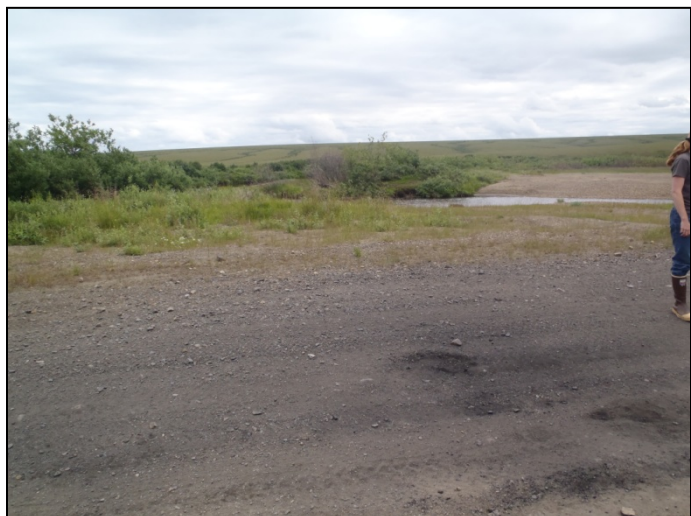
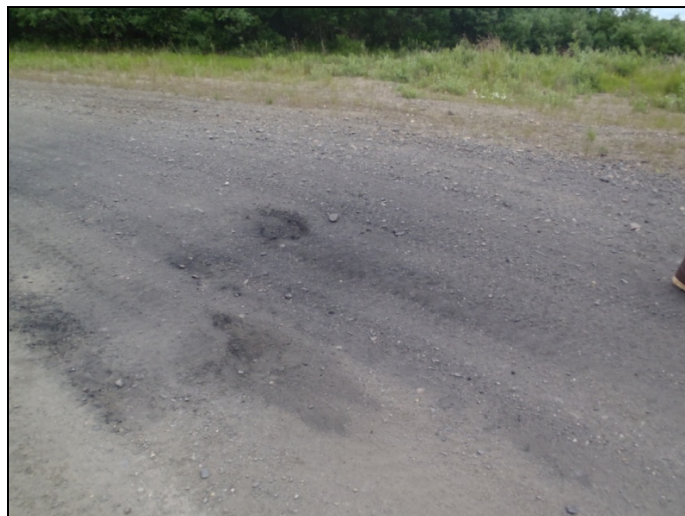
- **Vehicle Collision Site, 66.063789/-162.757371 (Abandoned)** – It was reported that during the airport project, there was a serious vehicle collision involving two large military grade trucks. The contractor was using a convoy of these trucks to haul gravel on a one-lane road. They miscounted the trucks and allowed two trucks on the road at the same time heading towards each other. The vehicles collided in a head-on accident that resulted in injuries to the drivers and destruction of the vehicles. The vehicles caught fire and expelled most of their fluids directly on the ground less than 50 feet from the Inmachuk River.

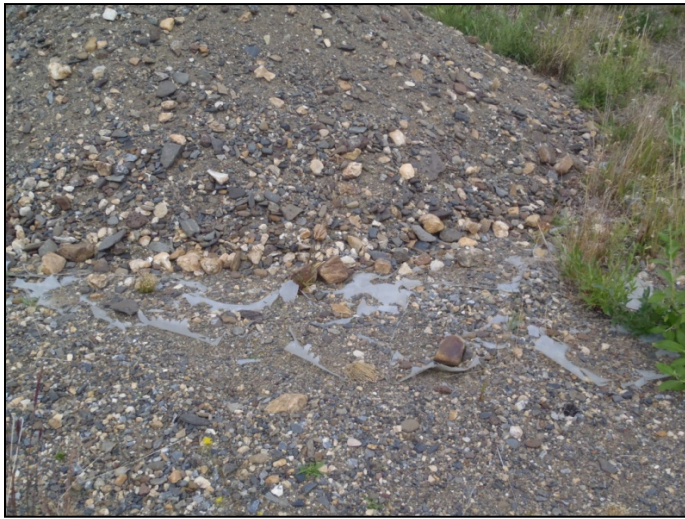
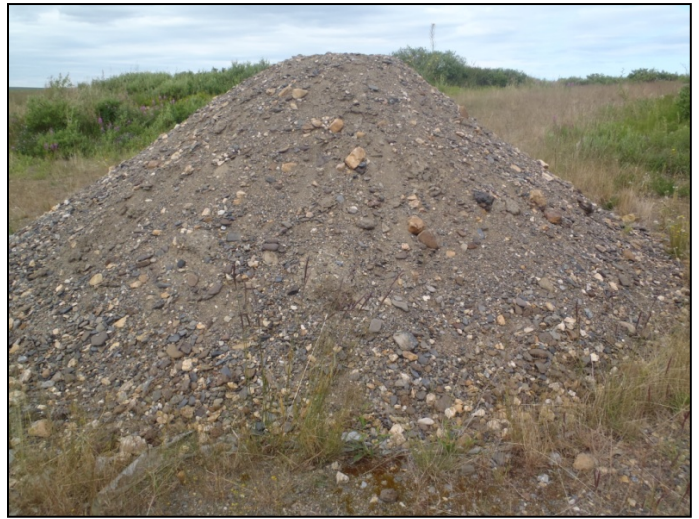
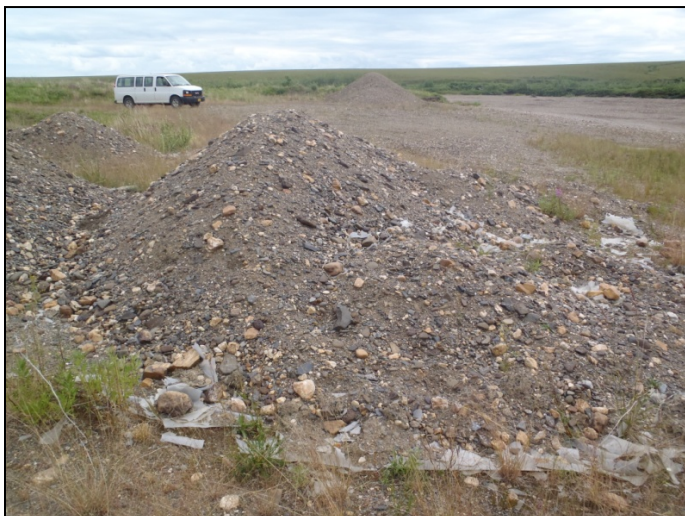
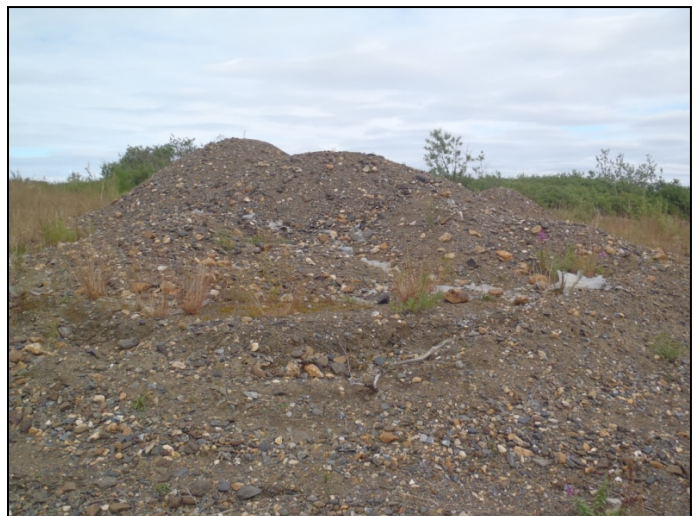
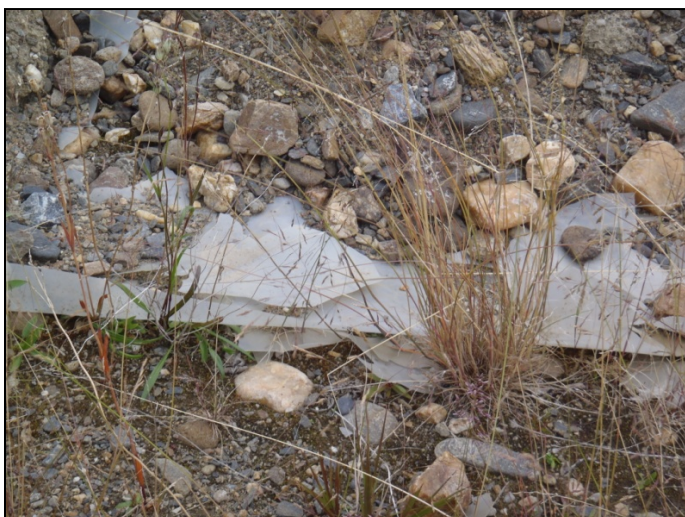
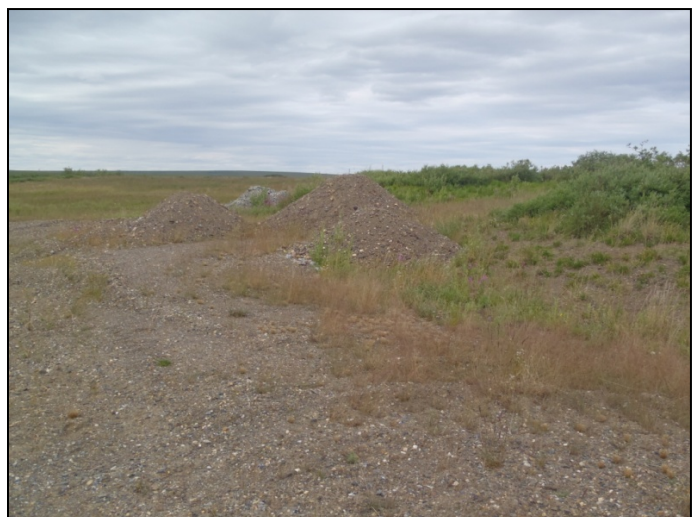
- **Diesel Fuel Spill, 66.052925/-162.785989 (Abandoned)** – It was reported that during the airport project an outside contractor spilled diesel fuel while extracting gravel. The fuel was spilled 150 feet from the Inmachuk River. The contaminated soil was consolidated into several small piles on plastic sheeting. The outside contractor is now out of business according to the Tribal Administrator.
