CIAP WEAR Trip Report
Kongiganak (population 456)
July 9, 2013

Alaska Department of Environmental Conservation (ADEC) Solid Waste Program (Doug Huntman and Jacob Timmons) conducted a Coastal Impact Assistance Program (CIAP), Waste Erosion Assessment and Review (WEAR) site visit for Kongiganak on July 9th, 2013. Roland Andrew, Tribal Coordinator, and Dalores Lozano, Environmental Coordinator participated in the site visit. The following narrative is a brief description of our findings during the July inspection.

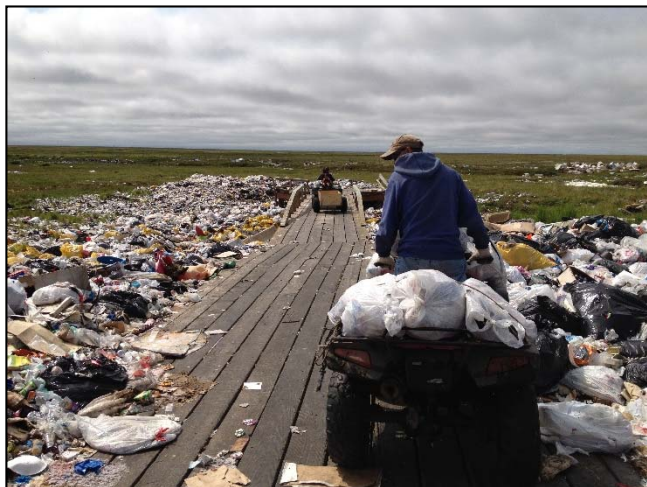
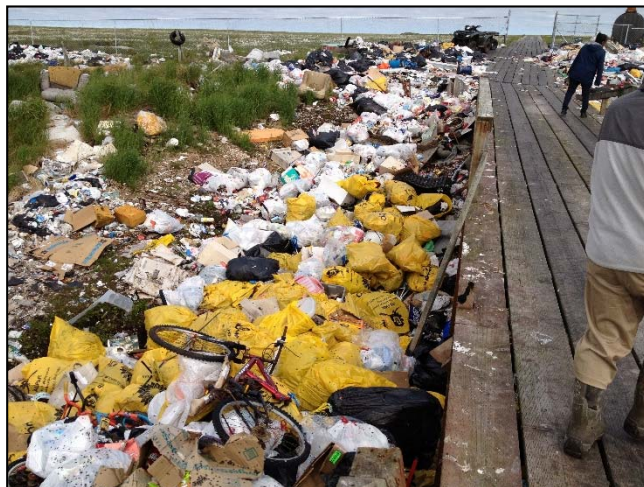
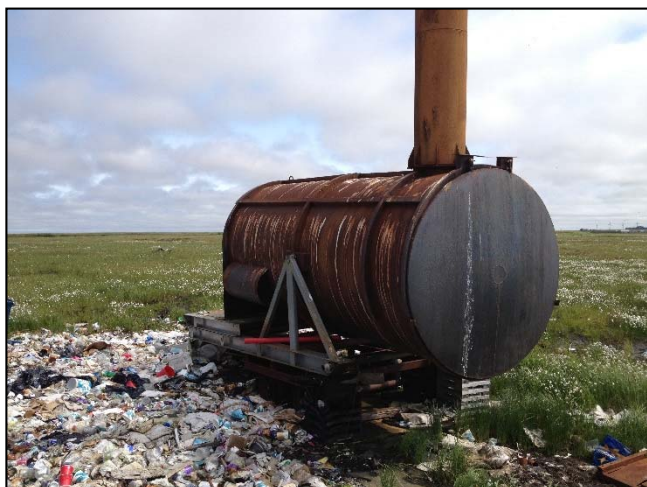
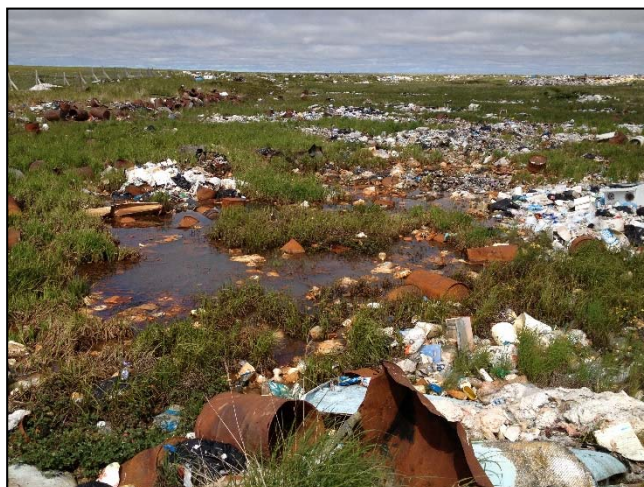
- **Landfill, 59.964824/-162.915424 (Active)** – The Kongiganak Landfill is roughly 9 acres in size and is located .7 miles directly northwest of the village. The site is managed on an “as needed” basis and is only partially fenced. No equipment is available in the village to maintain the site. The Village does not control access to the site, there are no restrictions as to what is thrown away, and residents only option is to self-haul waste to the landfill. Waste is disposed of along an elevated boardwalk that accesses the center of the landfill. The end of the boardwalk is partially collapsed due to improper disposal. There are no operations in place to reduce the volume of waste at the landfill. It has a newer Tok burn unit designed for burning household waste; however, the unit did not appear to have been used in some time. It was observed that electronic equipment, lead-acid batteries, unlabeled barrels, and other household hazardous wastes were disposed of in the landfill at the time of the July inspection. It is 265 feet from the Kongnignanohk River.

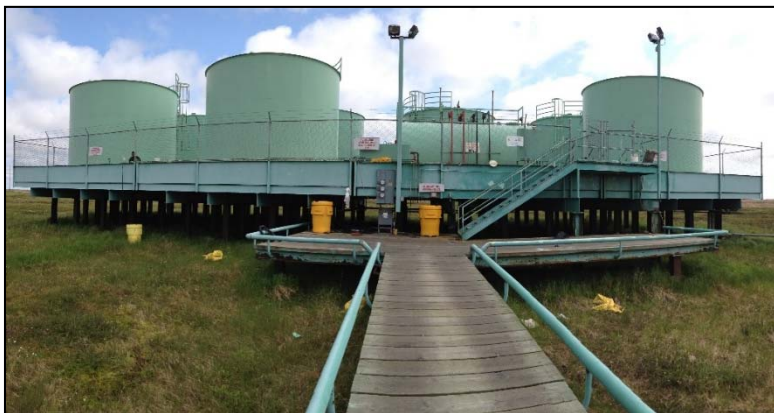
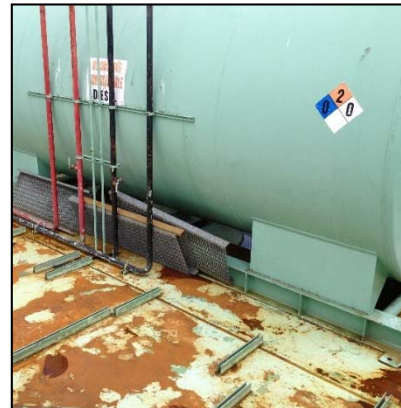
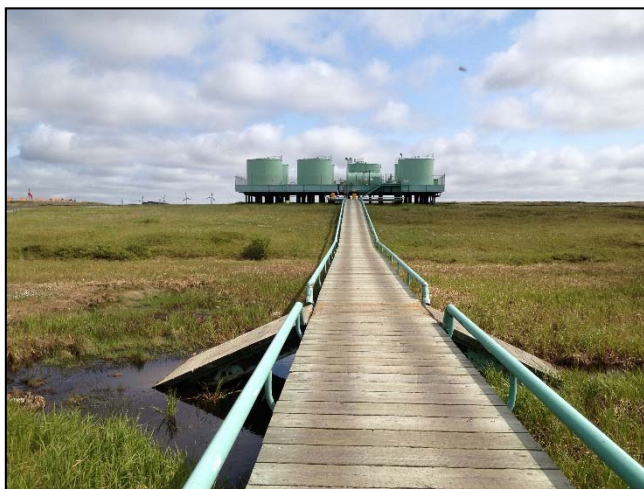
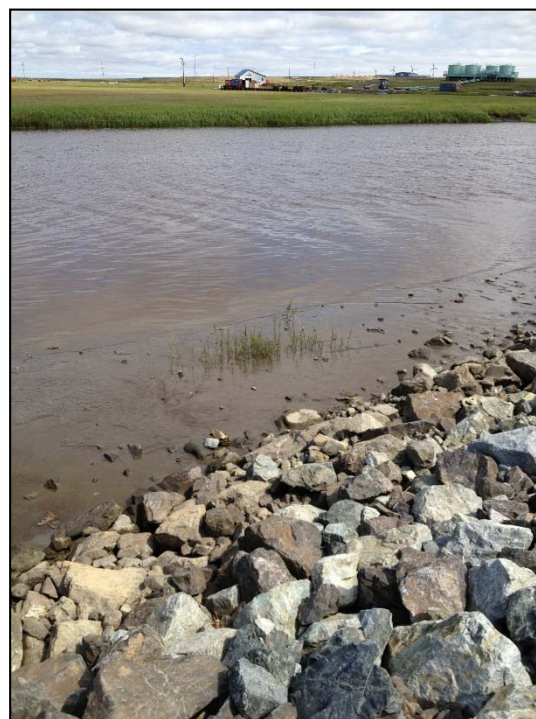
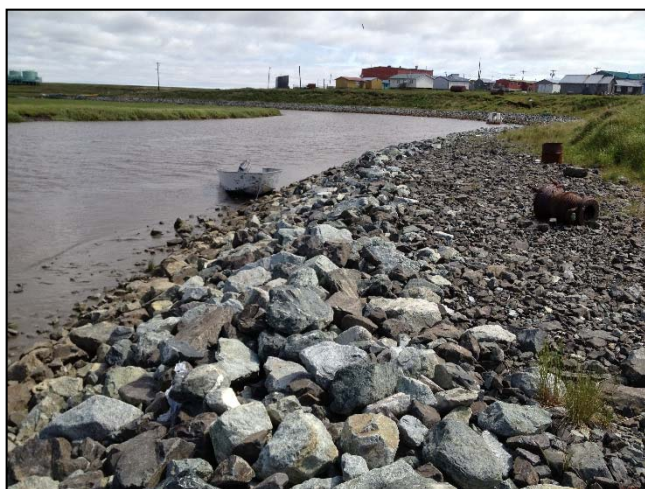
- **Tank Farm, 59.961212/-162.884781 (Active)** – The Kongiganak tank farm has a bulk storage built in 2003. This tank farm is a cooperative effort between the Qemirtalek Coast Corporation (QCC), the Kongiganak Traditional Council (KTC), the Lower Kuskokwim School District (LKSD) and the Alaska Energy Authority. QCC is the manager and operator for the tank farm. A welded steel platform on pilings, elevated about four feet above the tundra supports the site. The total area of the site is 7,700 square feet and includes 7 vertical tanks and one horizontal tank with a total capacity of 348,000 gallons. A steel dike wall, three feet high surrounds the tank farm at the perimeter. All tanks are a single wall, welded steel construction. It is located approximately 800 feet from the Kongnignanohk River. The Army Corps of Engineers 2009 Baseline Erosion Assessment (BEA) lists this section of river eroding at 3.8 feet per year. A gravel revetment has been installed along the eastern shore of the riverbank starting just south of the barge landing.

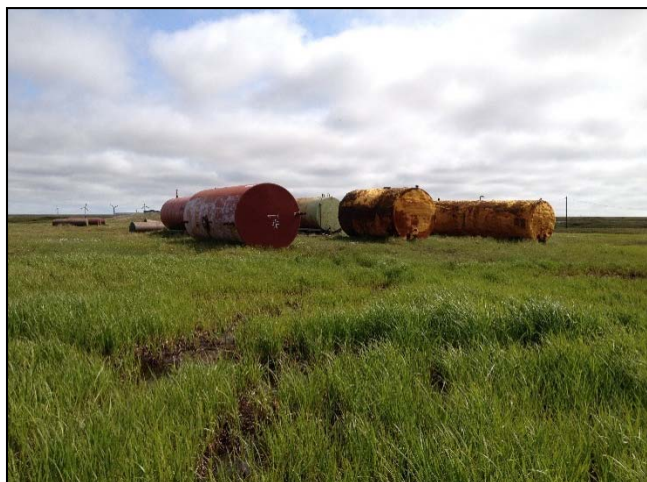
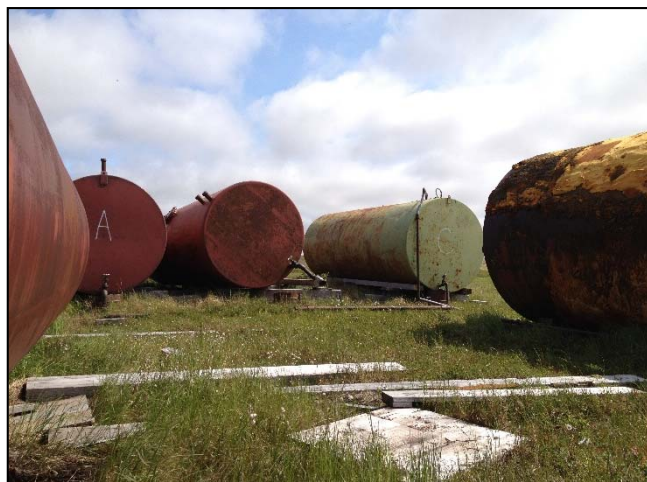
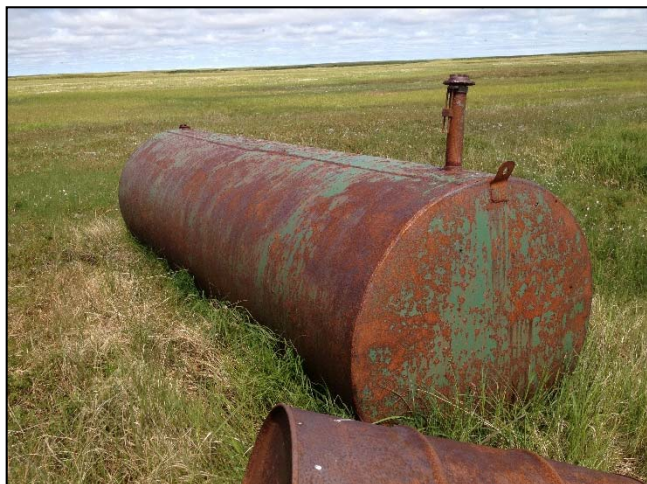
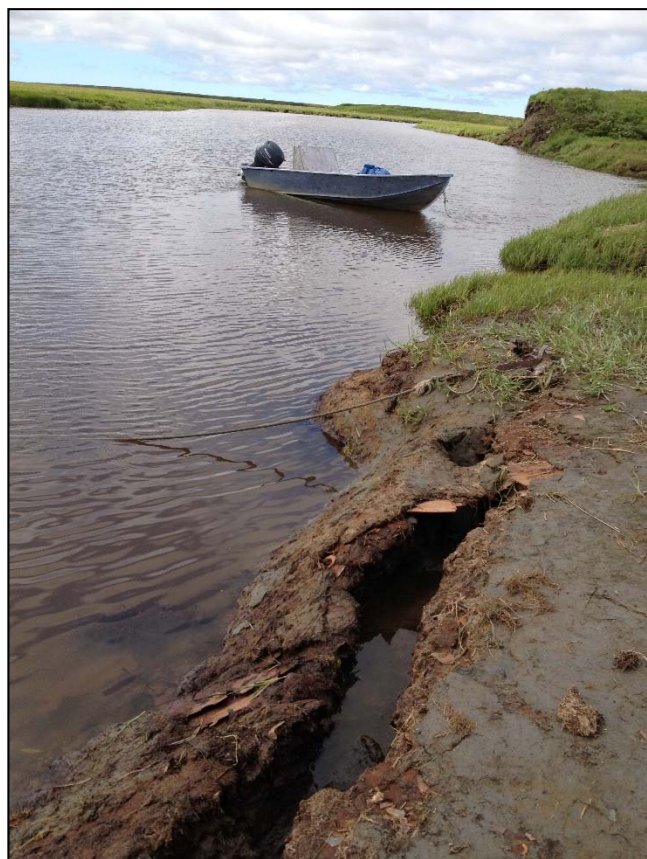
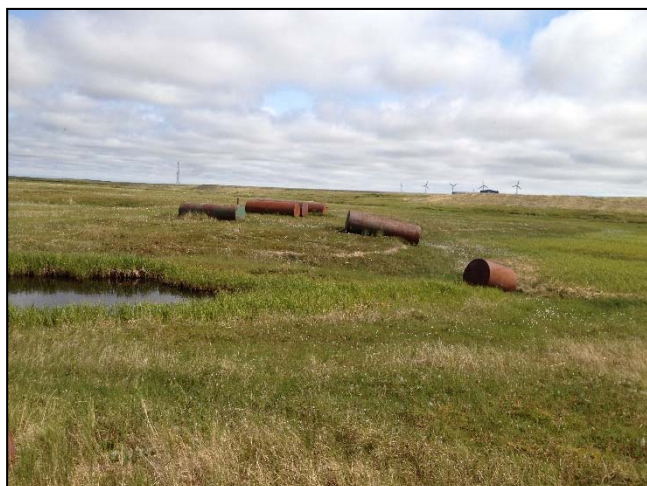
- **Qemirtalek Coast Corp Tank Farm, 59.963421/-162.886607 (Active)** – This is a former Qemirtalek Coast Corporation tank farm which has not been in use since the new tank farm constructed in 2003. It is a known Contaminated Site (File ID 2454.38.002) due to petroleum contamination. There are around 24 tanks with the largest tanks around 18,000 gallons. Most have been moved here from other locations throughout Kongiganak. All were reported to be emptied. Estimated age of the tanks is from the 1970's. This site is 775 feet northwest of the new tank farm and less than 300 feet from the Kongnignanohk River. The river at this bend is reported to erode at 1.5 feet a year per the BEA study.
