Alaska Department of Environmental Conservation (ADEC) Solid Waste Program (Trisha Bower and Kym Bronson) conducted a Coastal Impact Assistance Program (CIAP), Waste Erosion Assessment and Review (WEAR) site visit for the Village of Nuiqsut, August 19th, 2013. Tom Nicolos, the North Slope Borough Airports and Landfills Manager, helped coordinate our visit. The following narrative is a brief description of our findings during the August inspection.

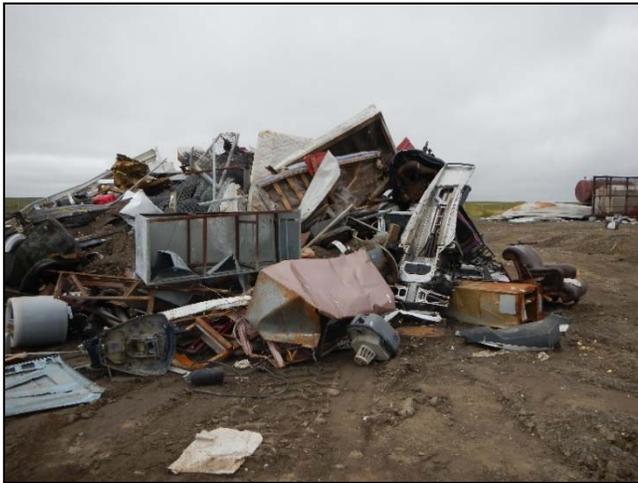
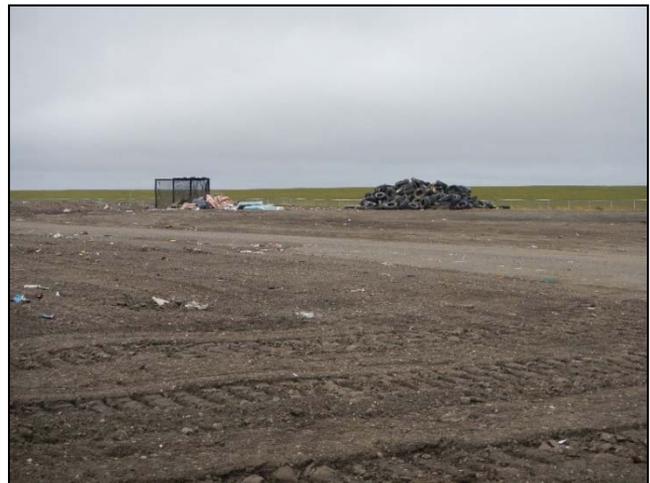
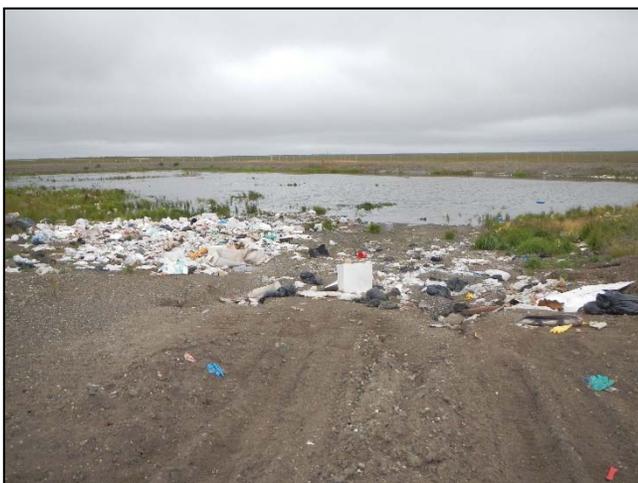
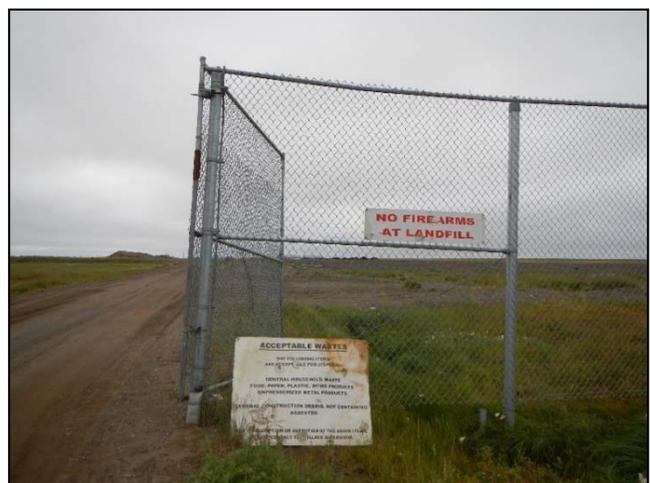
- **Landfill, 70.226421/-151.056011 (Active)** — The permitted landfill is operated by the North Slope Borough Public Works Department. It is fully fenced and operated as an above-ground trench and fill landfill with a functioning burn unit. The North Slope Borough allows only municipal waste and construction and demolition waste from Nuiqsut residents to be placed in the landfill without prior approval. Waste from special projects may be allowed if the project submits an application to the North Slope Borough, and it is approved. ADEC approval is required in the North Slope Borough application process for polluted soil and other special wastes. There is currently a small amount of soil being land farmed at the landfill for remediation. This facility is located approximately 5100 feet from the Nechelik Channel of the Colville River Delta.

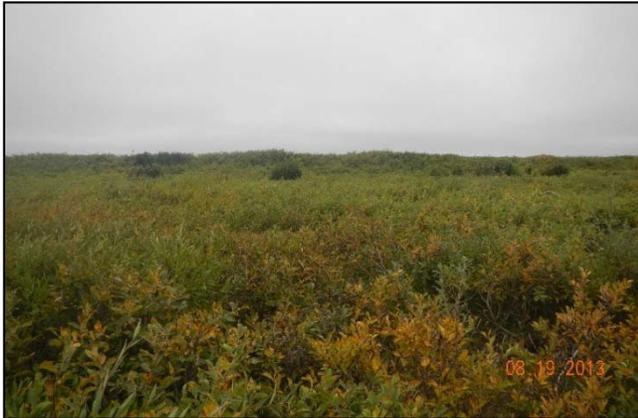
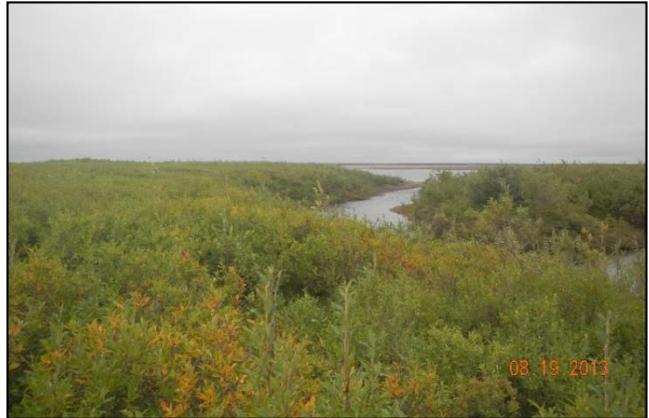
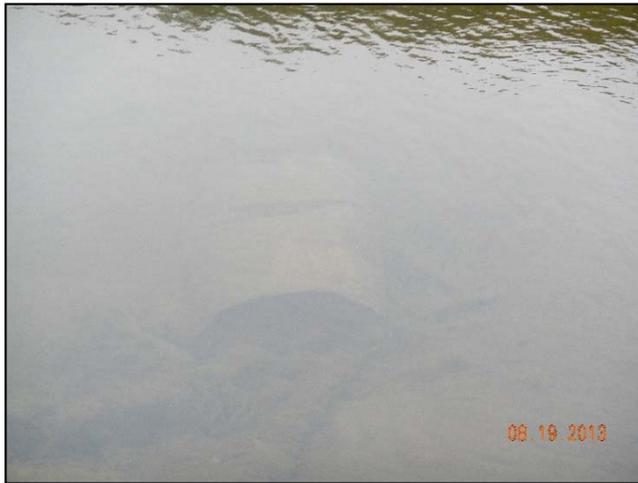
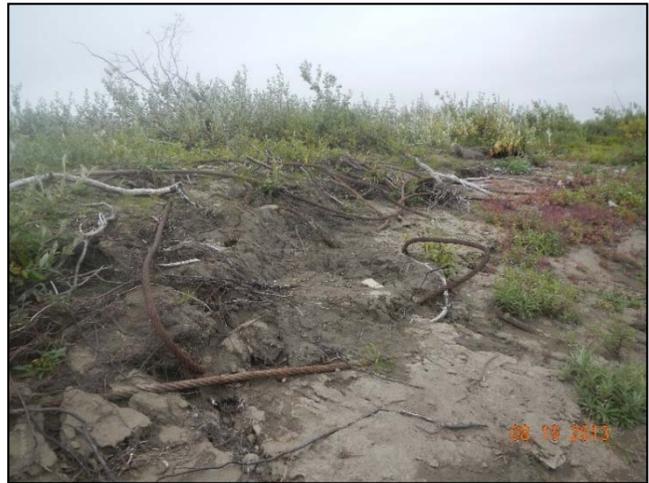
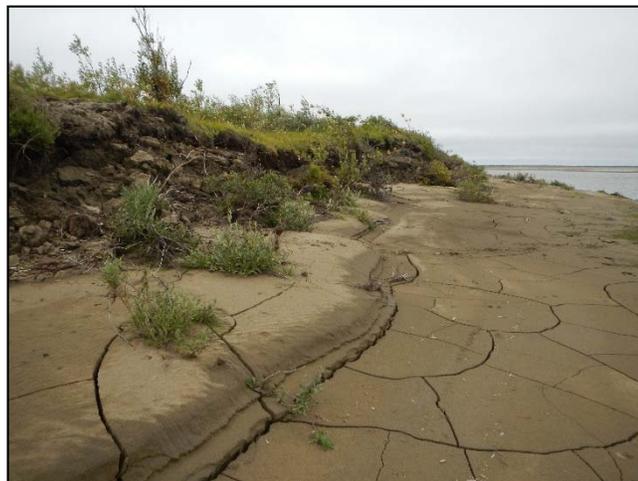
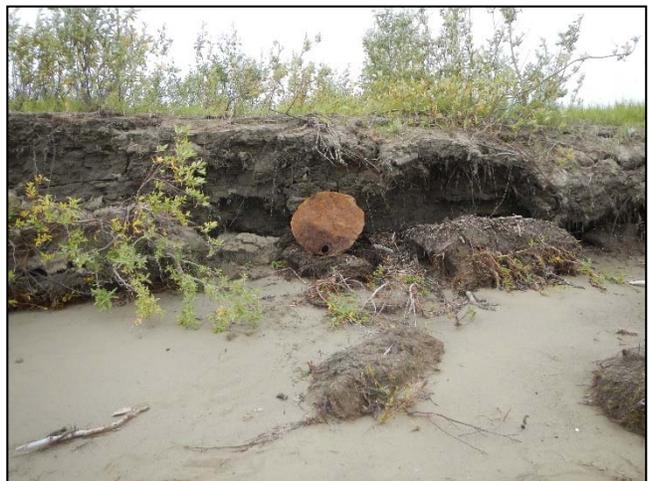
- **Pingo Beach Landfill, 70.088333/-151.030155 (Abandoned)** – This site is located approximately 9 air miles south of Nuiqsut. This site was visited by the Solid Waste Program, the Contaminated Sites Program and the Army Corps of Engineers in response to public complaints that possible military debris was eroding out of this landfill. There was minimal documentation on this site. It was unknown if it was military in origin, if it had already eroded away, or if it was in the beginning stages of eroding. The site visit was inconclusive as there wasn't any waste observed that could be directly tied to the site and identified as military waste. This site will be monitored, and the community members agreed to notify all of the above participants if additional material is found in the future after a storm or break-up event. This site is located 5-10 feet from the Colville River.

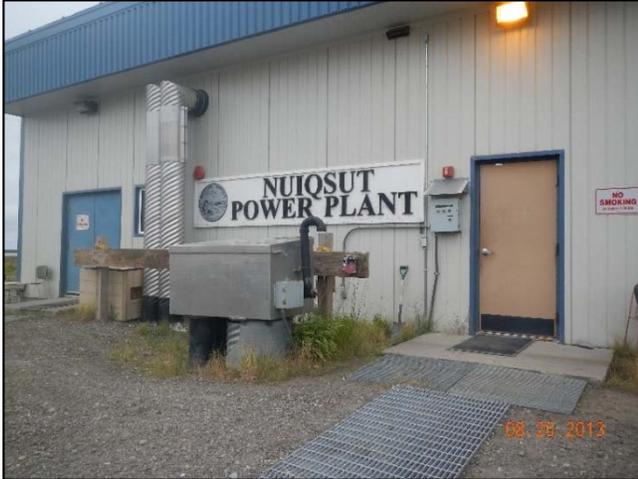
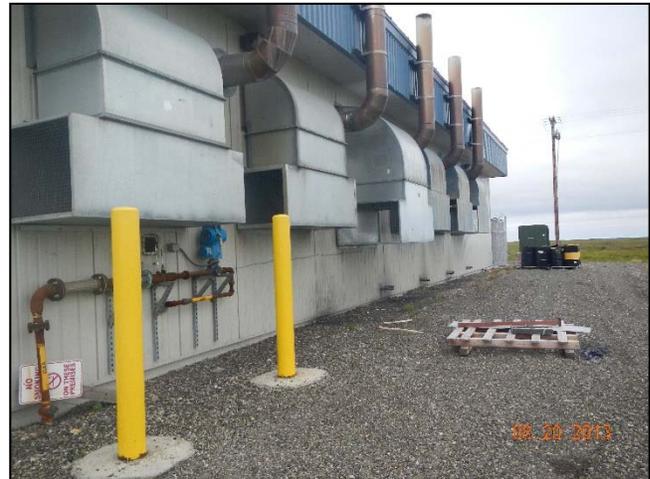
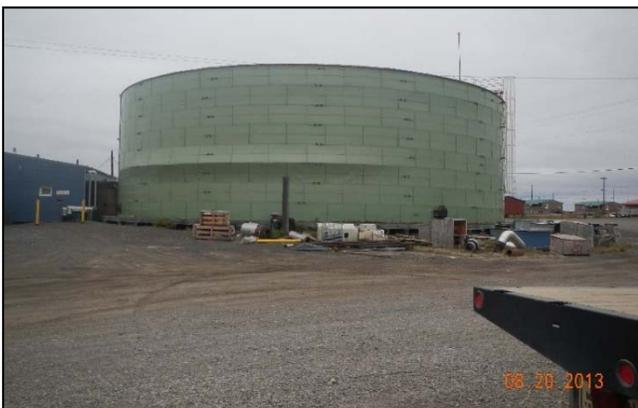
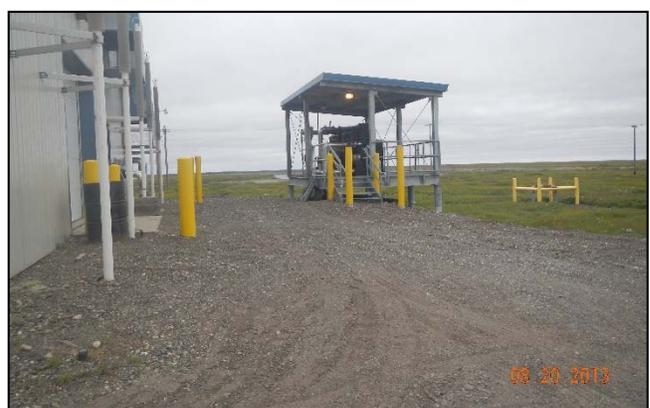
- **Power Plant, 70.220340/-150.994868 (Active)** – This is a known Contaminated Site (File ID 370.38.001) with the North Slope Borough as the Responsible Party. In July 2012 during excavation activities to install underground diesel fuel piping between the North Slope Borough power plant and washeteria, petroleum-contaminated soil was discovered. Field testing was conducted in 2012 and 2013, and further work was recommended to determine the extent of contamination. The Nechelik Channel of the Colville River Delta is 510 feet directly east of this site.

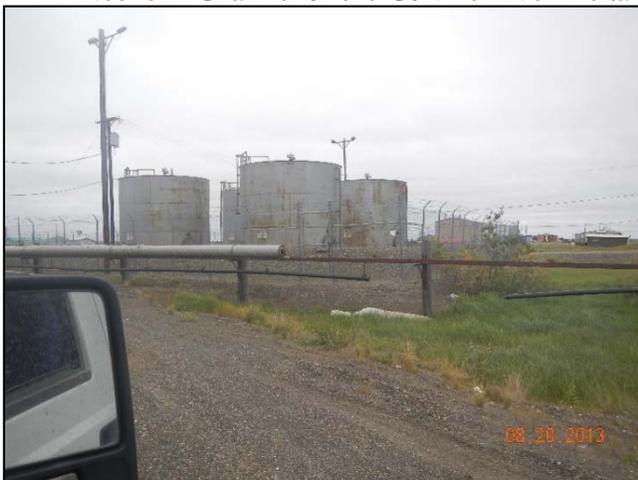
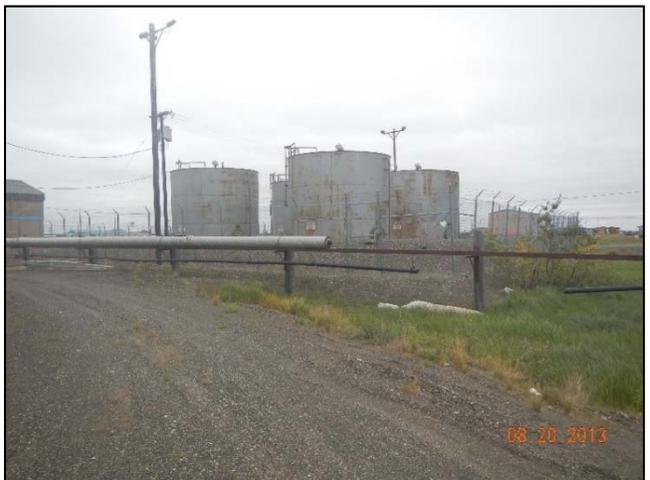
- **Tank Farm, 70.220382/-150.996380 (Active)** – This is a tank farm that runs the adjacent Nuiqsut Power Plant and other North Slope Borough facilities. There are four vertical fuel tanks at the facility within a locked, fenced area. This site is located approximately 620 feet from the Nechelik Channel of the Colville River Delta.

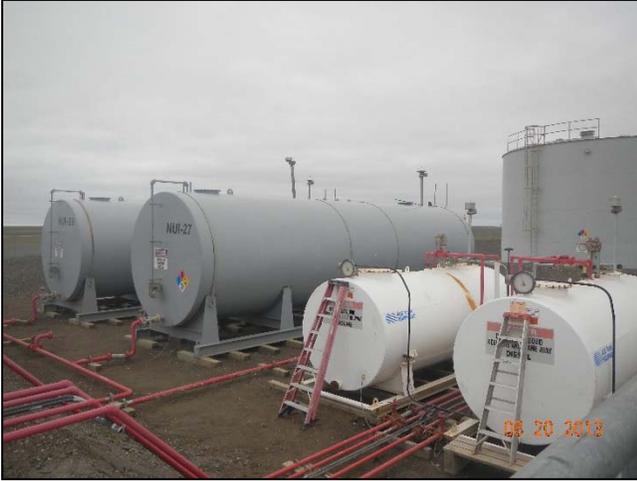
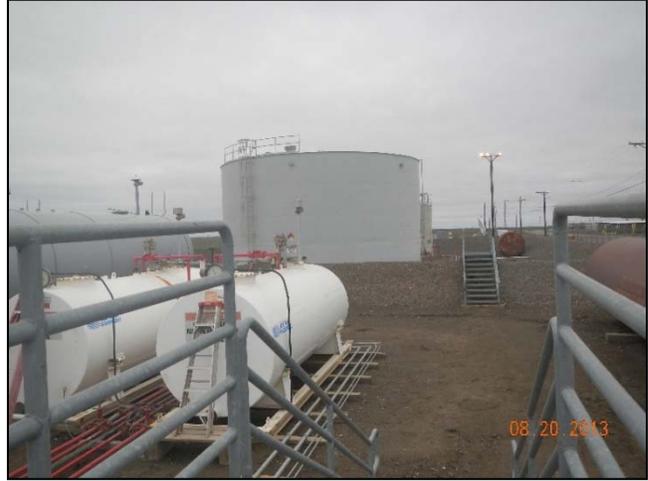
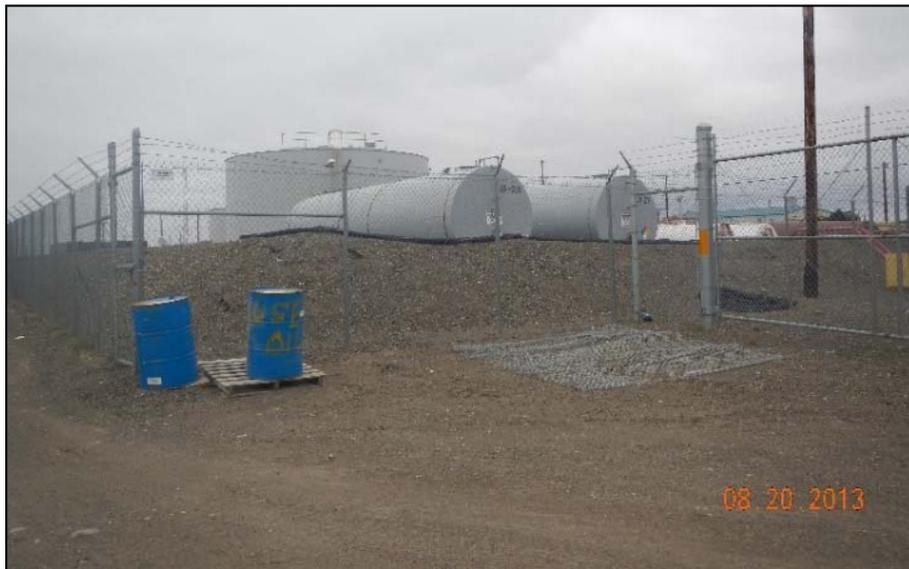
- **NSB Tank Farm, 70.213686/-150.998848 (Active)** – This is a tank farm located near the runway apron and is owned and operated by the North Slope Borough. It is regulated by the DEC Terminals and Tank Farms Section. There were multiple vertical and horizontal tanks at the facility that have a total capacity of 488,124 gallons. The site is raised above grade within a fenced and locked area. It is located approximately 1670 feet from the Nechelik Channel of the Colville River Delta.
