Alaska Department of Environmental Conservation (ADEC) Solid Waste Program (Trisha Bower and Kym Bronson) conducted a Coastal Impact Assistance Program (CIAP), Waste Erosion Assessment and Review (WEAR) site visit for the Village of Point Hope, August 25th, 2014. Tom Nicolos, the North Slope Borough Airports and Landfills Manager, helped coordinate our visit. The following narrative is a brief description of our findings during the August inspection.

WEAR Sites

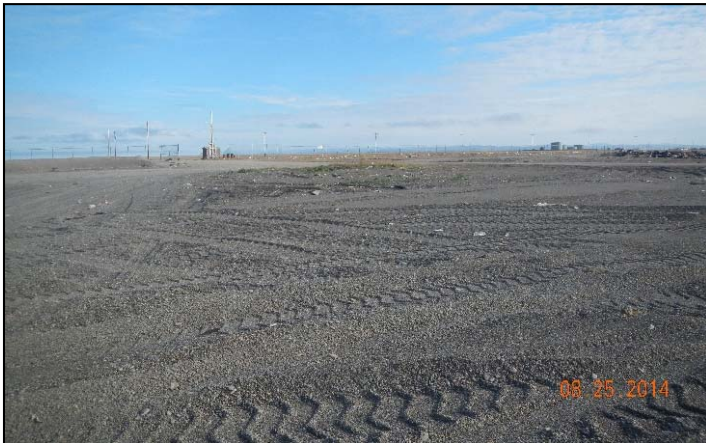
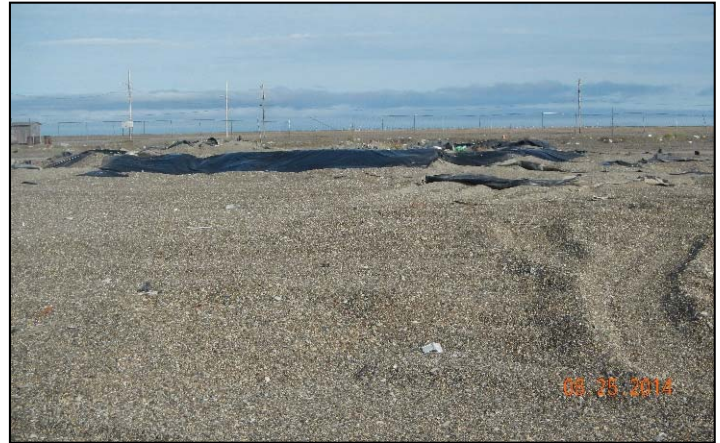
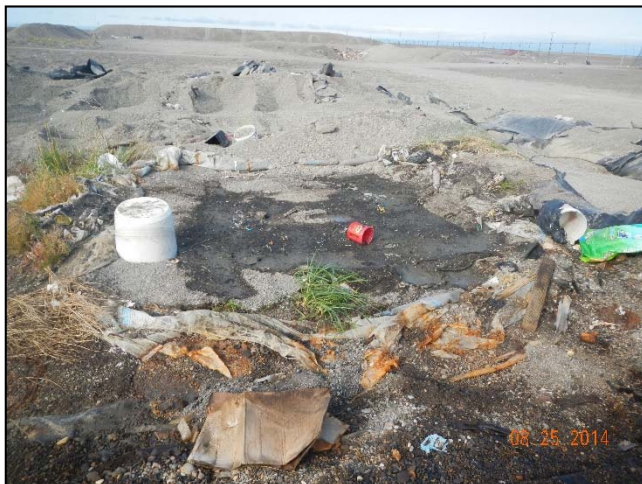
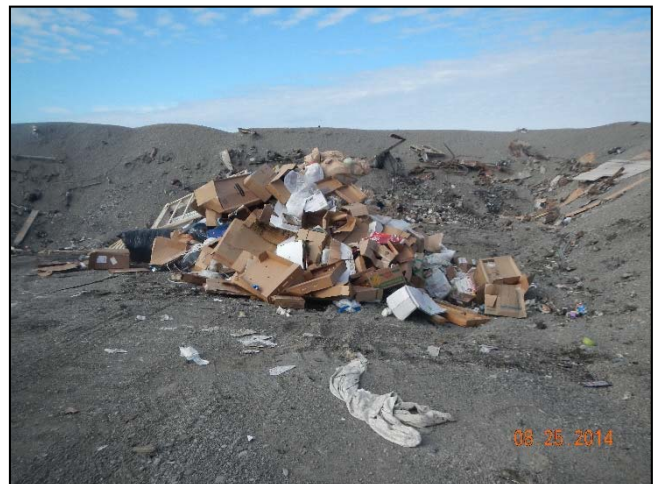
- **Landfill, 68.345217/-166.785069 (Active)** — This permitted landfill is operated by the North Slope Borough (NSB) Public Works Department. The landfill is approximately 11 acres and is operated as a trench and fill design. It was constructed around 1983 and accepts municipal waste, construction and demolition debris (C&D), and sewage sludge. The NSB allows only waste from Point Hope residents to be placed in the landfill. Waste from special projects may be allowed if the project submits an application to the NSB, and it is approved by NSB and ADEC. The site is fully fenced; however some areas are in need of repair. There are separate trenches for municipal waste, C&D, and sewage sludge. There is currently a bermed area that includes polluted soil that needs to be tested in the center of the landfill. This facility is located approximately 320 feet from the Chukchi Sea.

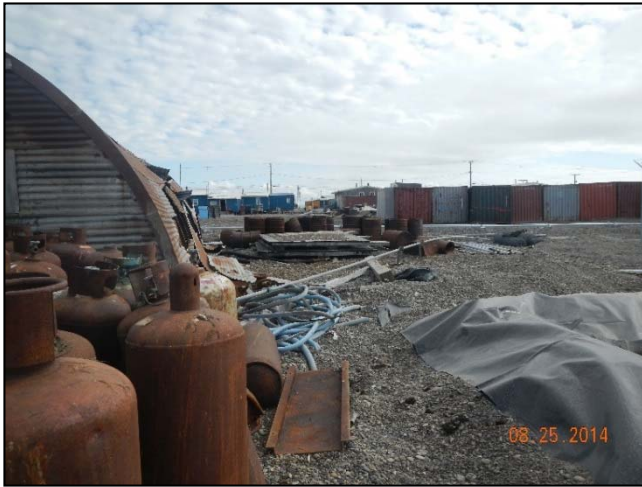
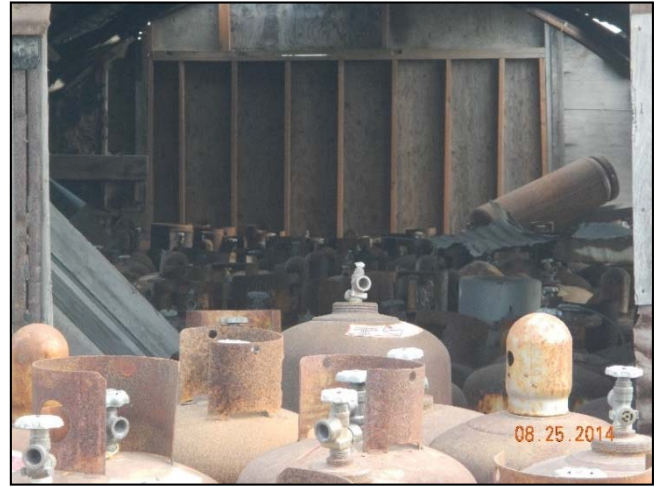
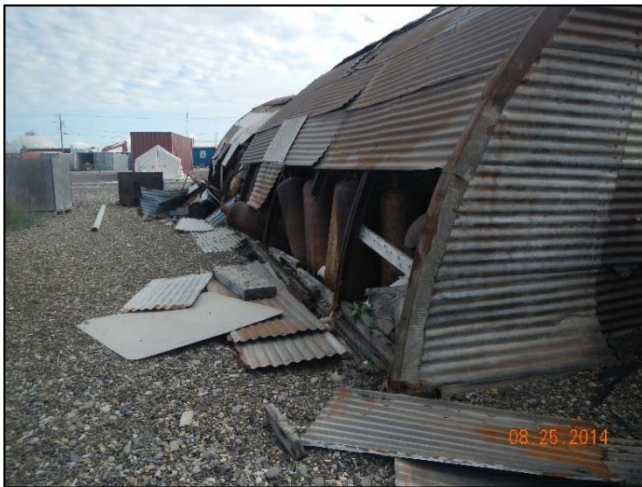
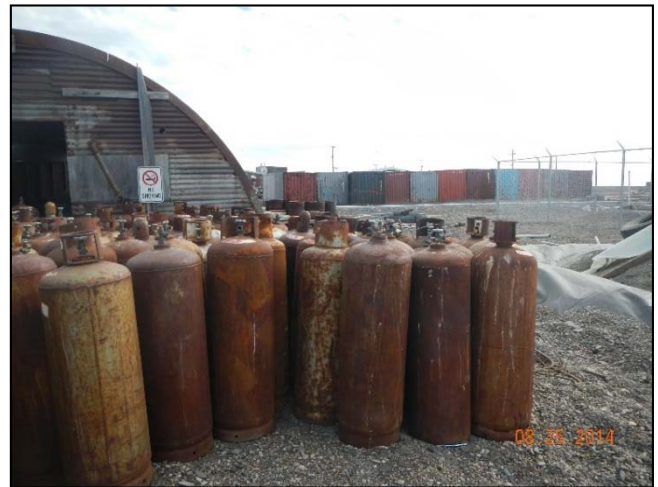
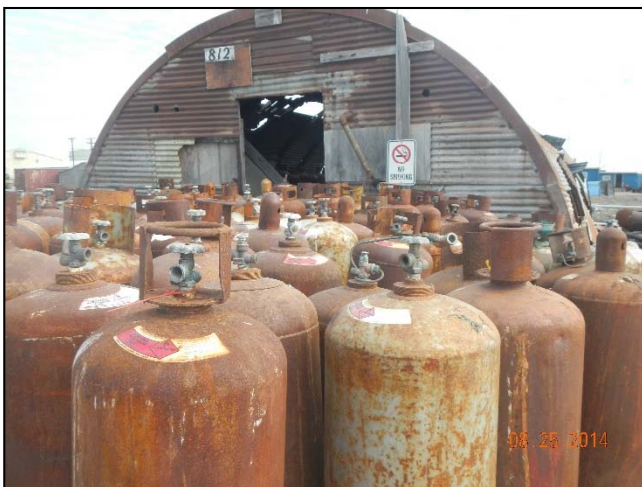
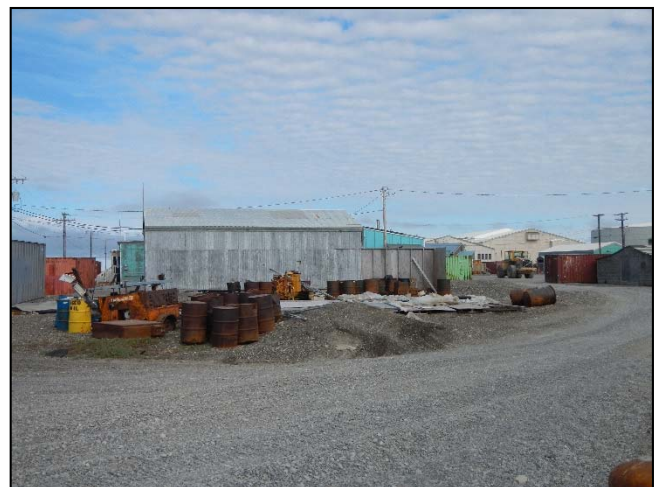
- **Quonset Propane Tanks Storage, 68.347634/-166.739685 (Active)** – This site is located in the southwest of the community, on the north side of the fueling station. It consists of a dilapidated Quonset hut full of rusted propane tanks with more propane tanks and 55 gallon drums with unknown contents outside the building. The site is not fenced and is accessible to the public. The owner of the site is unknown. This site is approximately 1,200 feet from the Chukchi Sea.

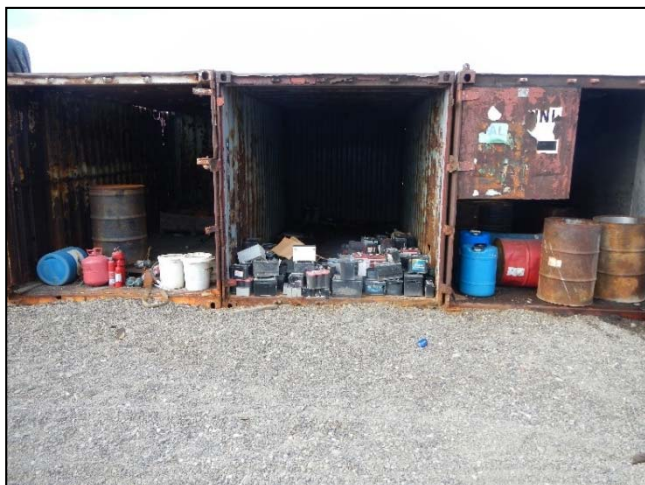
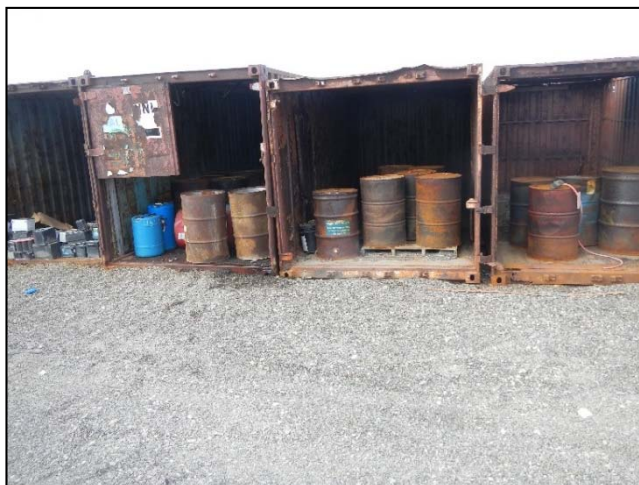
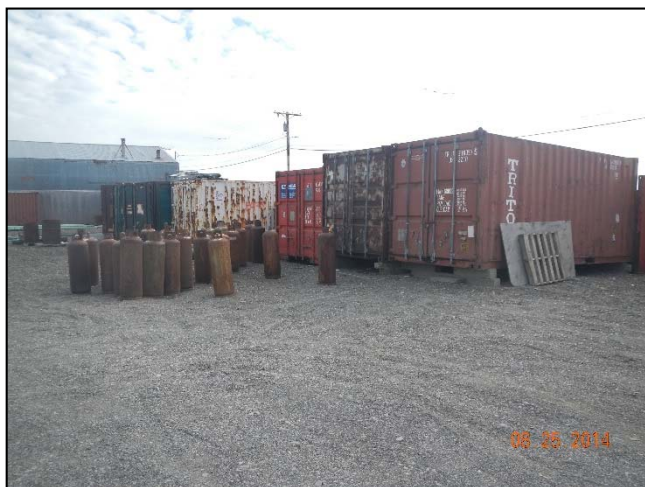
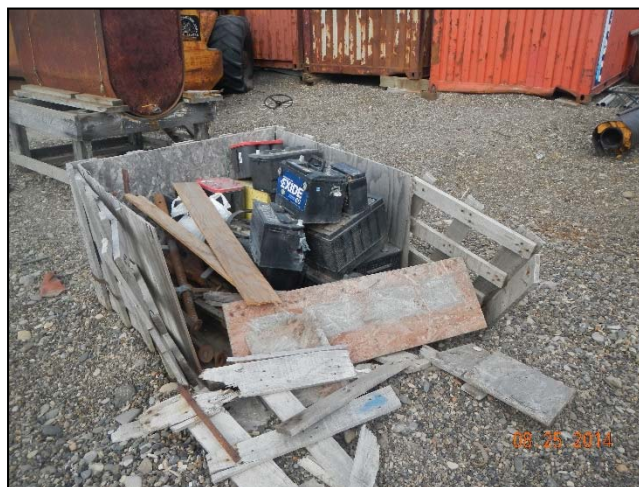
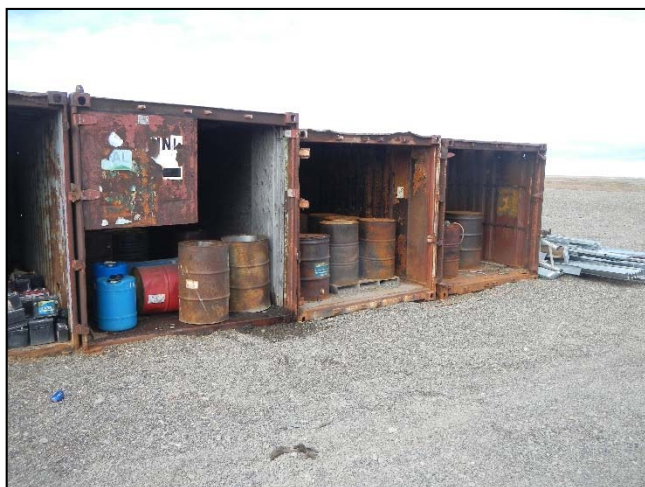
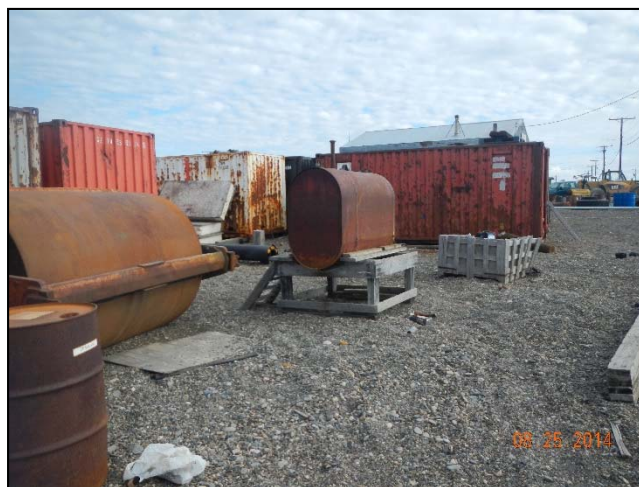
- **NSB Drum Storage Area, 68.346974/-166.740118 (Active)** – This site is located in the southwest area of town on the south side of the fueling station. This active Contaminated Site (File ID 420.38.002) is named *NSB Point Hope Drum Storage Area* and is due to soil contamination. It is a 5 acre site with the property owned by multiple landowners. As part of the cleanup, 320 drums were removed from Point Hope in August 2012. During the 2014 site visit, part of the site consisted of many Connex containers storing lead-acid batteries, 55 gallon drums with unknown contents and rusted propane tanks. The site is not fenced and is accessible to the public. The owner of the site is unknown. This site is approximately 960 feet from the Chukchi Sea.

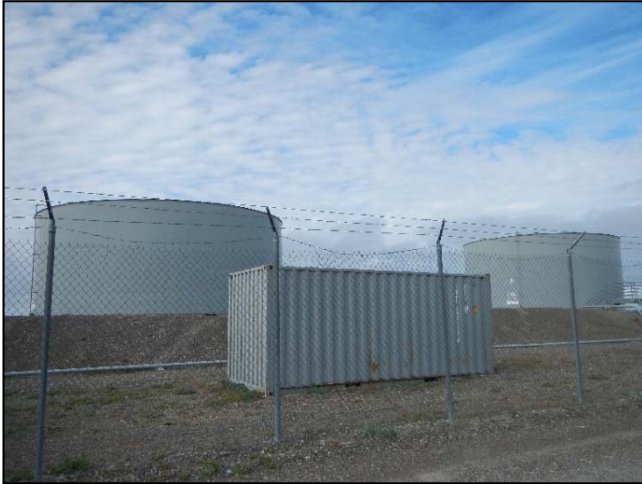
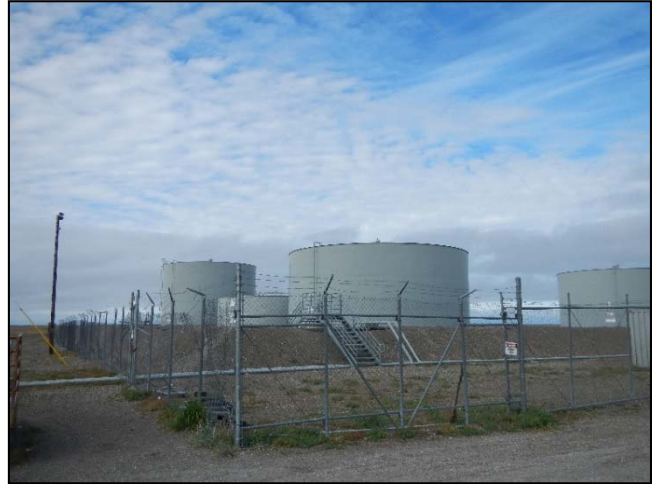
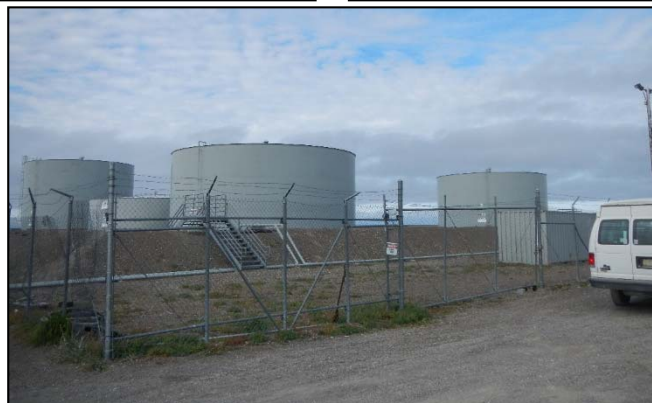
- **Community Tank Farm, 68.349346/-166.766151 (Active)** – This 1.5 acre site is an active community tank farm operated by the North Slope Borough and was constructed in the 1980s. This site is located a half mile directly west of the community. It is regulated by the ADEC Terminals and Tank Farms Section. It contains 4 large vertical tanks with a total capacity of 1,275,792 gallons of fuel. The site is completely fenced with secondary containment. This site is approximately 1,900 feet from the Chukchi Sea.

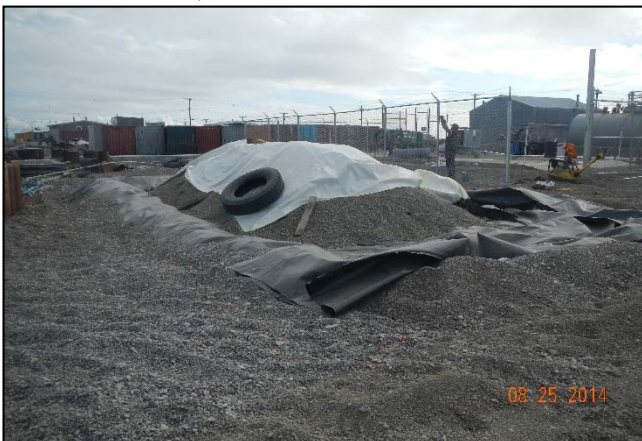
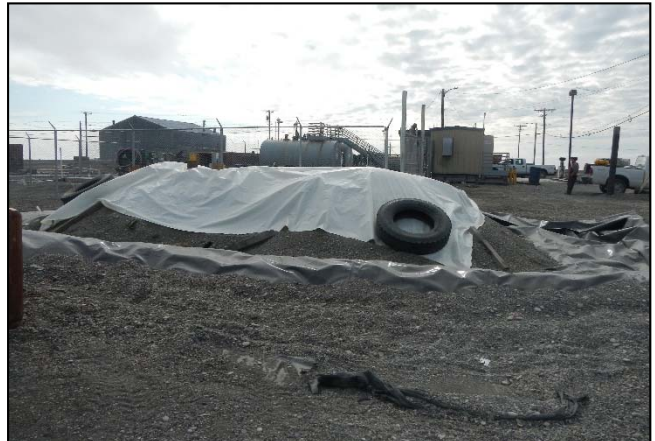
- **Fueling Station Tank Farm, 68.347285/-166.739909 (Active)** – This tank farm is located on the southwest side of the community. It is operated by the North Slope Borough and serves as the community fueling station. The site contains two small horizontal tanks with unknown capacity in a fenced secondary containment area. There was remediation work and tank farm upgrades in process during the visit. It has been in operation since around the 1980s and is located 1,050 feet from the Chukchi Sea.
