# ALASKA

## North Slope Spills Analysis

*Final Report on North Slope Spills Analysis and Expert Panel  
Recommendations on Mitigation Measures*

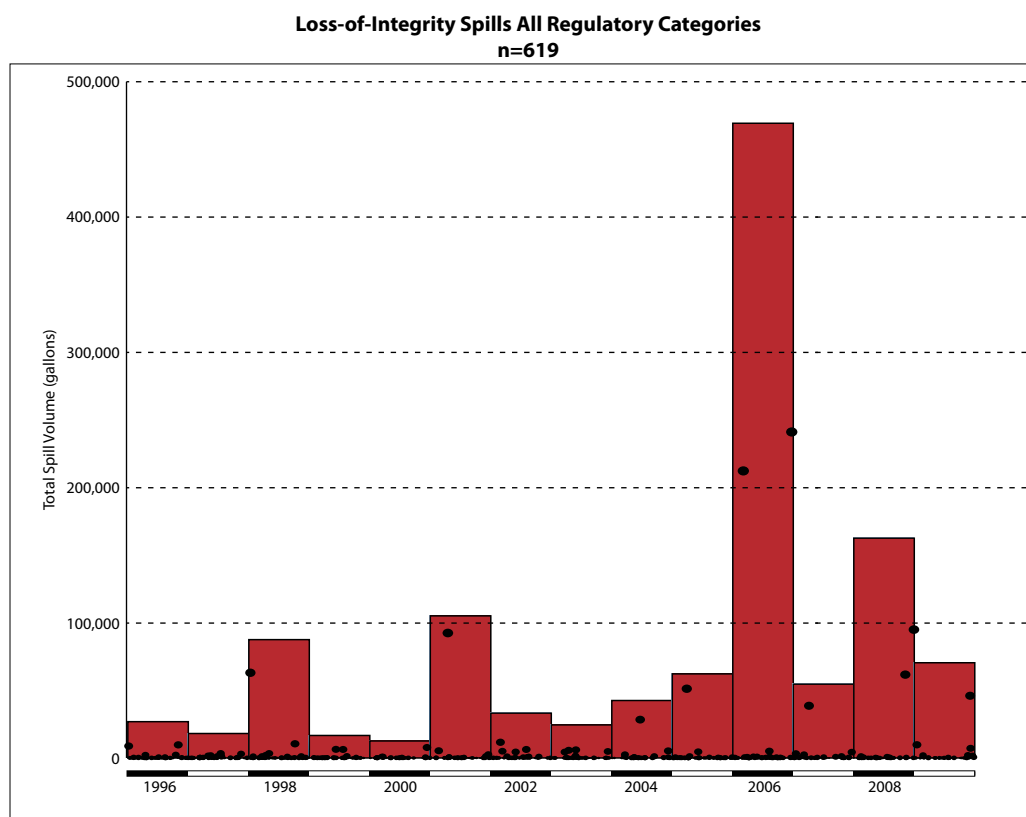
**Figure 3-4. Bar graph of total spill volume (gallons) by year and scatter plot of actual spill events, all North Slope loss-of-integrity spills.**

Figure 3-4 depicts a bar graph of total spill volume by year with an overlaid scatter plot of actual spill events plotted over the same time period. Note that the two largest spill events occurred in 2006 and 8 of the 12 spills greater than 10,000 gallons occurred in the years 2004 to 2009. This graph shows evidence of a trend of increasing spill quantity over the analysis time period. However, this trend is dependent on the two spills in 2006 and statistical tests are inconclusive in determining whether spill volume is increasing over time.

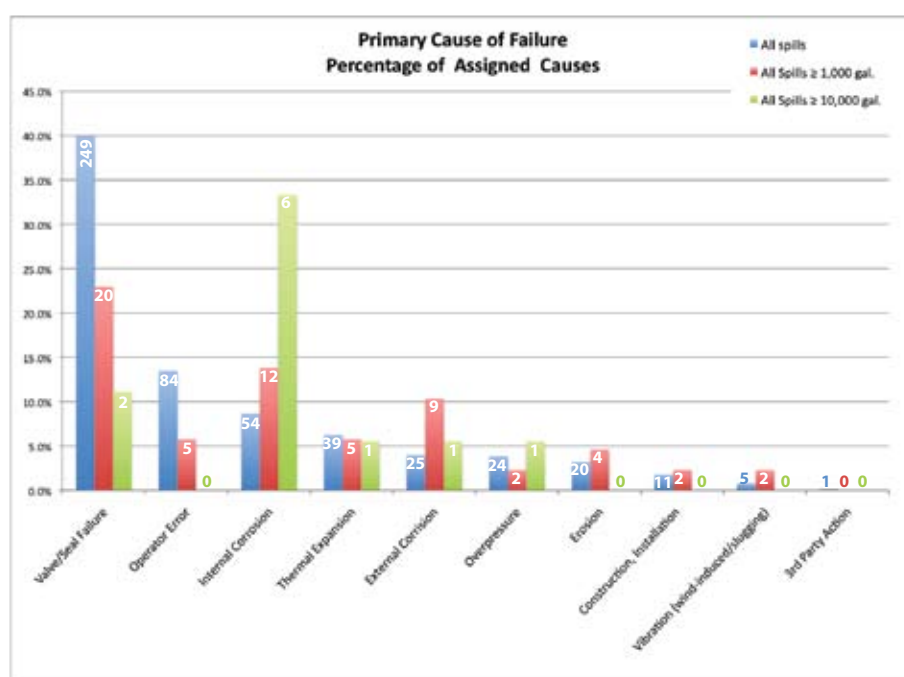
**Figure 3-6. Primary cause of failure assigned to three sets of spill size classes from loss-of-integrity spills reported by North Slope oil and gas operators during the study period.**

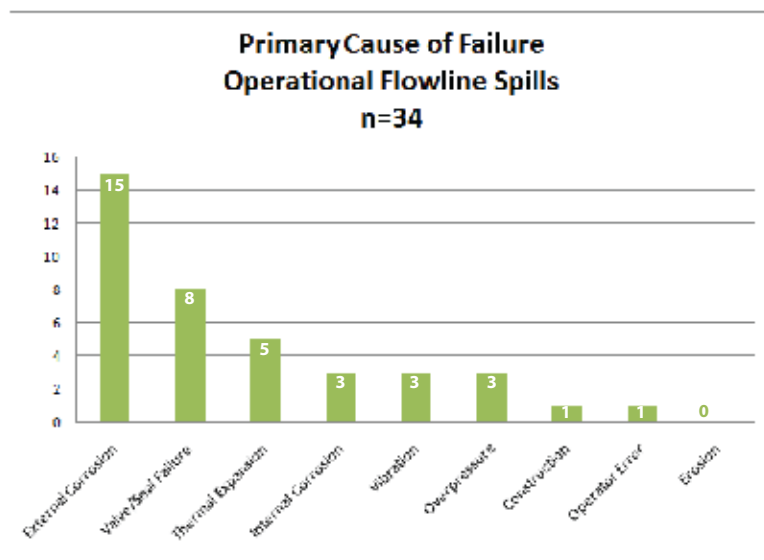
**Figure 3-13. Primary cause of failure for operational flowline spills.**

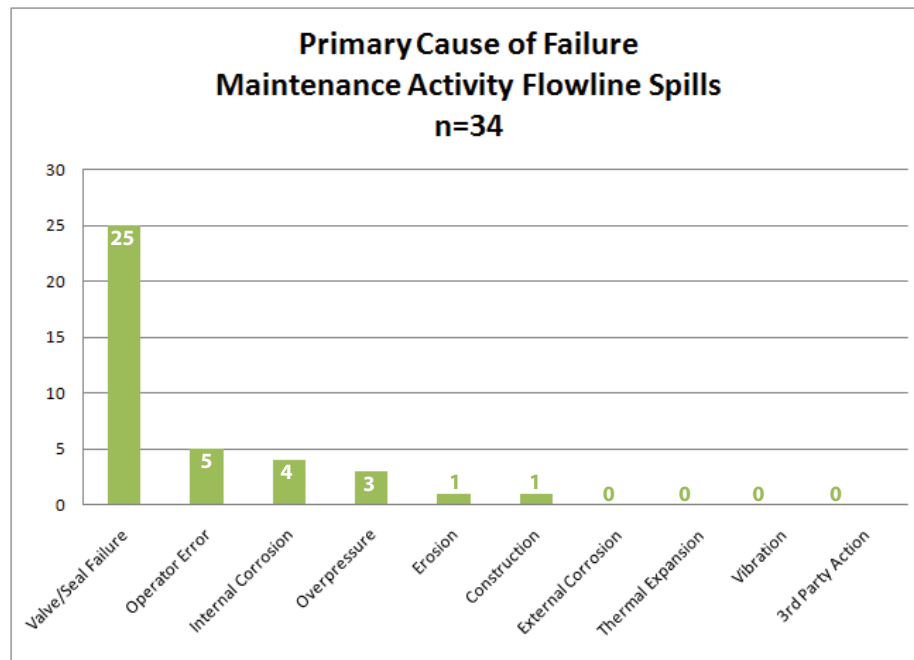
**Figure 3-17. Primary cause of failure for maintenance activity flowline spills.**
