ALASKA DEPARTMENT OF ENVIRONMENTAL CONSERVATION Division of Spill Prevention and Response Prevention Preparedness and Response Program SITUATION REPORT (SITREP)

## **Shungnak School Tank Heating Oil Release**

SITREP #: 3 and Final

SPILL #: 20389917201

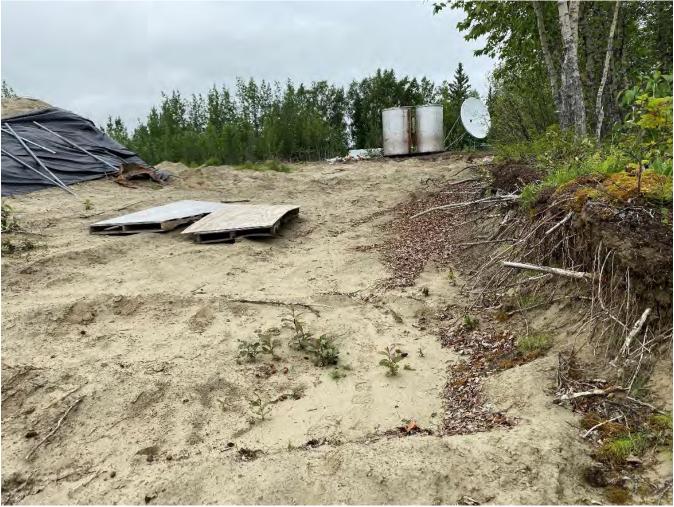
Photo 1: Spill site; looking northeast. (Photo: Tanana Commercial, July 15, 2021)

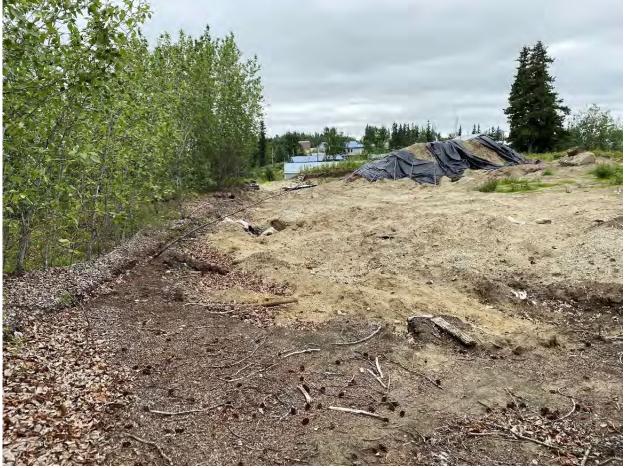
Photo 2: Spill site and contaminated soil stockpile; looking southwest. (Photo: Tanana Commercial, July 15, 2021)

**FUTURE PLANS AND RECOMMENDATIONS:** Due to ongoing management, this site has been transferred to the ADEC Contaminated Sites Program. The ADEC Contaminated Sites Program will continue to monitor the response actions and review plans being developed to clean up contaminated soils from the area and prevent heating oil migration to nearby resources. Clean up updates can be found online at:
