areALASKA DEPARTMENT OF ENVIRONMENTAL CONSERVATION  
Division of Spill Prevention and Response  
Prevention Preparedness and Response Program  
***SITUATION REPORT (SITREP)***

## **F/V Sea Ern Izhut Bay Kodiak Diesel Release**

**SITREP #:** 2 and final

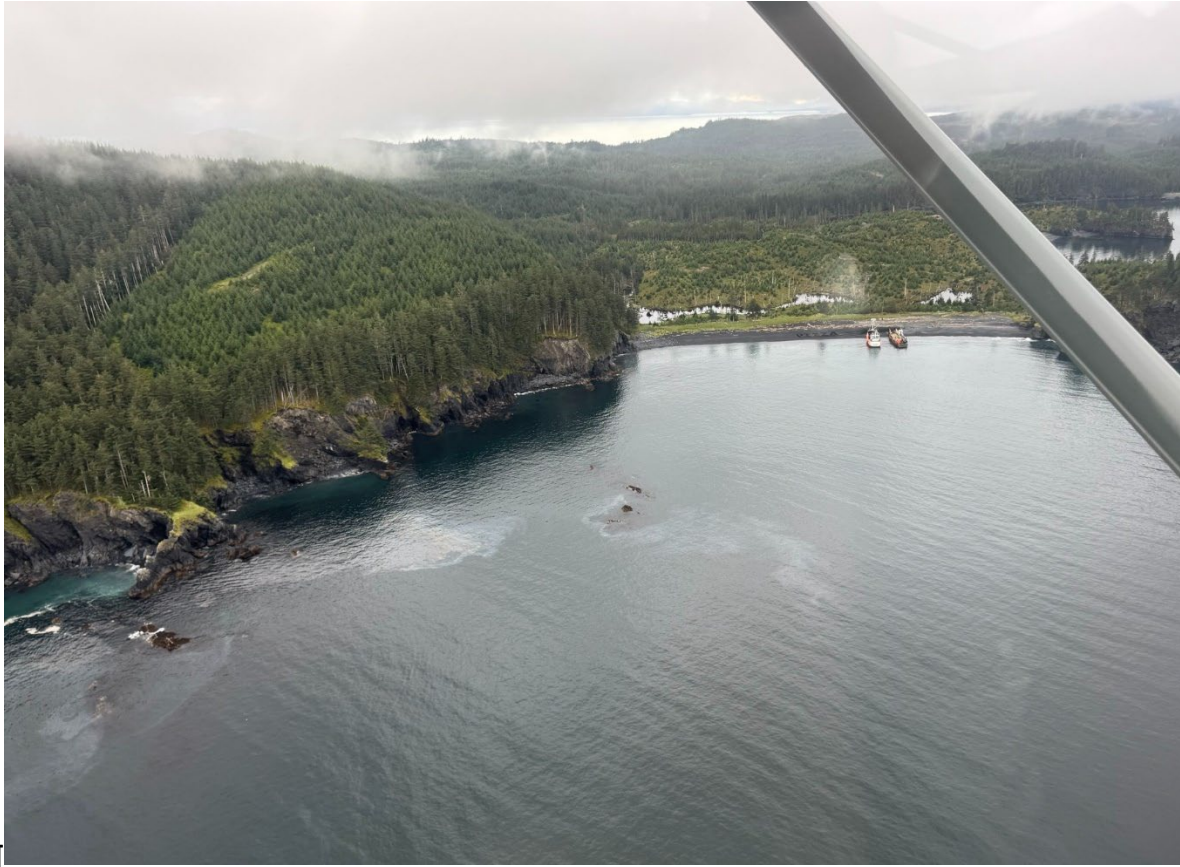
**Photo:** Izhut Bay, September 4, 2025. Photo credit, Alaska Department of Fish and Game
