Seldovia Slough, KB-15

Center of map at 59° 26.6' N Lat., 151° 42.7' W Lon.

Geographic Response Strategies for

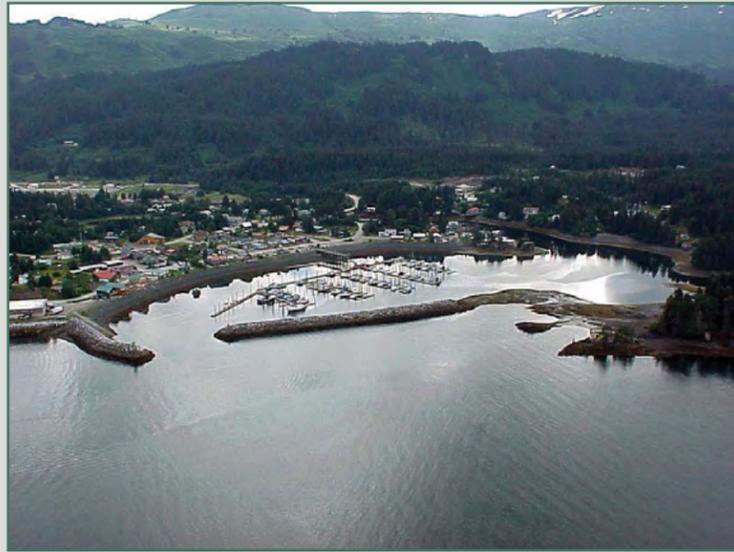
Seldovia Harbor, KB-15 as viewed from the West.

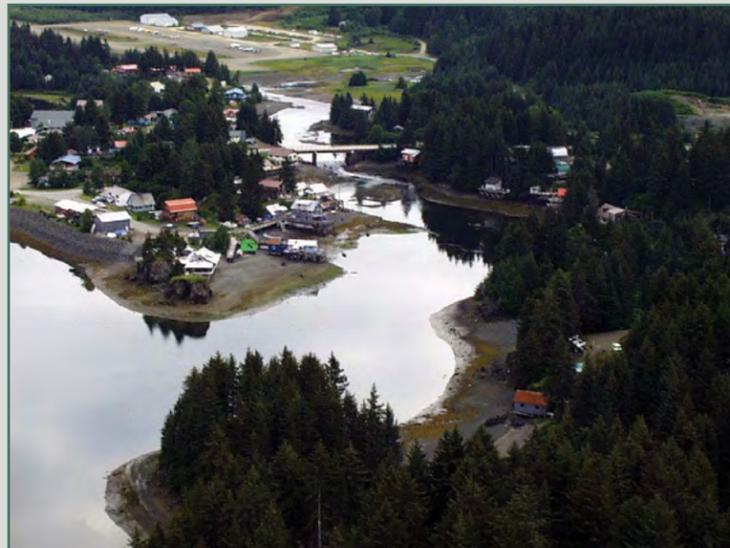
Seldovia Slough, KB-15-02 as viewed from the South.

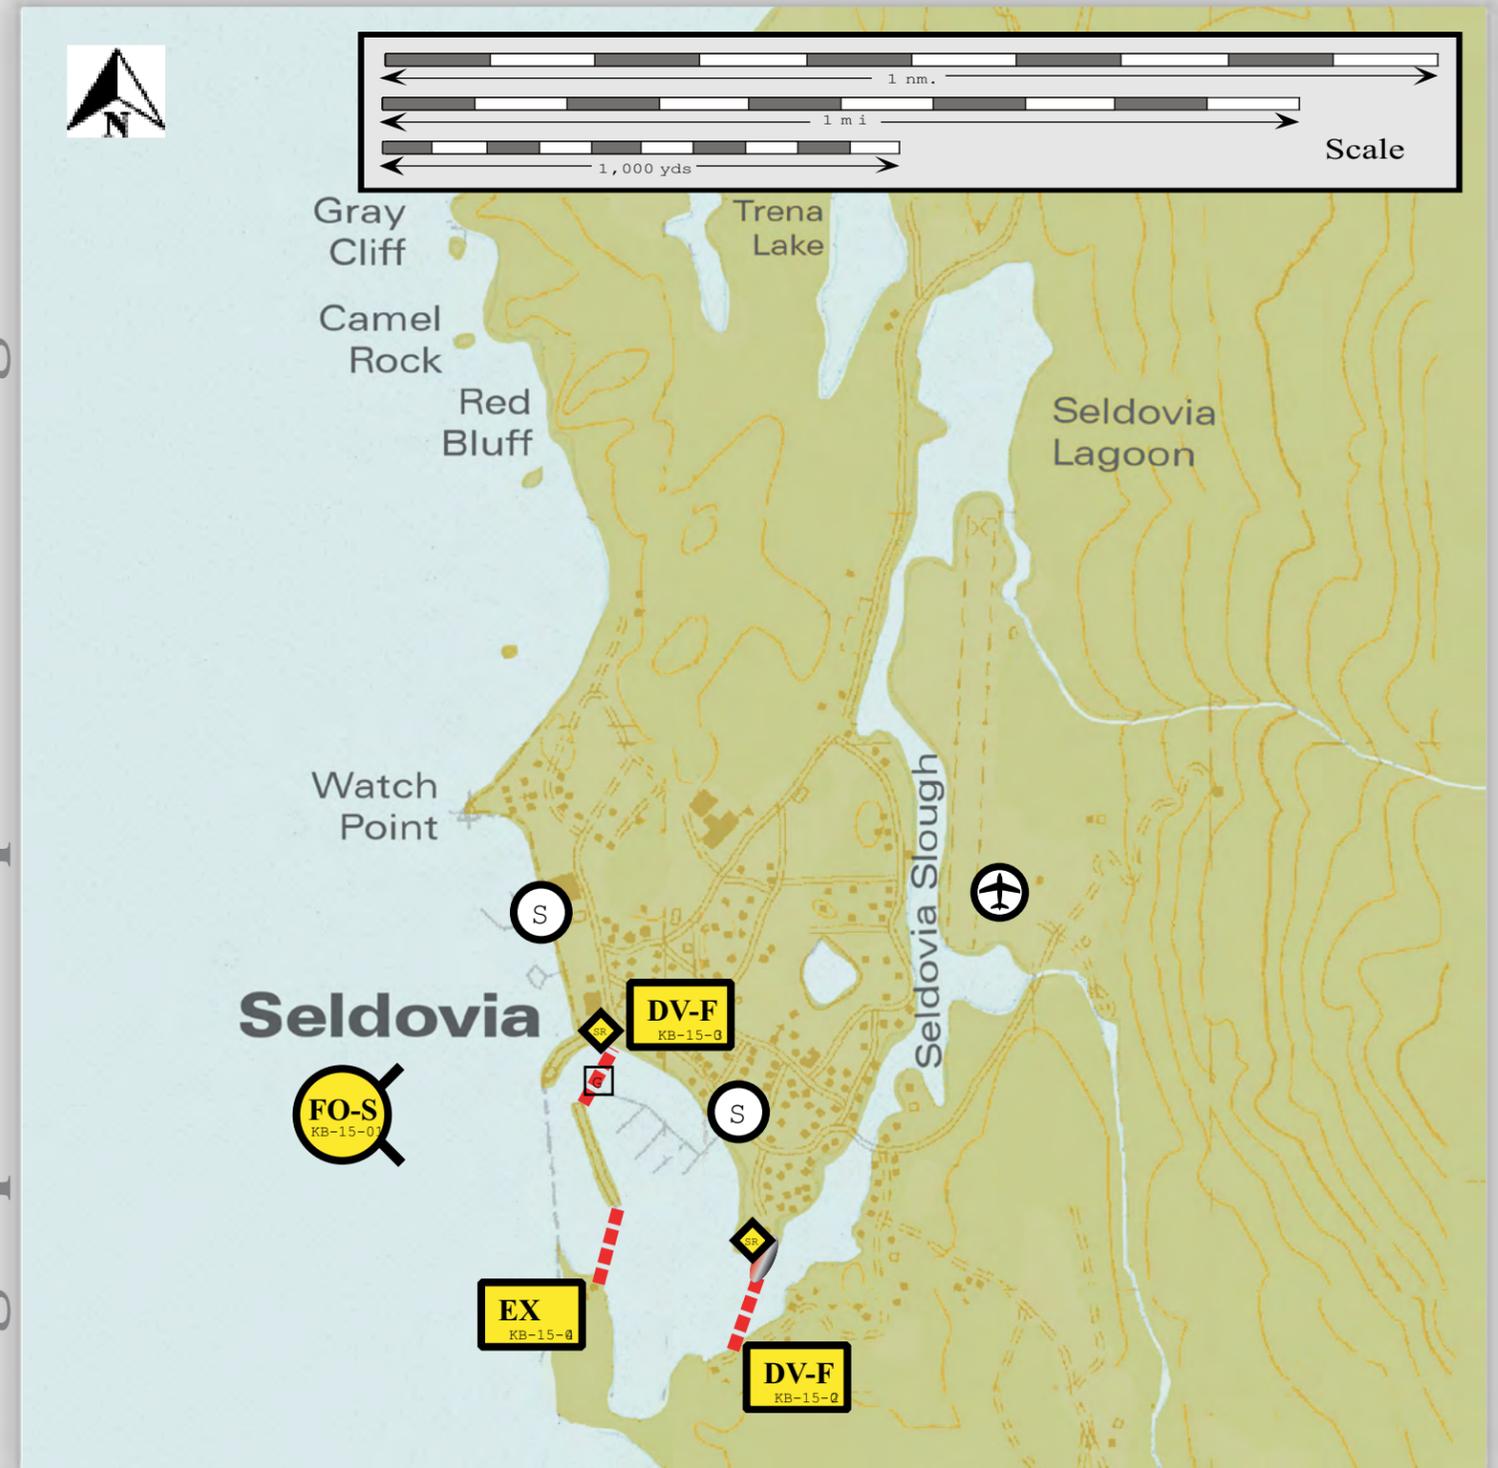
Soundings in fathoms
