ALASKA DEPARTMENT OF ENVIRONMENTAL CONSERVATION

SITUATION REPORT

Alaska Petroleum Dalton Highway MP 81.5 Release

SITREP#3

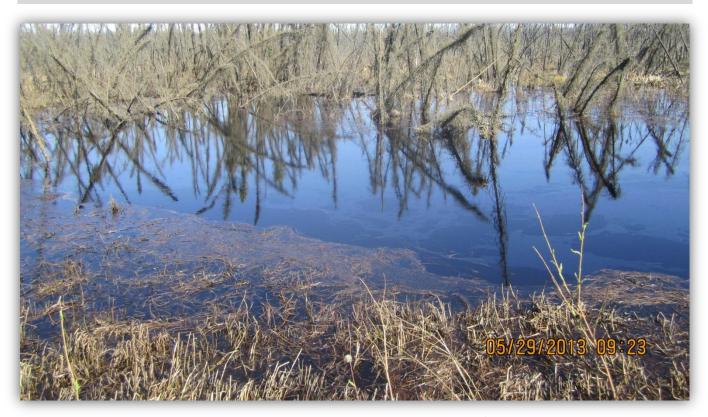
RESOURCES AFFECTED: One acre of moist tundra in the ditch has been impacted. A small pond that is approximately 300 feet away from the spill site has been impacted and has a visible sheen on the surface of the water. The Bureau of Land Management owns the land affected by the spill.

Fuel sheen observed on the pond south of the spill site, May 29, 2013. (Photo/ADEC)

FUTURE PLANS AND RECOMMENDATIONS: Alaska Petroleum is working with contractors to develop detailed cleanup, waste management and traffic plans for ADEC, Alaska Department of Transportation Maintenance and Operation (ADOT M&O), and BLM to review. ADEC will continue to monitor the response. ADEC is coordinating the response with ADOT M&O to ensure the roadway is restored to its previous condition.
