## ALASKA DEPARTMENT OF ENVIRONMENTAL CONSERVATION

SITUATION REPORT

## **Galena Flooding Event 2013**

SITREP#3

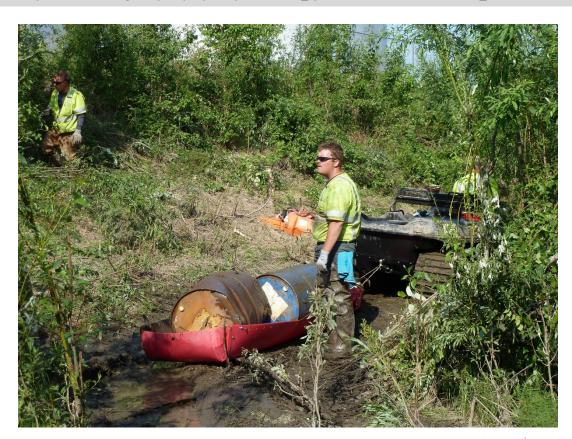
Flood-displaced drums being collected by a cleanup task force, June 24, 2013. (Photo/ADEC)

**SOURCE CONTROL:** More than 1,200 containers containing hazardous liquids, ranging in size from 55-gallon drums to aerosol cans, have been brought to a secure collection area by cleanup crews and Galena residents. Potentially hazardous solid wastes, such as refrigerators, freezers, electronic devices, batteries, and fire extinguishers are also being brought to the collection area. Responders continue work to identify additional potential sources of contamination.
