ALASKA DEPARTMENT OF ENVIRONMENTAL CONSERVATION
Division of Spill Prevention and Response
Prevention and Emergency Response Program
SITUATION REPORT

Kotzebue 483 8th Ave., HHO Spill

SITREP # 2

SPILL #: 14389904101

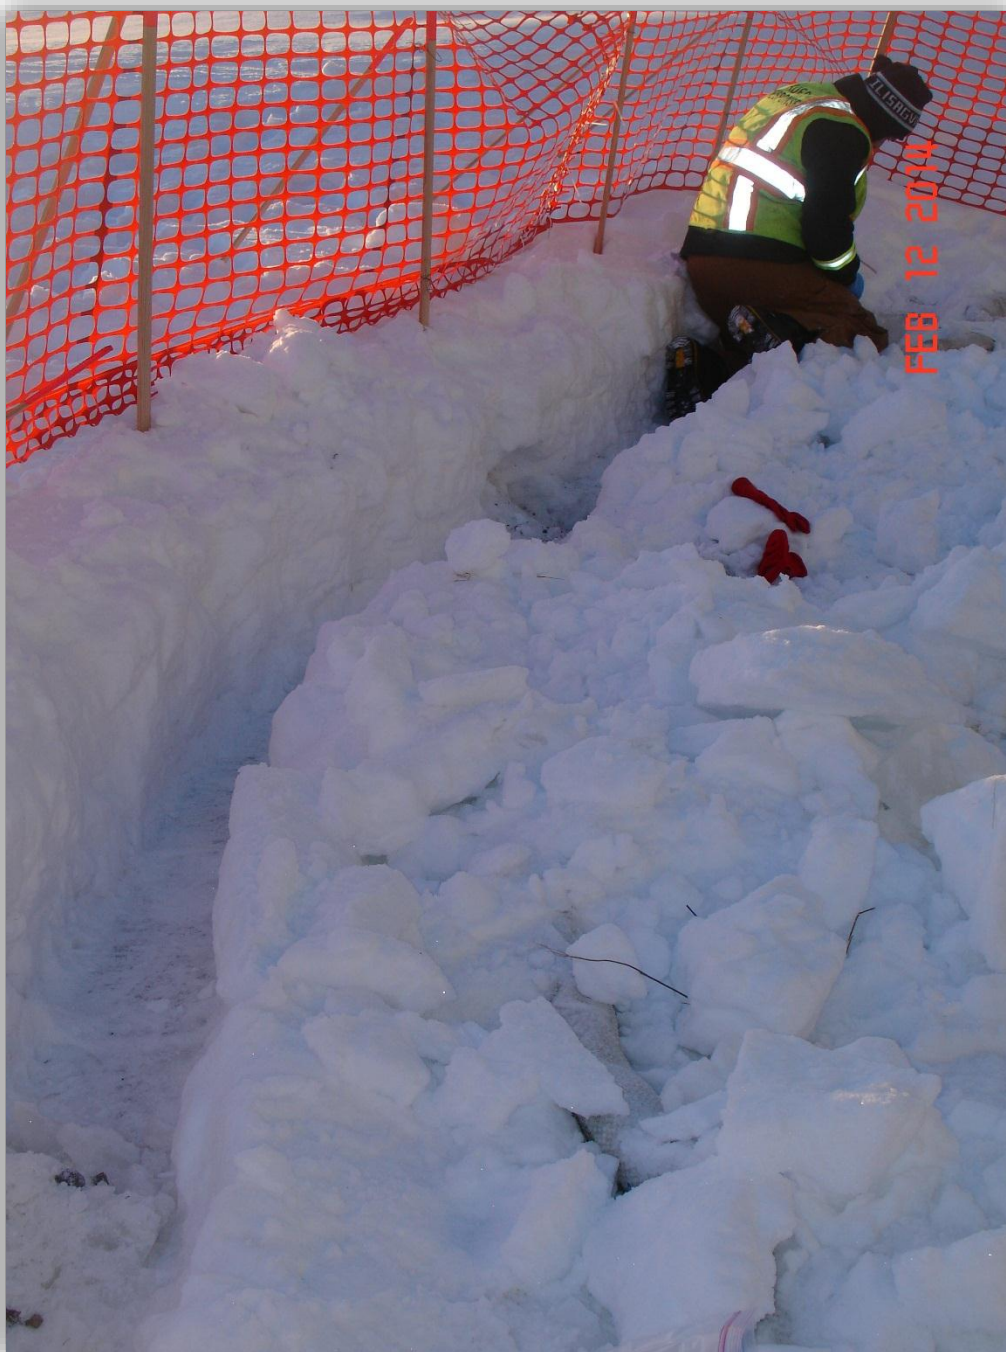
ADEC responder collecting screening samples during delineation efforts (John Ebel/ADEC photo)
