ALASKA DEPARTMENT OF ENVIRONMENTAL CONSERVATION
Division of Spill Prevention and Response
Prevention and Emergency Response Program
SITUATION REPORT

Kotzebue 483 8th Ave. HHO Spill

SITREP # 3 and Final

SPILL #: 14389904101

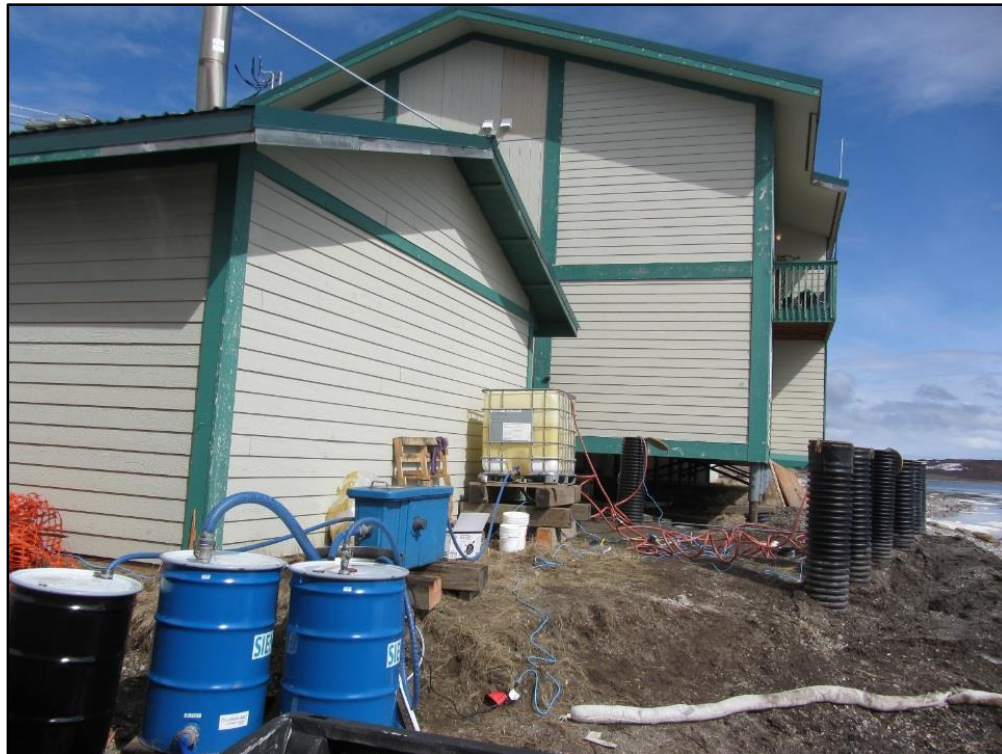
Spill area with recovery sumps and water treatment system (RSE photo)

Prior to spring breakup, KIC employees together with environmental consultant Restoration Science Engineering, LLC (RSE) installed eight recovery sumps. During spring breakup, a water treatment system was installed to treat oily water recovered from the sumps. As of July 7, 2014, three barrels of spilled diesel have been recovered from the sumps. KIC will continue to monitor the sump operations and will monitor the Kotzebue Lagoon daily for any evidence of sheen. They will provide ADEC will a weekly report on these operations.

FUTURE PLANS AND RECOMMENDATIONS: KIC will continue to operate the recovery sumps/water treatment system and will selectively remove affected gravel from the spill area. KIC is evaluating the potential to use flood and recovery tactics. This tactic will be developed and executed as appropriate to site conditions.
